# the **play inspection** company

## Annual Inspection

Colsterworth & District Parish Council

Colster Way Play Area

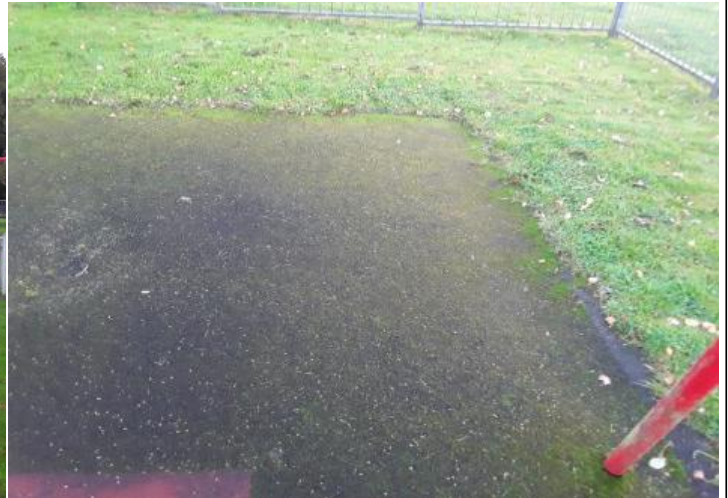
**Finding:** There is algae, silt or moss growth on the safety surface resulting in slippery conditions

**Action:** Clean and treat appropriately

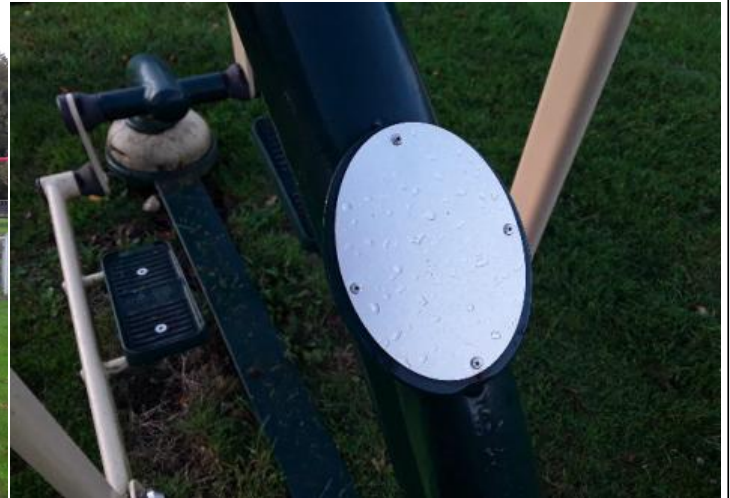
**Finding:** The fitness equipment I'D labels have faded and become illegible

**Action:** Replace the labels as required

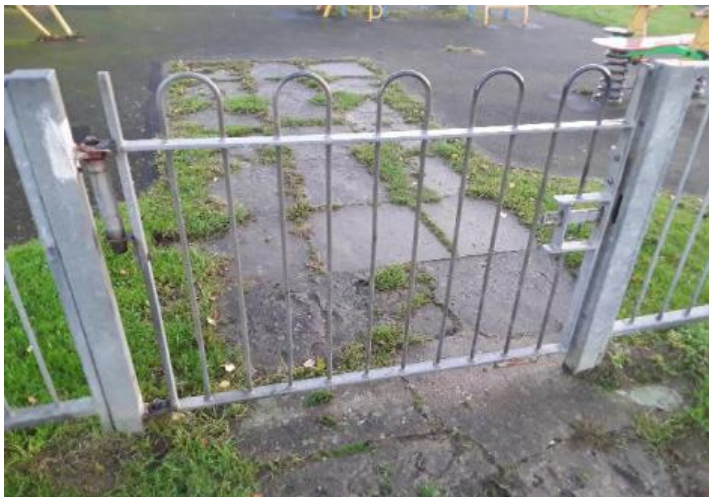
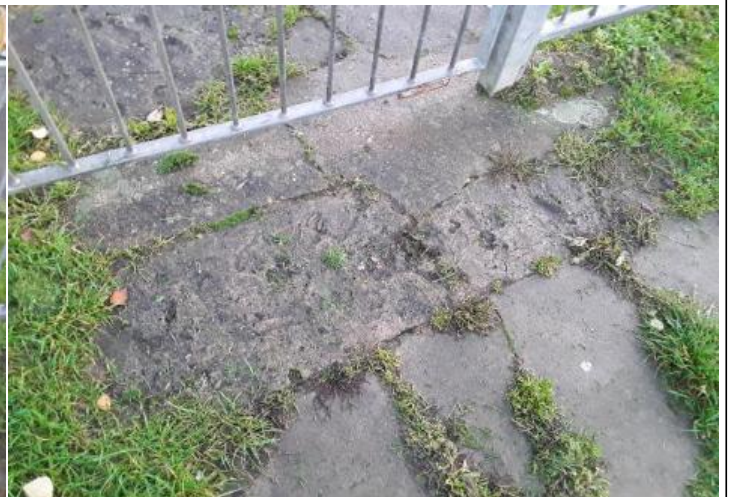
**Finding:** The concrete base under the gate is uneven creating trip hazards

**Action:** Repair the damaged areas of concrete to provide a uniform surface

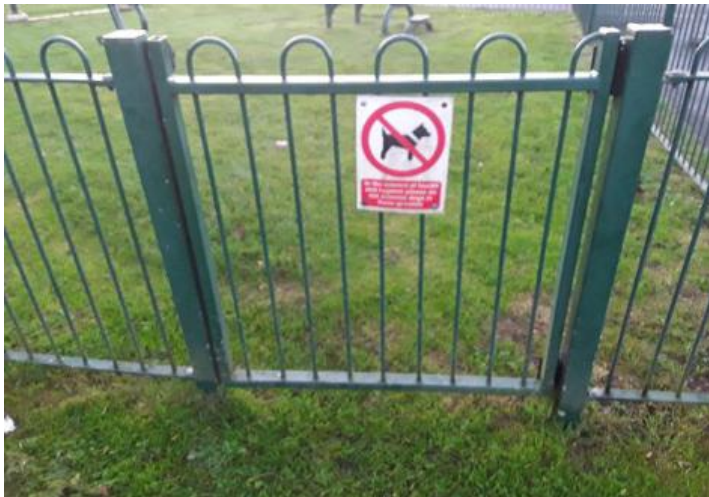
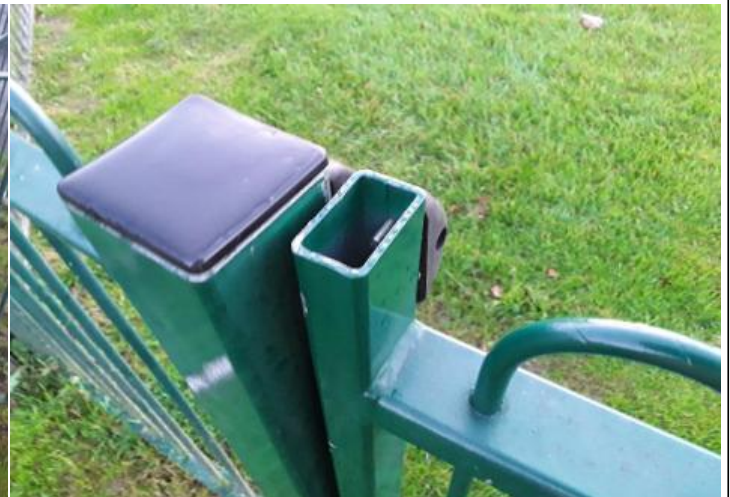
**Finding:** There is / are post or end caps missing / damaged  
**Action:** Replace missing / damaged post or end caps on the item

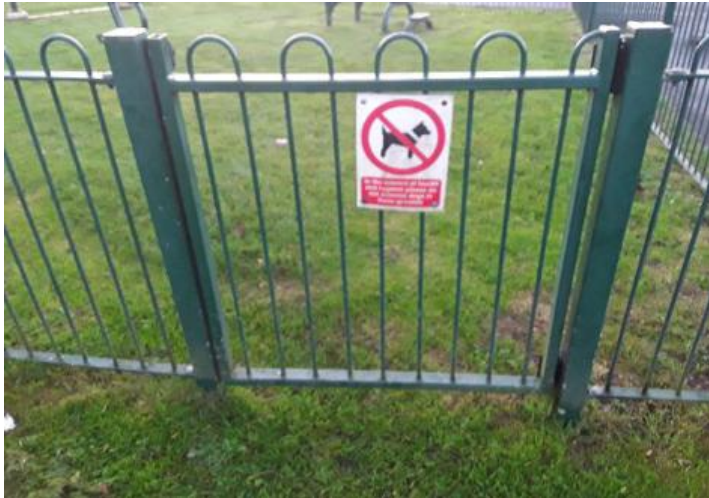
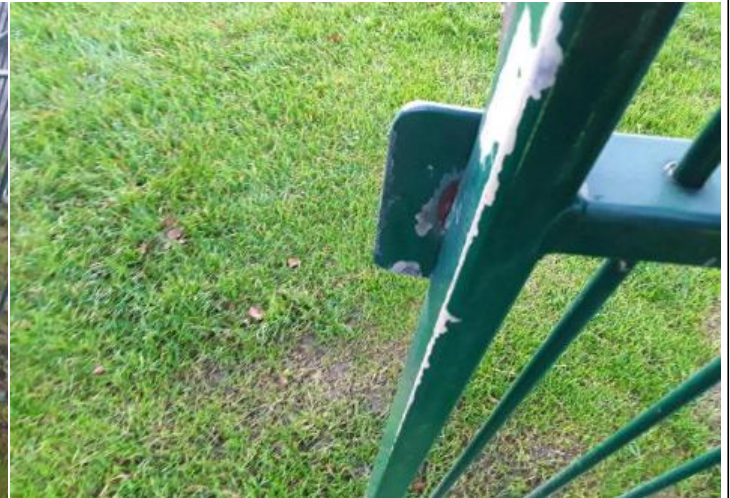
**Finding:** The rubber buffer is missing from the latch plate

**Action:** Replace rubber buffer

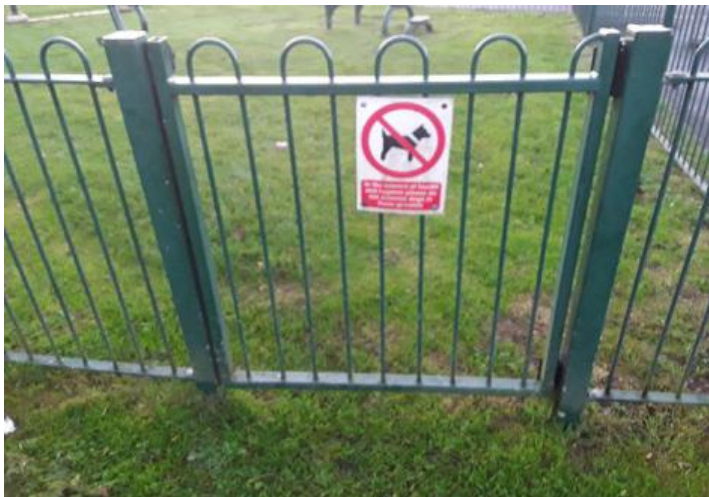
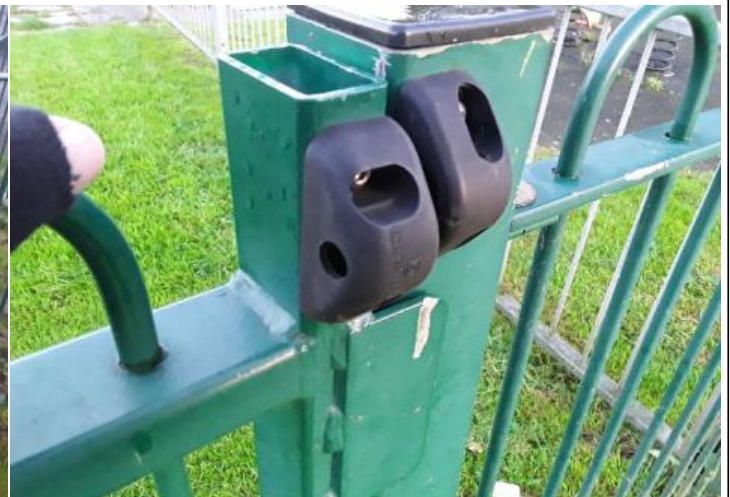
**Finding:** The gate latch is damaged

**Action:** Repair or replace the latch

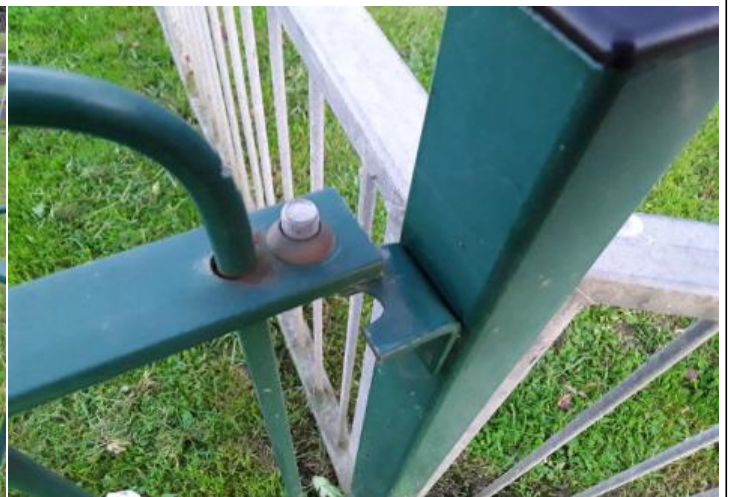
**Finding:** A number of fixings have worked loose around the fencing

**Action:** Secure all loose fixings

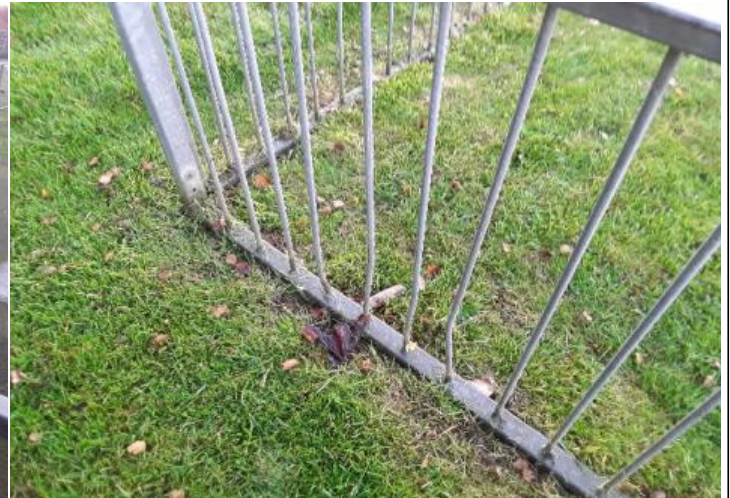
**Finding:** There is minor damage to the fence sections

**Action:** Monitor for any further deterioration and repair as required

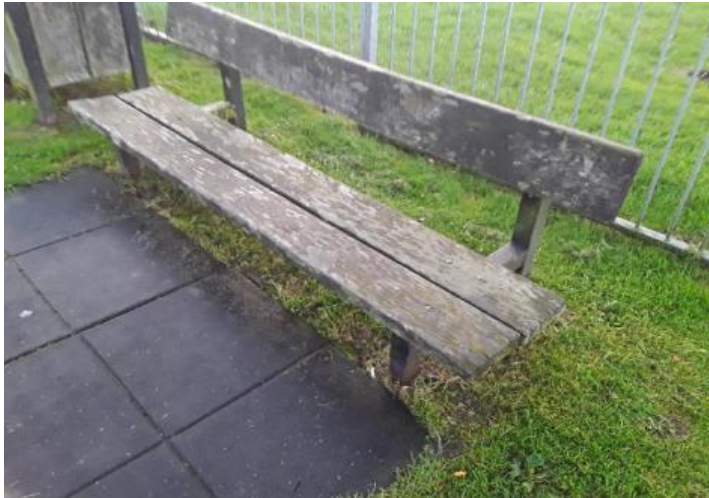
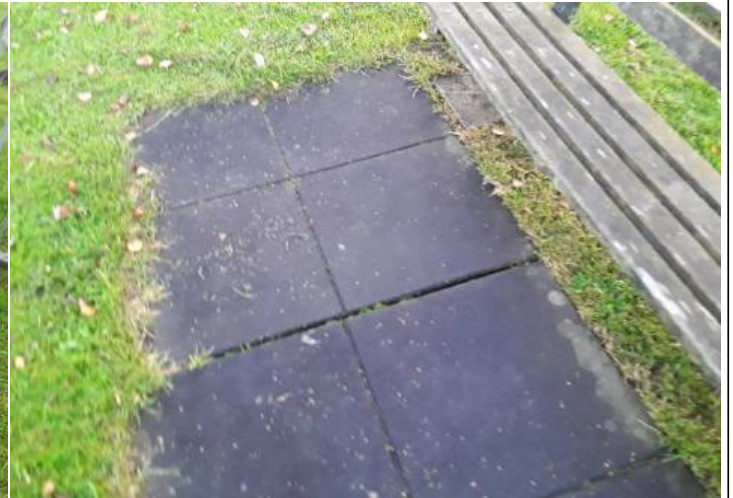
**Finding:** There are gaps opening in between the tiles in front of the bench

**Action:** Monitor for any further deterioration and repair as required

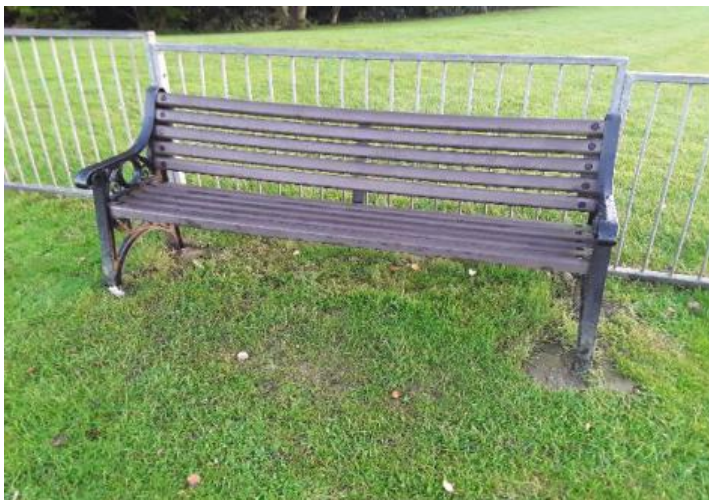
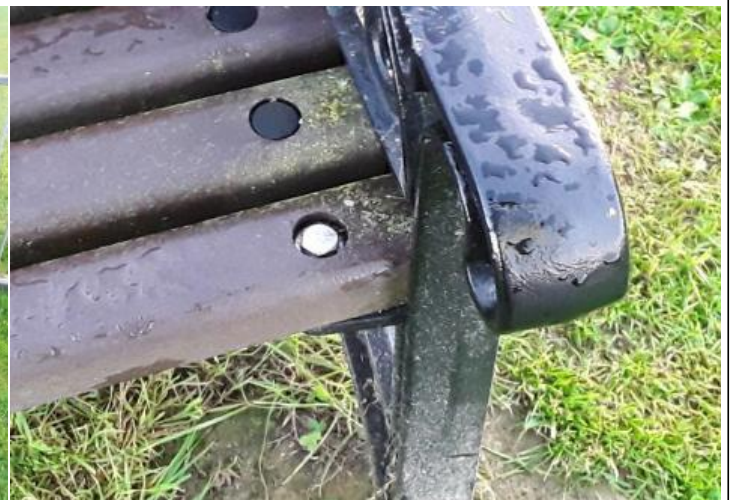
**Finding:** There is/are bolt cap covers missing or damaged on the item

**Action:** Replace missing or damaged bolt cap covers

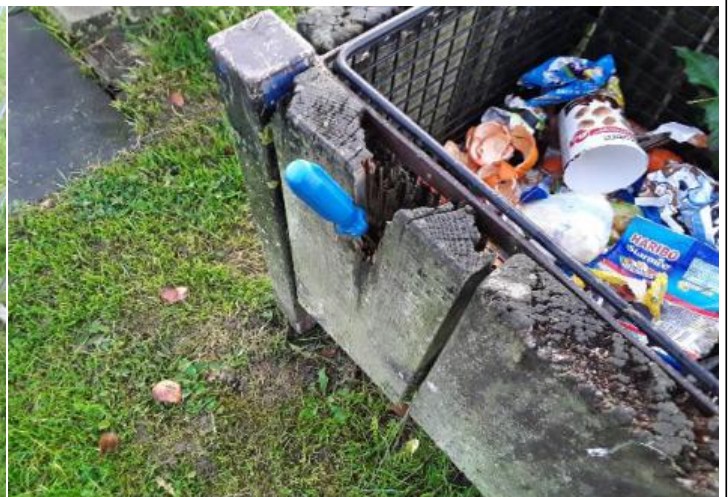
**Finding:** There are parts of the timber on the structure that have rotted

**Action:** Replace all affected timbers

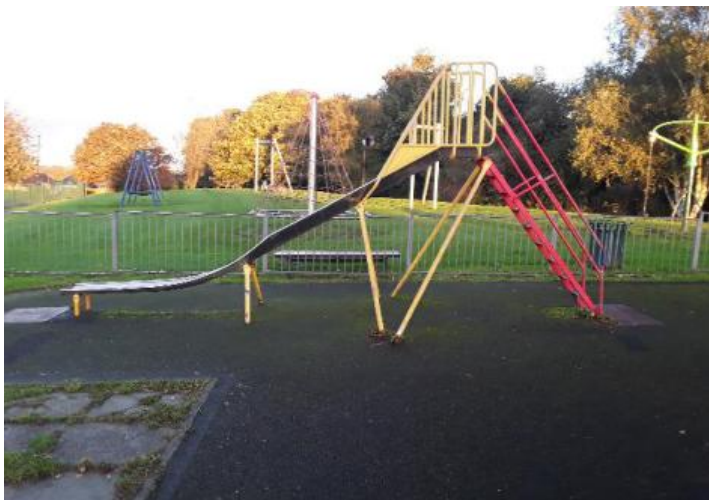
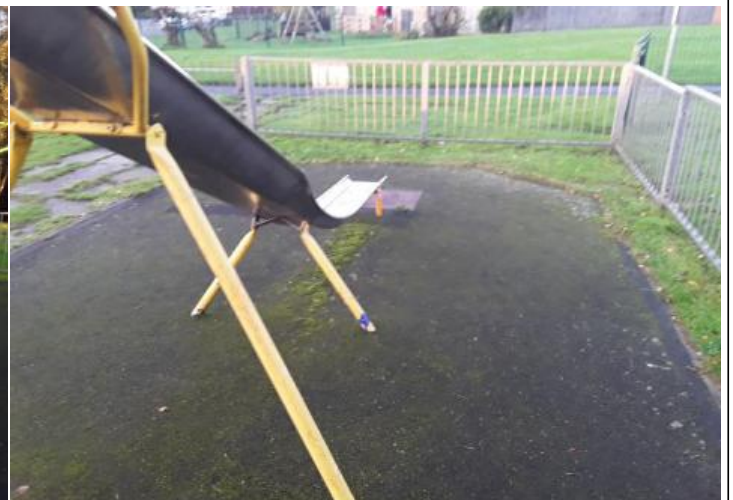
**Finding:** The slide is predominately south facing and will catch the majority of the sun's heat during the day. Slide surfaces can become very warm during periods of sustained sunny weather  
**Action:** Monitor - No remedial work recommended

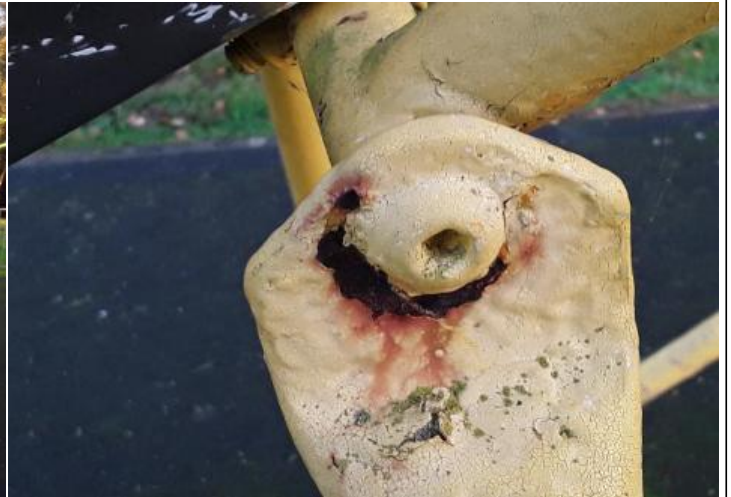
**Finding:** The paintwork on this item has been damaged or worn exposing the metal underneath which is rusting / corroding

**Action:** Treat affected areas and repaint

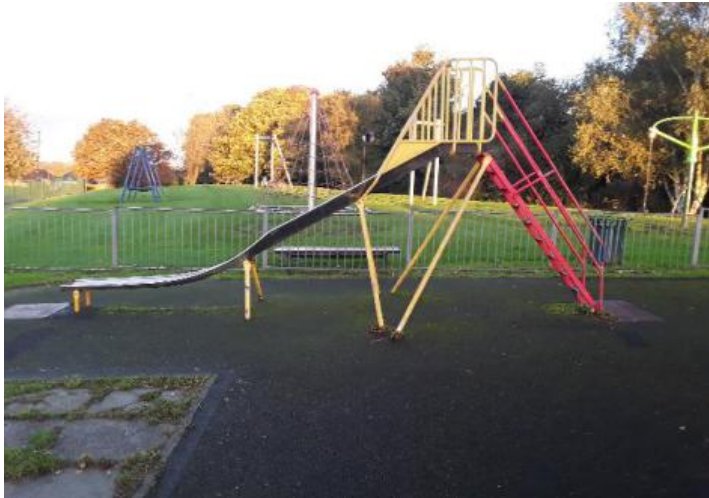
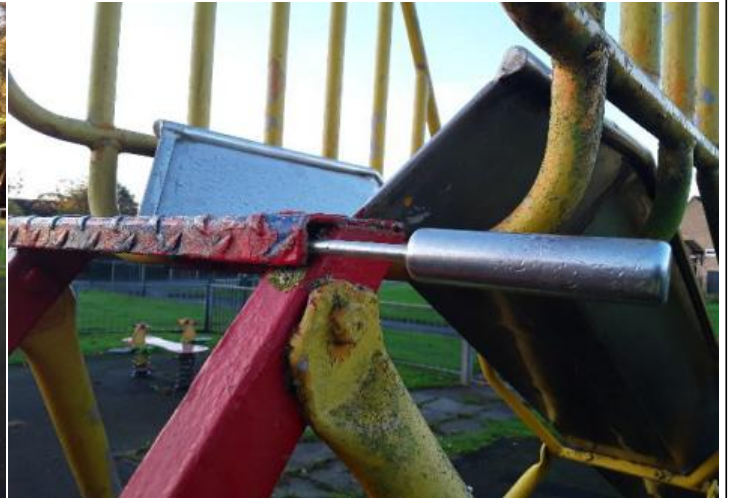
**Finding:** There is/are finger entrapment/s in the structure and the item fails to meet the requirements of BS EN 1176 Part 1 4.2.7.6 Entrapment of fingers

**Action:** Monitor - No remedial work recommended

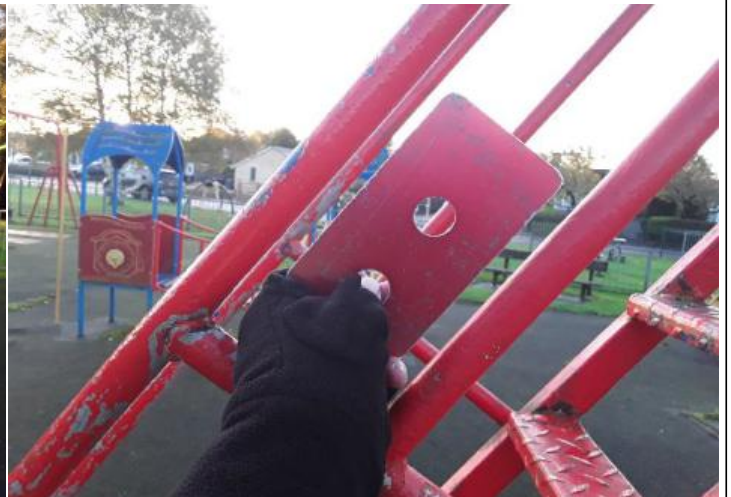
**Finding:** The item fails to meet the requirements of BS EN 1176 Part 1 4.2.7.2 head and neck entrapment in the barriers and/or steps

**Action:** Monitor - No remedial work recommended

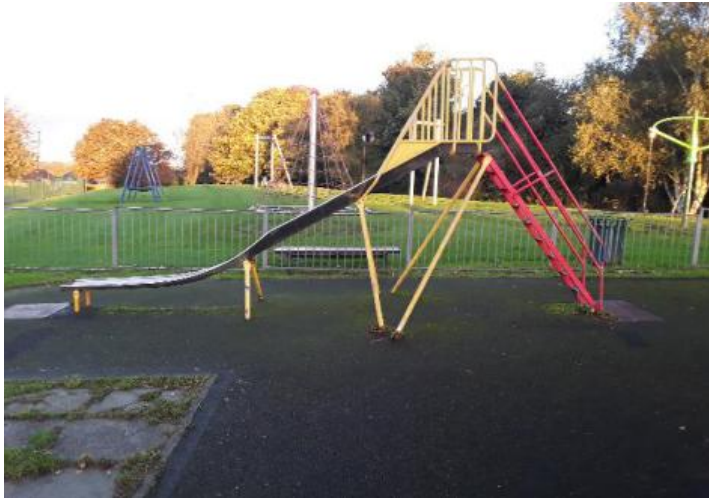
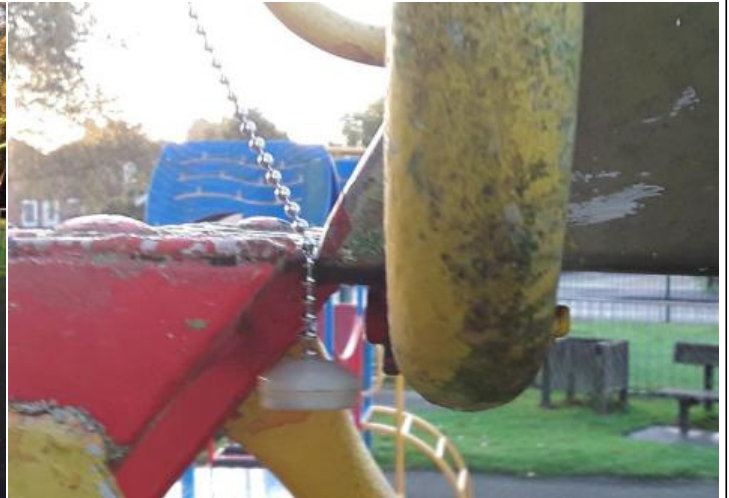
**Finding:** There is / are toggle entrapment/s present in contravention of the recommendations set out in BS EN 1176 Part 1

**Action:** Monitor - no remedial work recommended

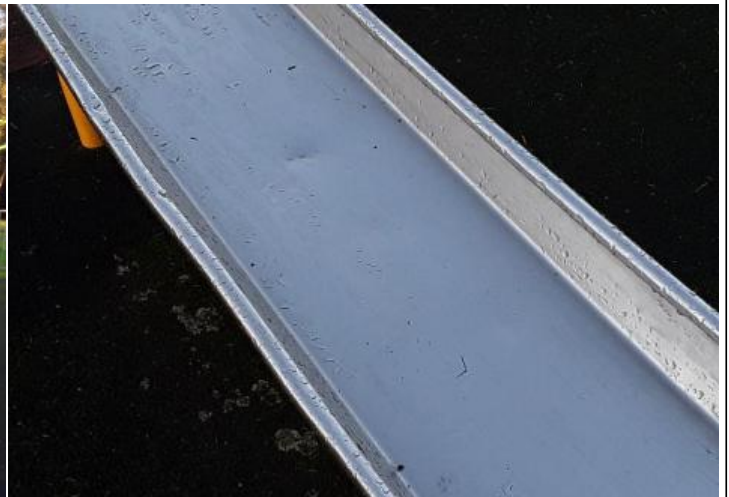
**Finding:** There are a number of dents in the slide surface

**Action:** Monitor for any further deterioration and repair as required

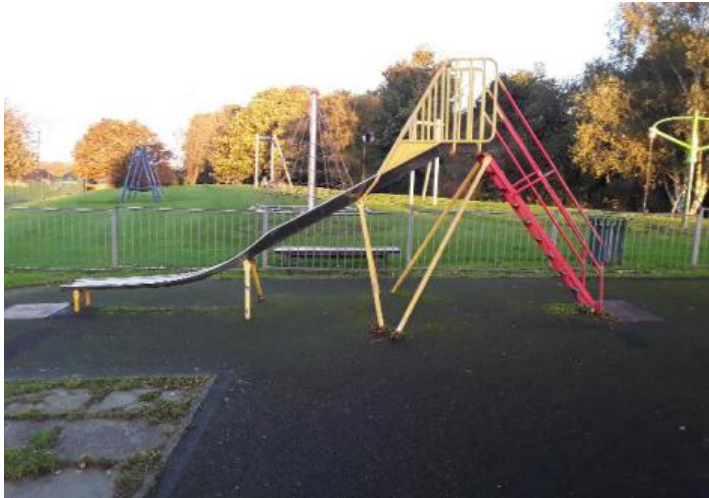
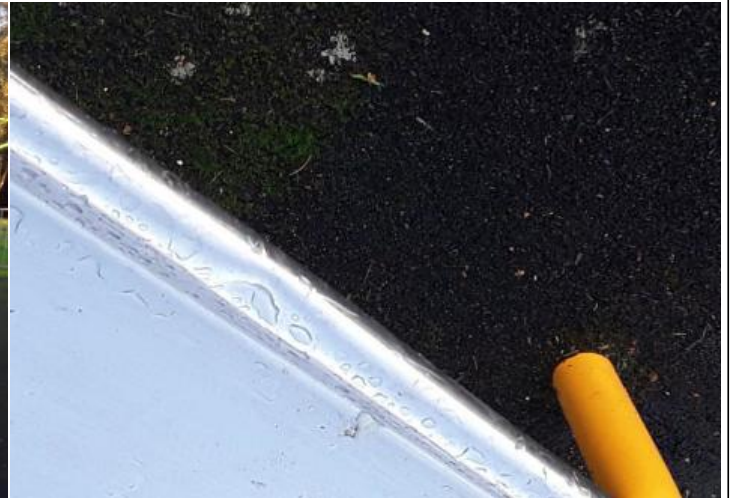
**Finding:** The side of the slide is damaged

**Action:** Monitor for any further deterioration and repair as required

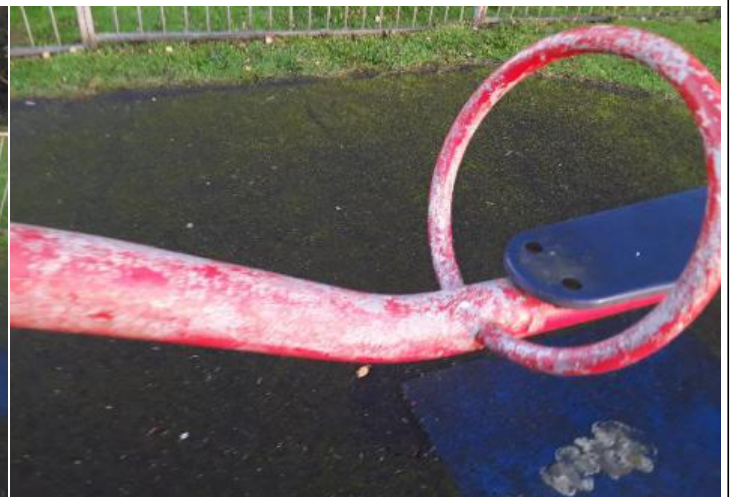
**Finding:** There is surface corrosion / rust present on the item

**Action:** Consider treating the item

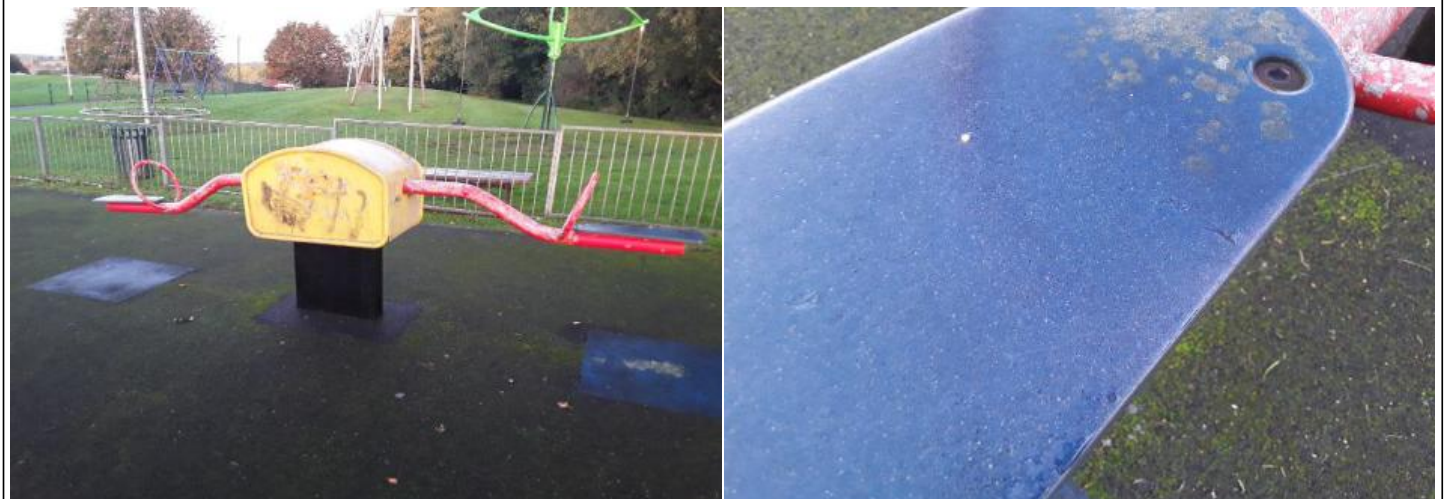
**Finding:** The seat has minor damage or wear  
**Action:** Monitor for any further deterioration and replace as required

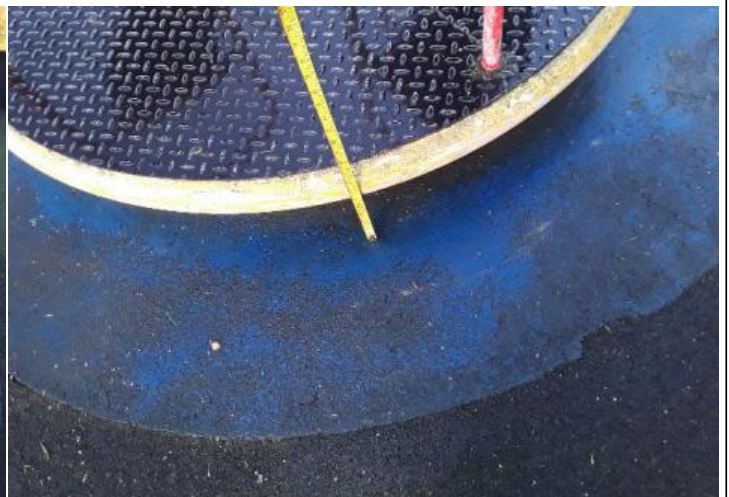
**Finding:** The distance between the underside of the roundabout platform and the playing surface is in excess of 110mm and contravenes the requirements of BS EN 1176 Part 5 which requires that the distance be maintained between 60mm-110mm - for the entire circumference of the roundabout

**Action:** Monitor - No remedial work recommended

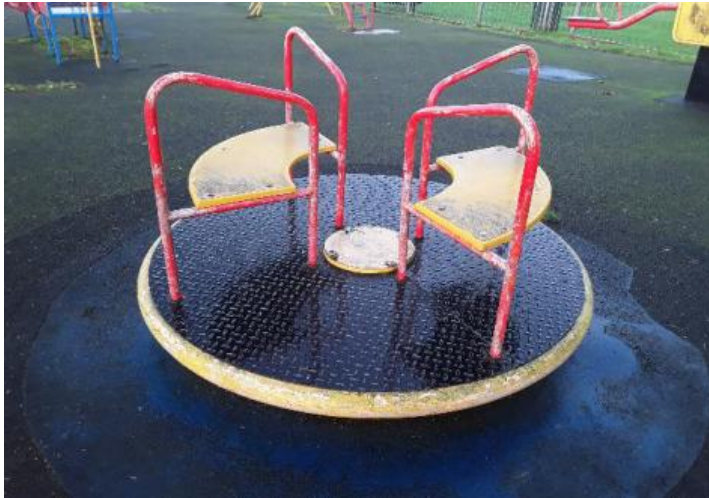
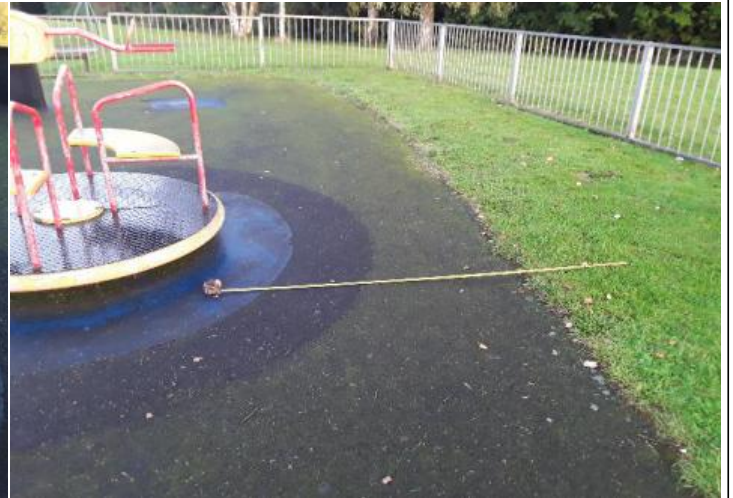
**Finding:** The surfacing dimensions are short and do not meet with the requirements of the current applicable standard

**Action:** Monitor - no remedial action recommended

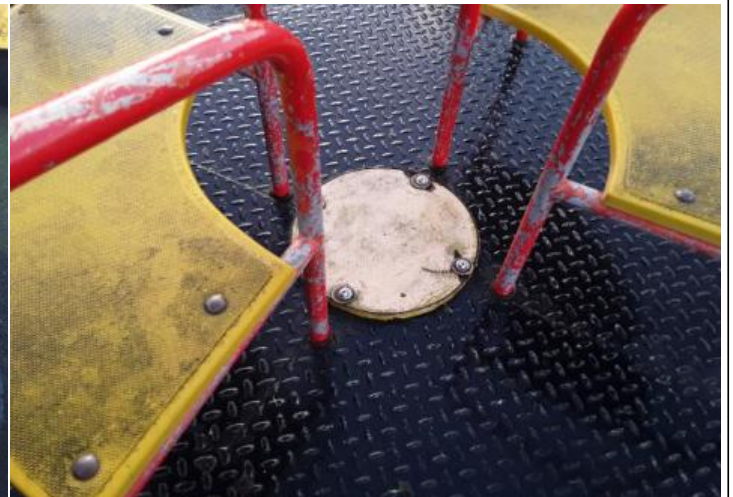
**Finding:** The bearing is showing signs of wear

**Action:** Monitor for any further deterioration and replace as required

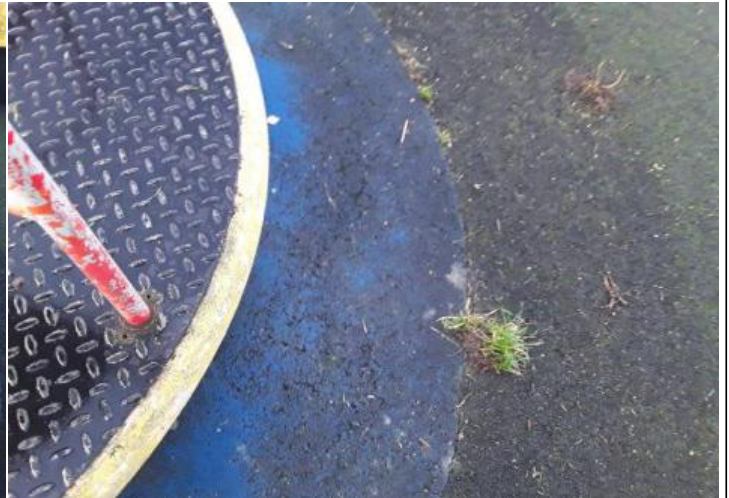
**Finding:** There is damage to the surface

**Action:** Repair the damaged areas of surfacing

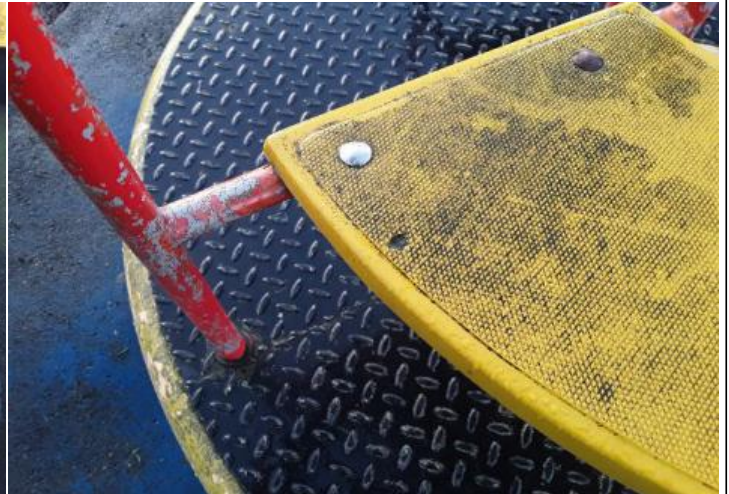
**Finding:** The seat has minor damage or wear

**Action:** Monitor for any further deterioration and replace as required

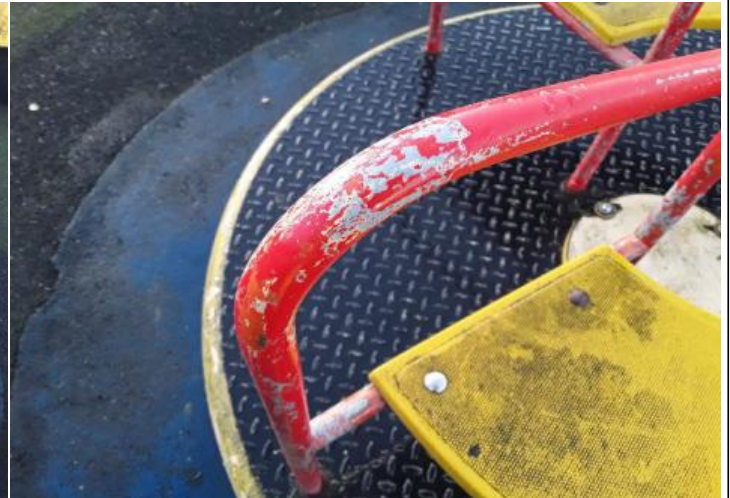
**Finding:** There is surface corrosion / rust present on the item

**Action:** Consider treating the item

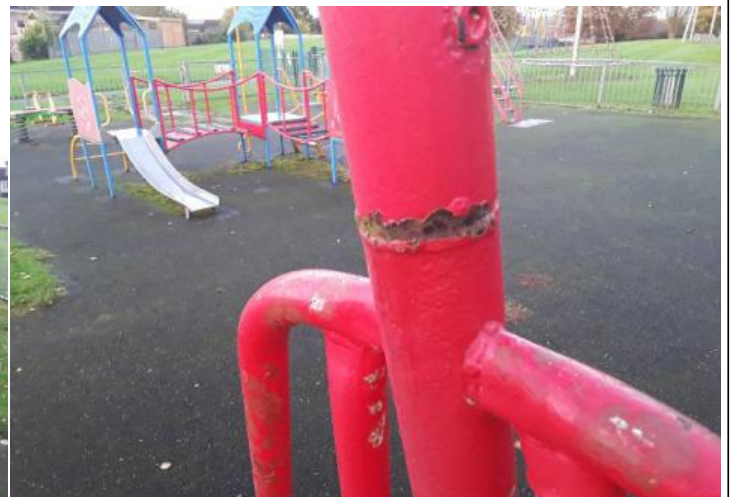
**Finding:** There is surface corrosion / rust present on the item

**Action:** Consider treating the item

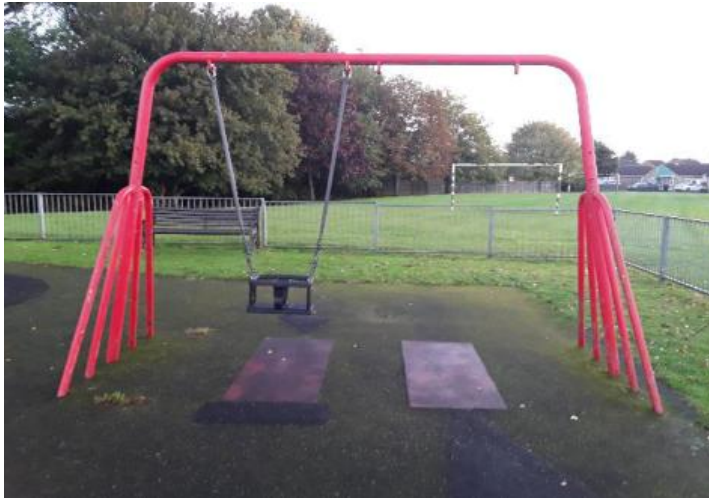
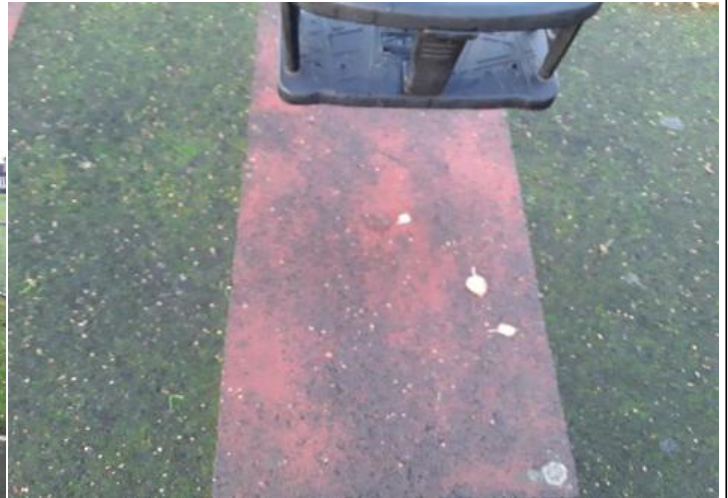
**Finding:** There is minor damage to the surface

**Action:** Monitor for any further deterioration and repair as required

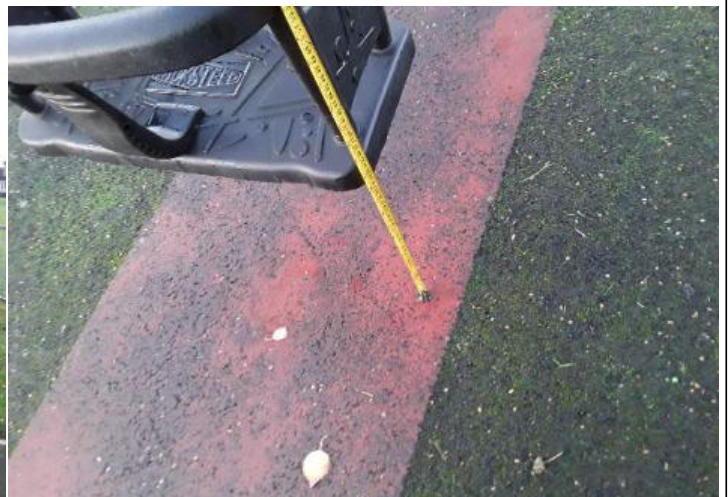
**Finding:** The seat clearance from finished surface level to the underside of the seat is too low and does not meet the requirements of BS EN 1176 Part 2 (350mm minimum clearance required)

**Action:** Adjust seat height/s (400mm-500mm is recommended)

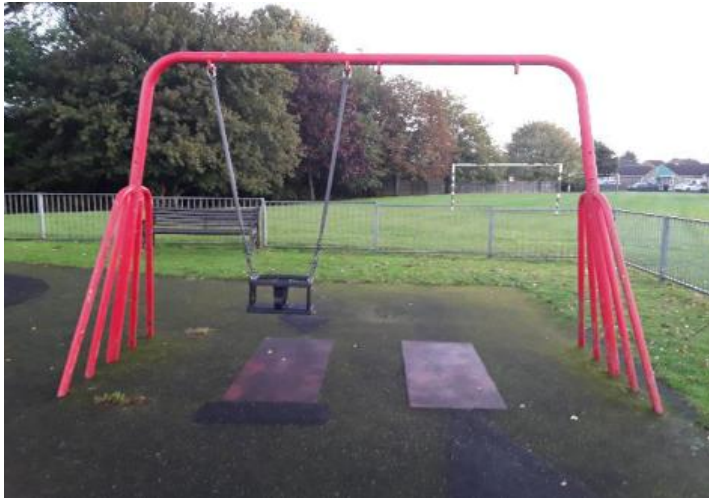
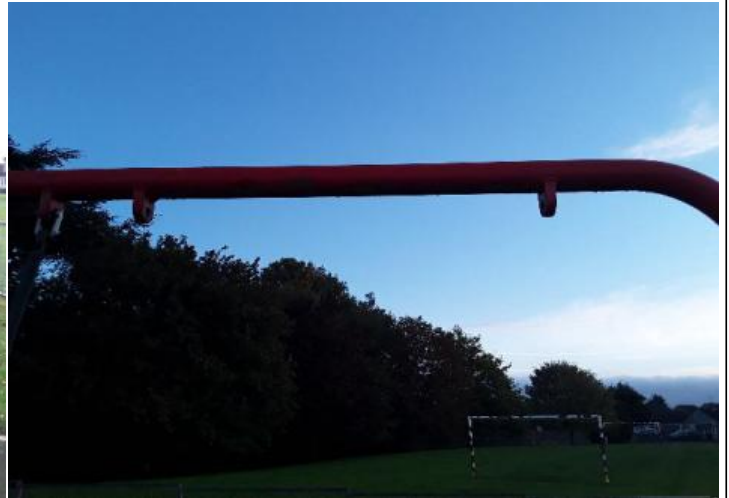
**Finding:** The item has missing component(s)

**Action:** Consider replacing missing components

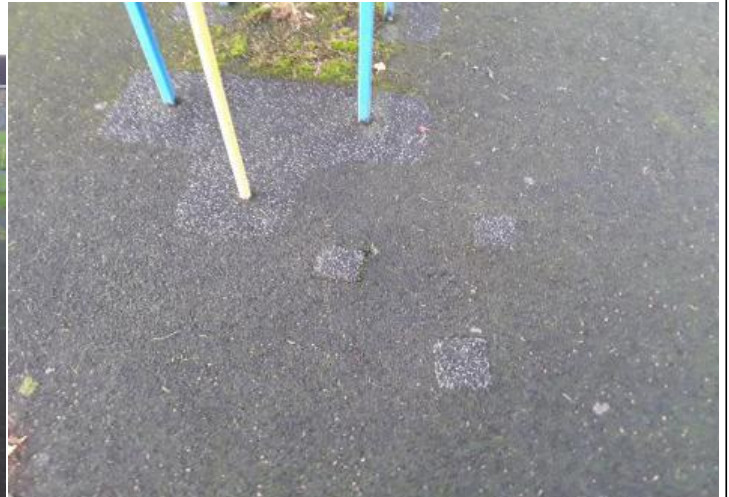
**Finding:** The safety surface is uneven under and around the fireman's pole creating trip hazards

**Action:** Provide a uniform surface

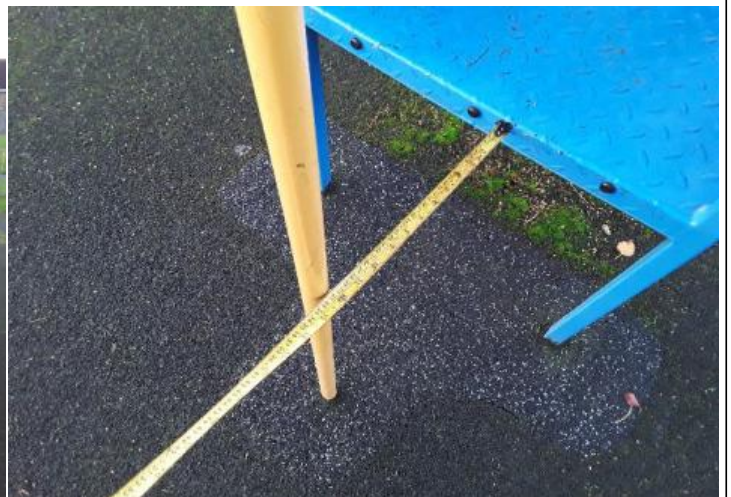
**Finding:** The free space between the fireman's pole and the platform is less than the minimum recommended dimension of 350mm in BS EN 1176 Part 1; this is however an intended design feature by the manufacturer to assist younger users in accessing the pole and is a very low risk finding - no remedial action is recommended

**Action:** Monitor - No remedial work recommended

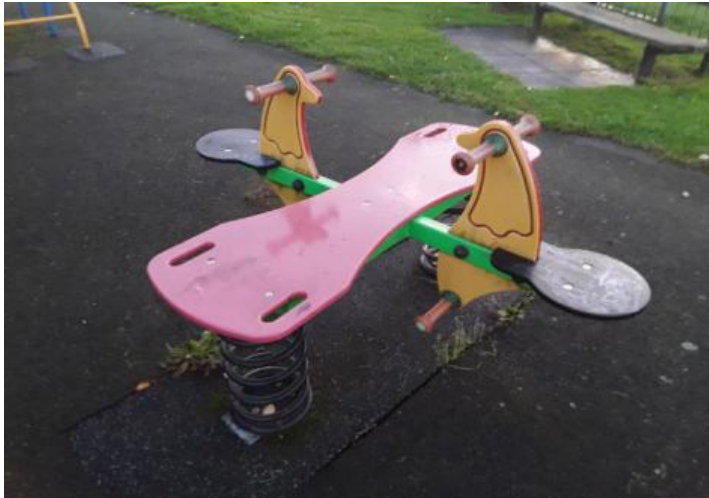
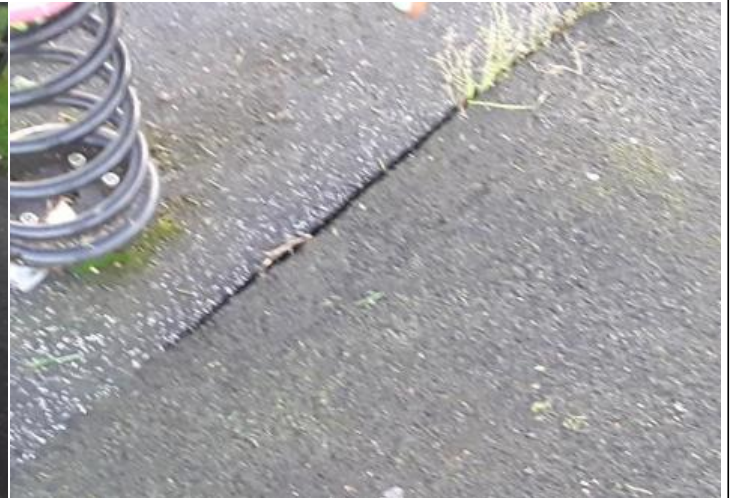
**Finding:** There are gaps opening between the surfacing and the edging surround or between the joints in the surfacing  
**Action:** Monitor for any further deterioration and repair as required

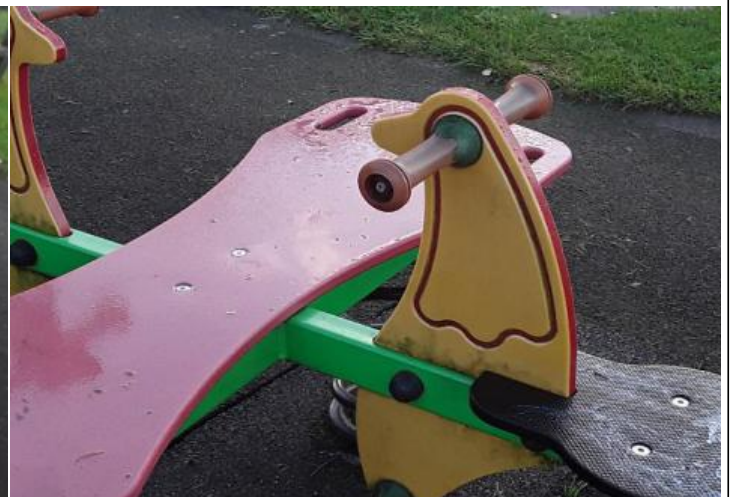
**Finding:** There is/are bolt cap covers missing or damaged on the item  
**Action:** Replace missing or damaged bolt cap covers

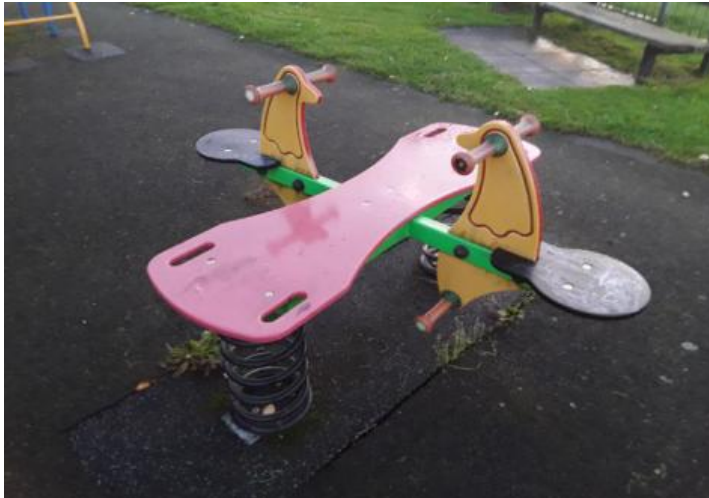
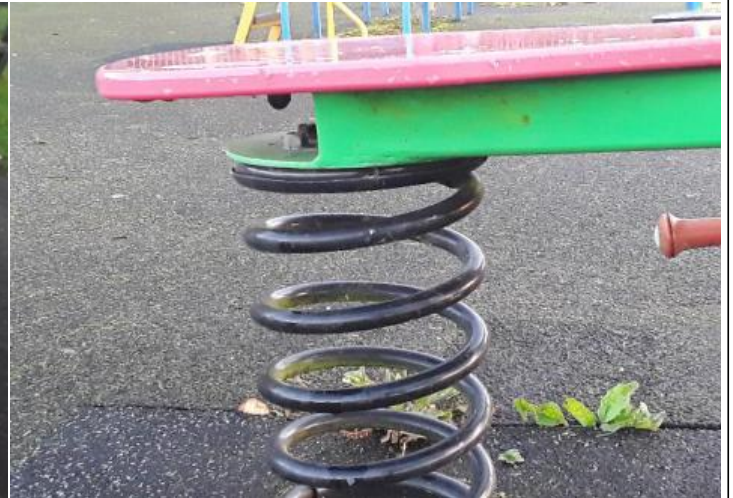
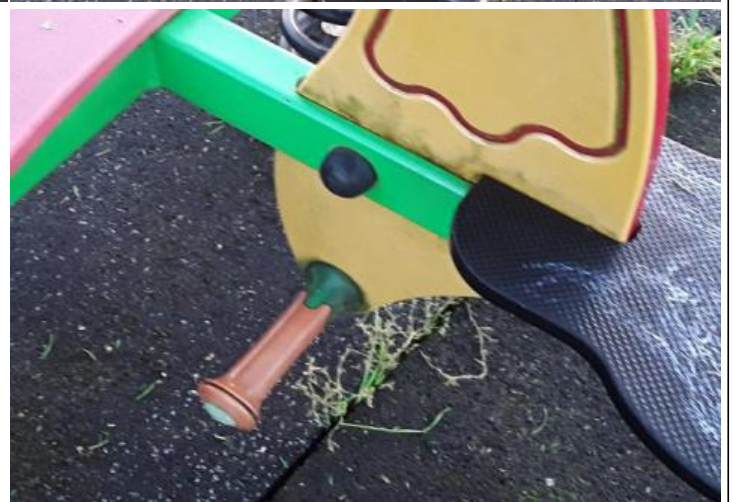
**Finding:** A number of fixing(s) have worked loose

**Action:** Secure all loose fixings

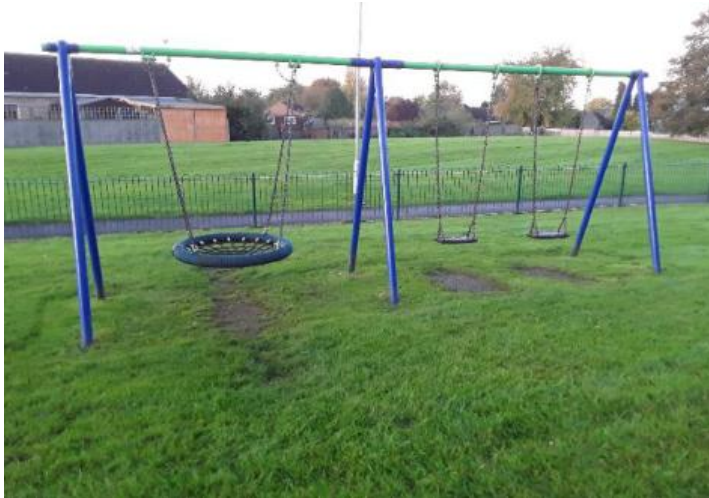
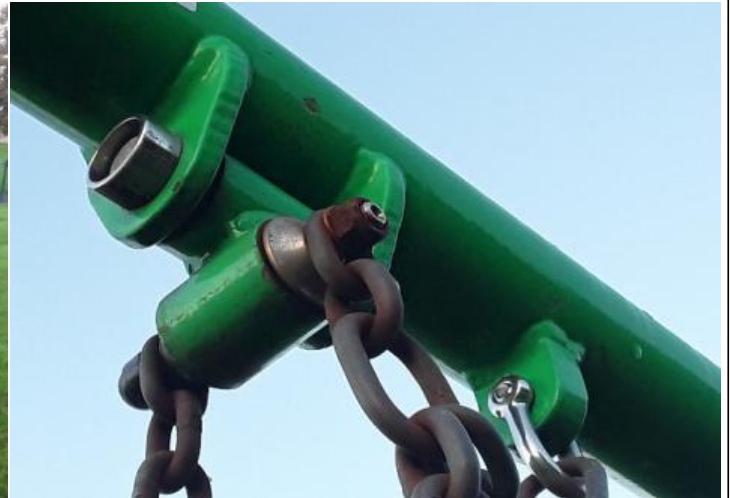
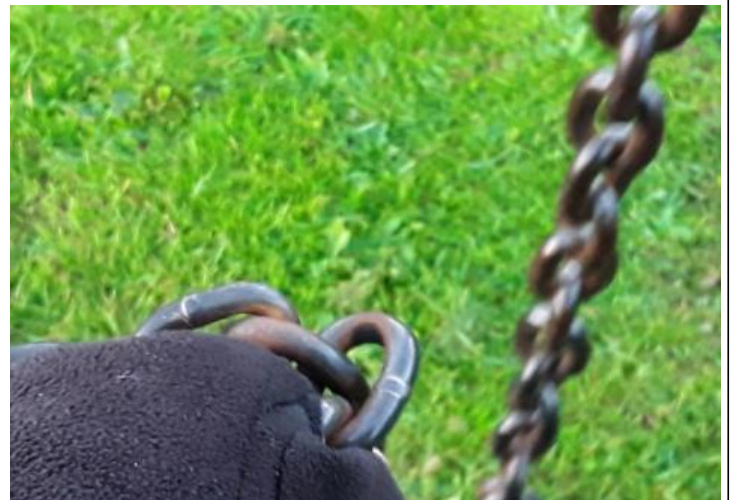
**Finding:** There is some notable evidence of chain wear

**Action:** Monitor for any further deterioration and replace when 40% worn

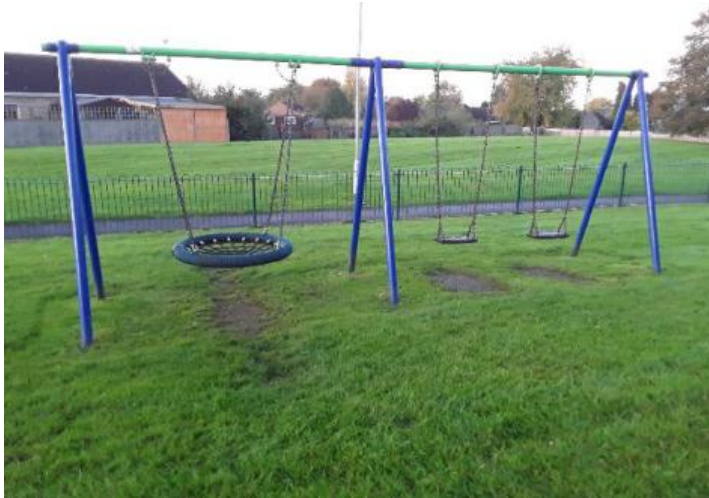
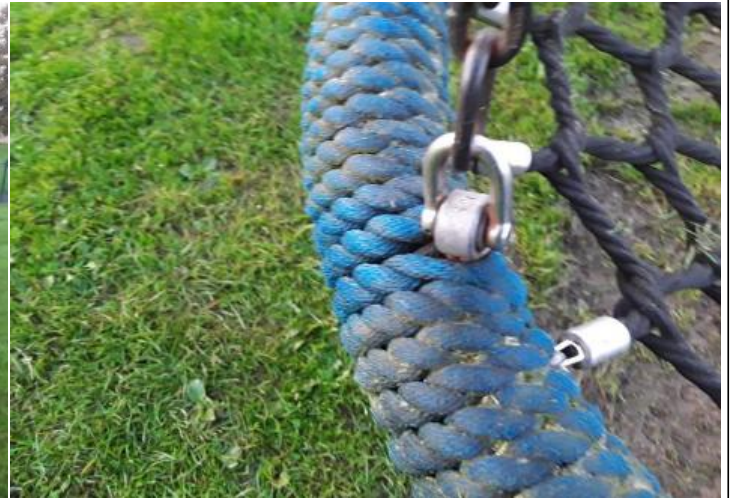
**Finding:** The basket bushes are showing signs of wear

**Action:** Monitor for any further deterioration and replace as required

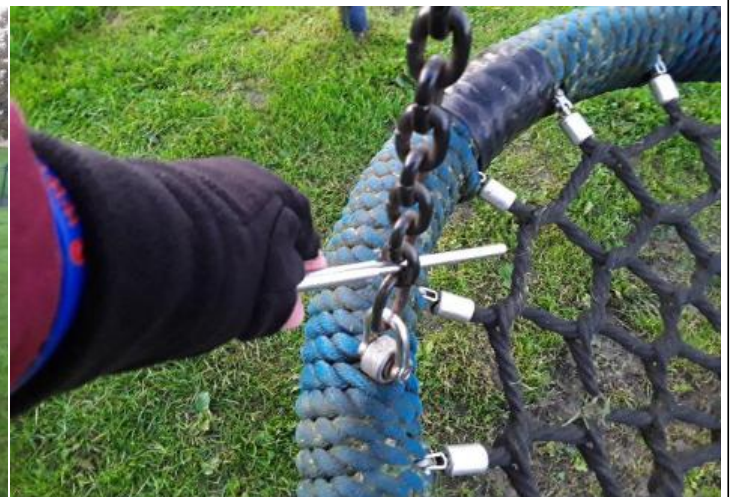
**Finding:** The chain openings are in excess of the 8.6mm as recommended by BS EN 1176

**Action:** Monitor - No remedial work recommended
