# the **play inspection** company

## Annual Inspection

Colsterworth & District Parish Council

Colster Way Play Area

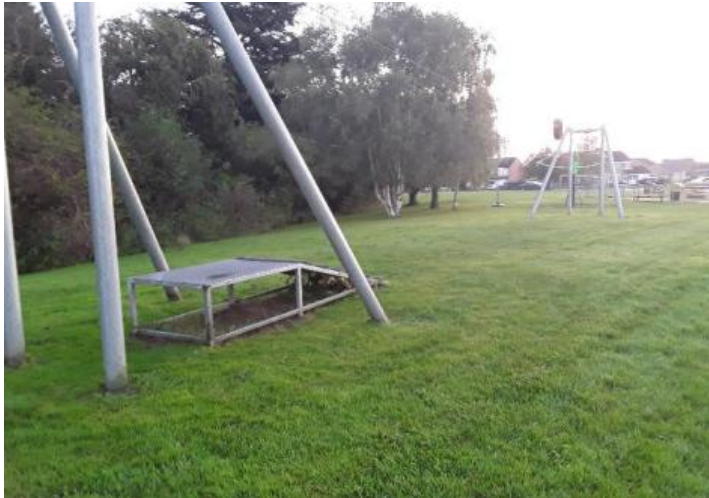
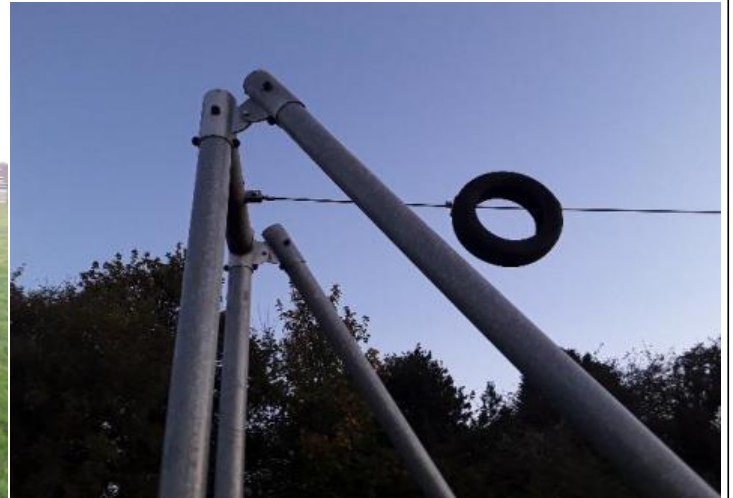
**Finding:** We have completed a visual inspection of the suspension links, cable and fixing points from ground level, however it is not possible to fully inspect these areas without either hiring equipment to gain access or removing the cable and suspension and inspecting at ground level. We recommend that the main cable and fixing security is thoroughly inspected at least in accordance with the manufacturers recommendations to check for wear, damage, security or internal rusting; this will help to ensure the continued safe use of the equipment

**Action:** Inspect in accordance with the manufacturers recommendations

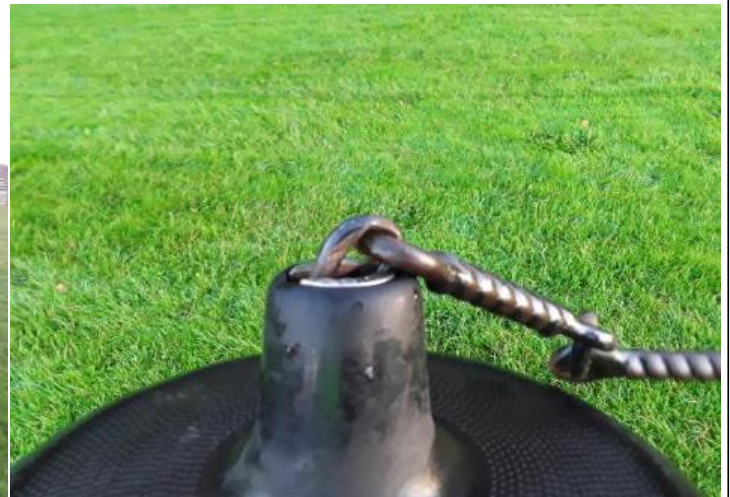
**Finding:** The chain links are worn excessively and require renewing

**Action:** Replace worn chains

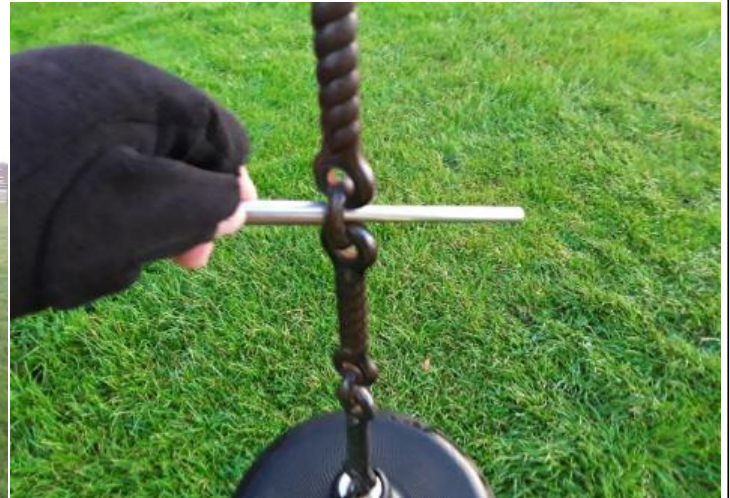
**Finding:** The chain openings are in excess of the 8.6mm as recommended by BS EN 1176 **Action:** Monitor - No remedial work recommended

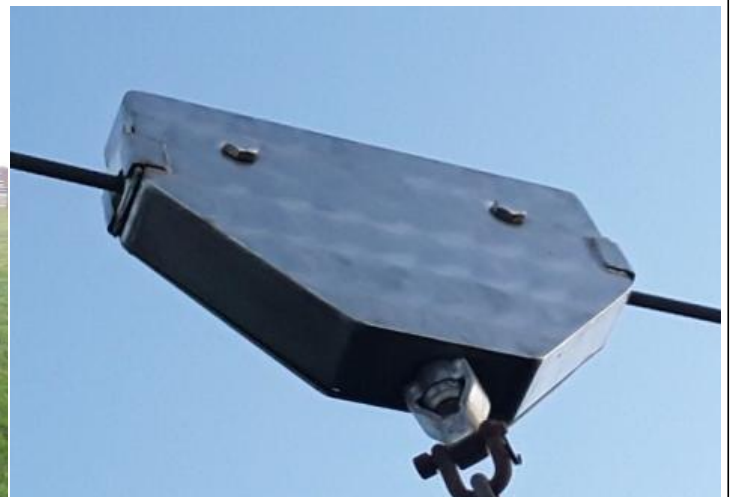
**Finding:** The traveller brake isn't working **Action:** Repair / replace the brake

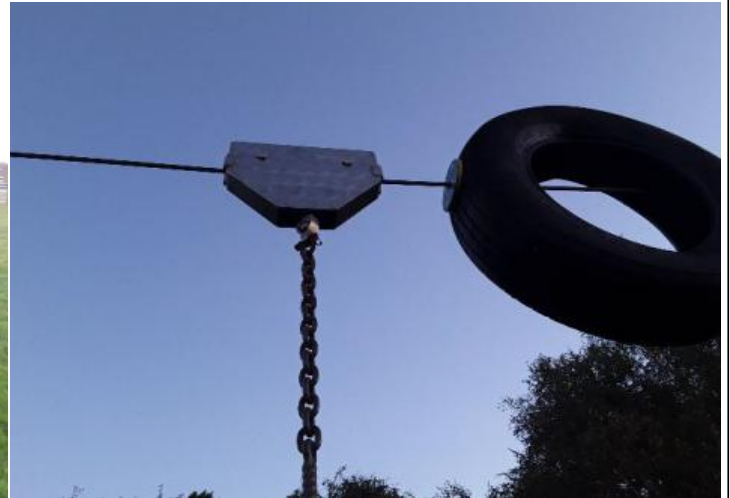
**Finding:** The traveller bearings are worn

**Action:** Replace the bearings

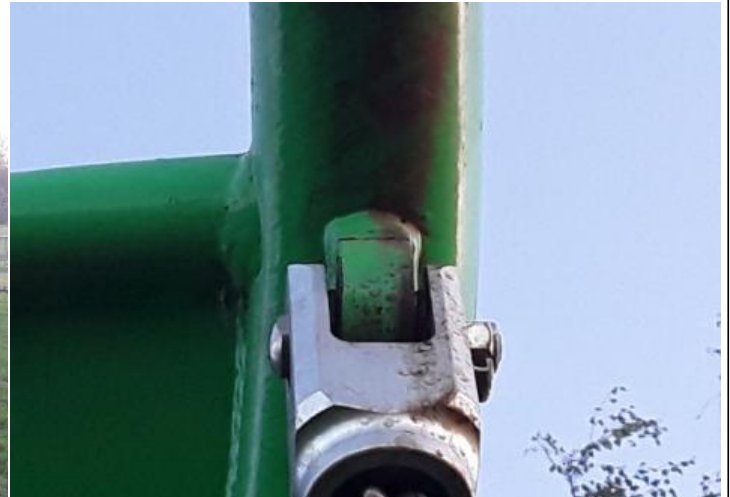
**Finding:** The bushes are worn or missing

**Action:** Replace worn or missing bushes

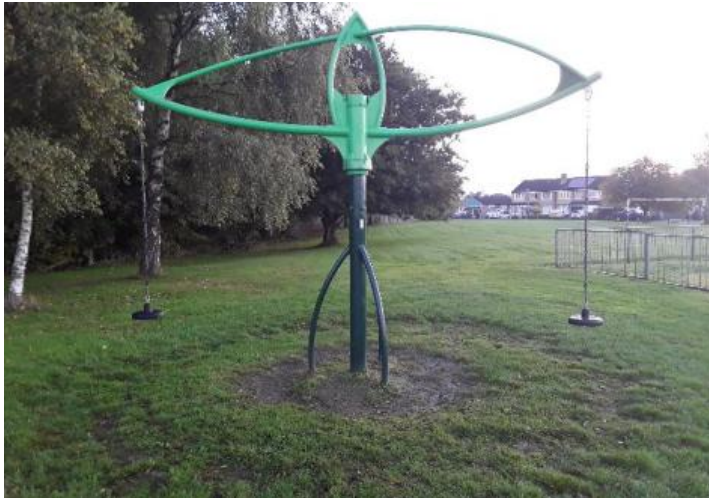
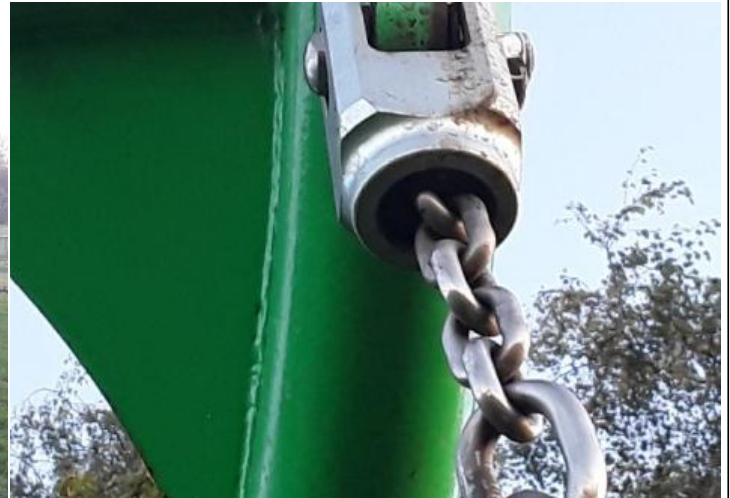
**Finding:** There is some notable evidence of chain wear

**Action:** Monitor for any further deterioration and replace when 40% worn

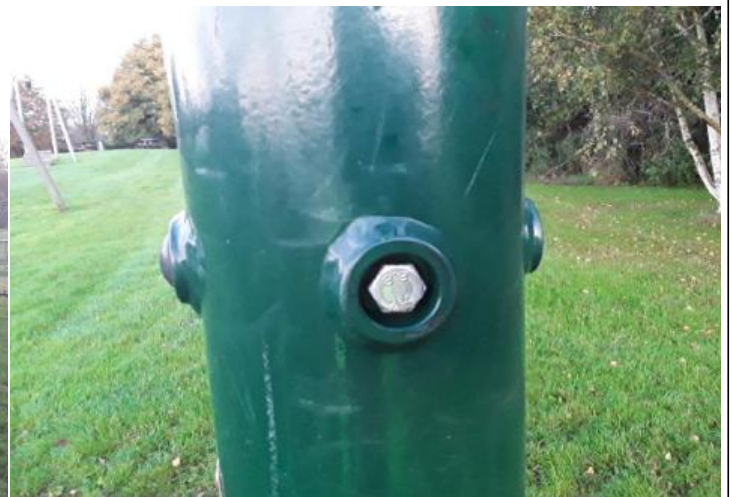
**Finding:** There is/are bolt cap covers missing or damaged on the item

**Action:** Replace missing or damaged bolt cap covers

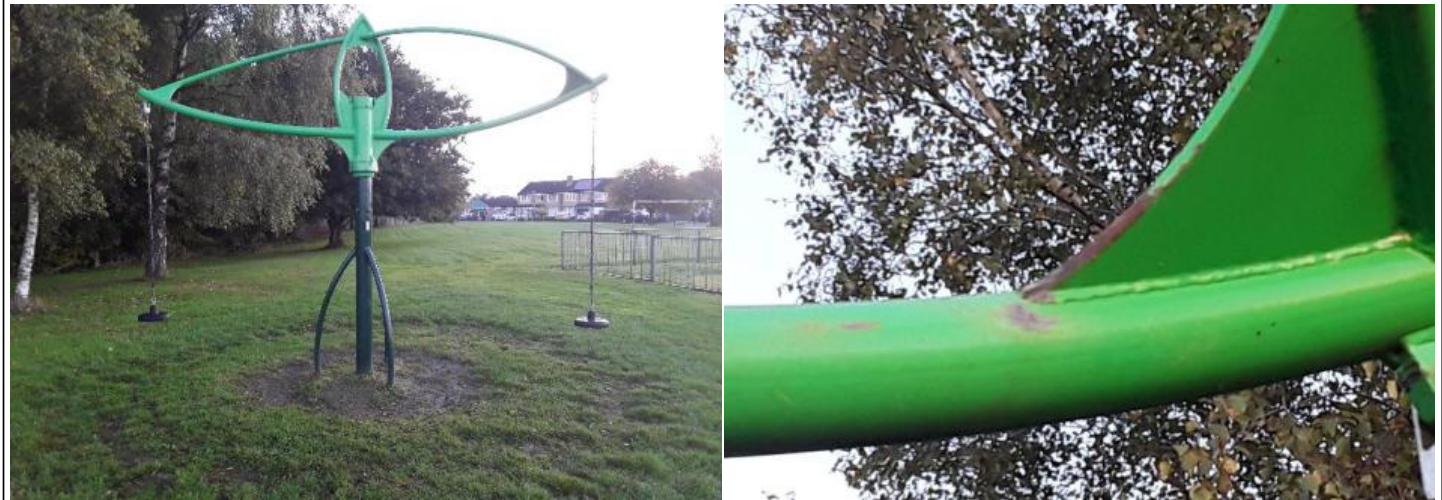
**Finding:** There is surface corrosion / rust present on the item  
**Action:** Consider treating the item

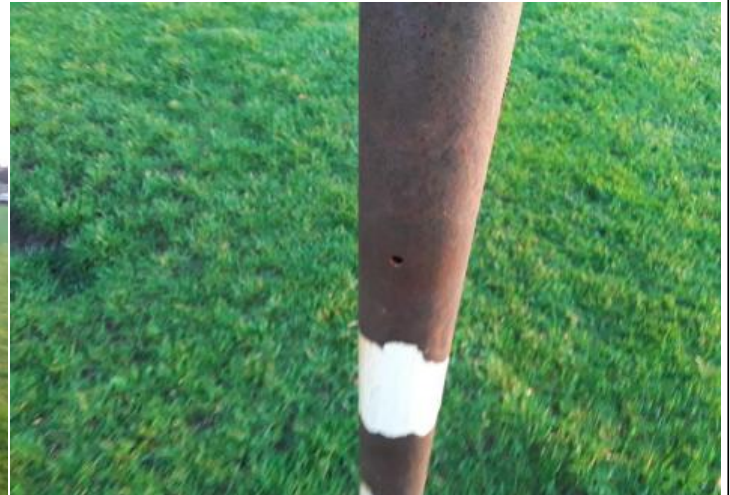
**Finding:** The paintwork on this item has been damaged or worn exposing the metal underneath which is rusting / corroding

**Action:** Treat affected areas and repaint

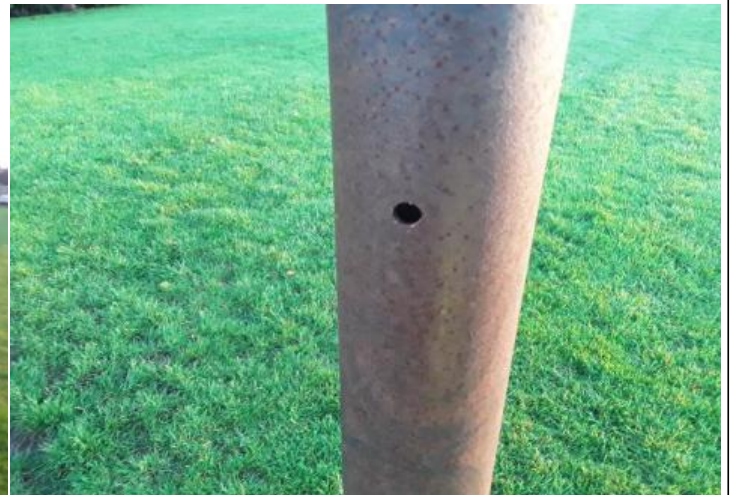
**Finding:** There is/are inserts missing

**Action:** Replace missing inserts
