## Annual Inspection

Colsterworth & District Parish Council

North Witham Village Hall

Inspection Ref: 2514003

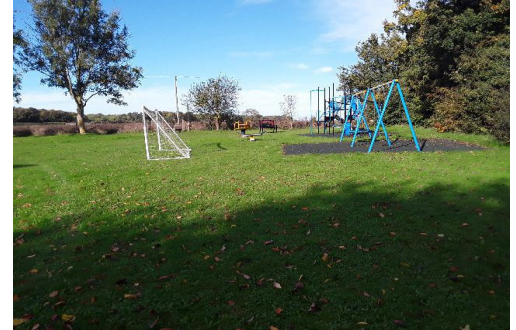
There is a portable / domestic football goal adjacent to the play equipment - Remove the goal

<b>Finding:</b> There is a portable / domestic football goal adjacent to the play equipment		<b>Action:</b> Remove the goal

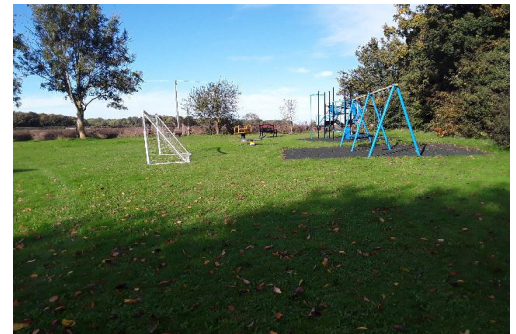
It is recommended that signage, with information including the site address, contact information for maintenance issues and emergency contact details are provided for the facility - Provide in accordance with the recommendations

<b>Finding:</b> It is recommended that signage, with information including the site address, contact information for maintenance issues and emergency contact details are provided for the facility		<b>Action:</b> Provide in accordance with the recommendations

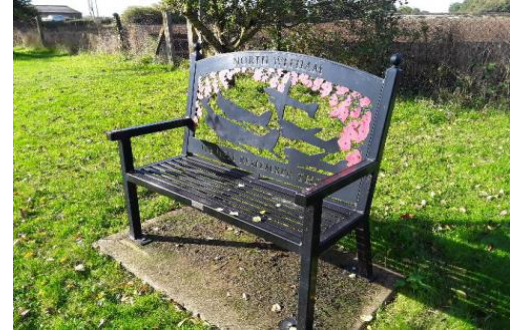
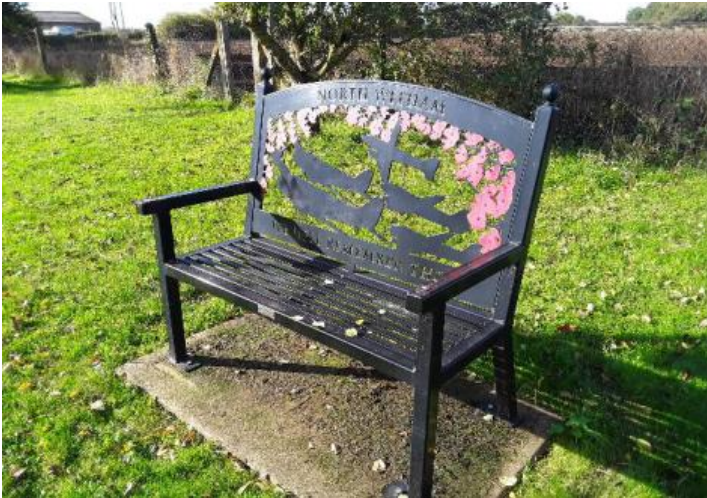
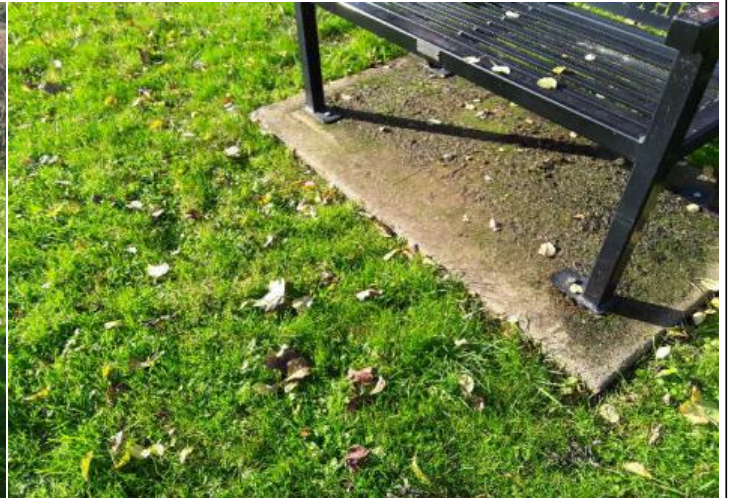
There are trip hazards present over the concrete base - Remove trip hazard

**Finding:** There are trip hazards present over the concrete base

**Action:** Remove trip hazard

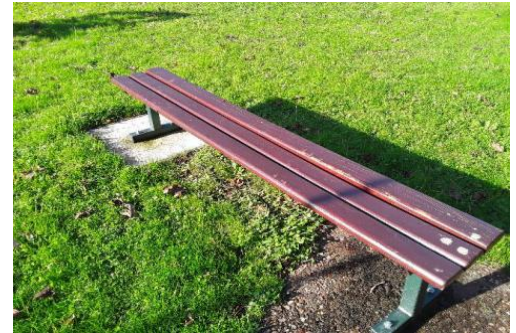
The timber stain is in poor condition - Prepare all affected parts and re-stain with an appropriate preservative

There are projecting bolt thread(s) present - Remove excess thread length and deburr or provide cap

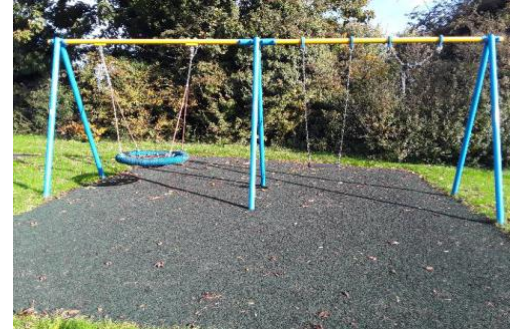
One seat has been removed and the chains wrapped to isolate from use however the area is still accessible and the means of isolation has either introduced additional hazards that may cause harm in the event of users accessing the area or is insufficient to stop users from accessing the chains - Provide a more suitable isolation method

The surface has subsided in some areas - Monitor for any further deterioration and repair as required

The connecting links are in excess of 8.6mm and less than 12mm and fail the requirements of BS EN 1176 Part 1; clause 4.2.13, Chains - Monitor - No remedial work recommended

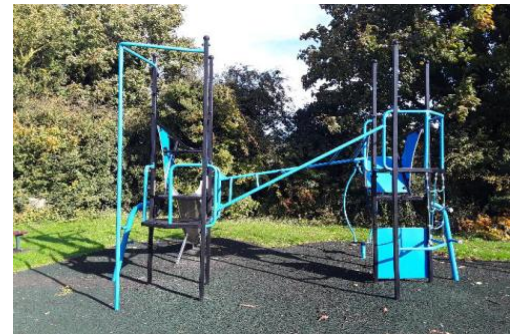
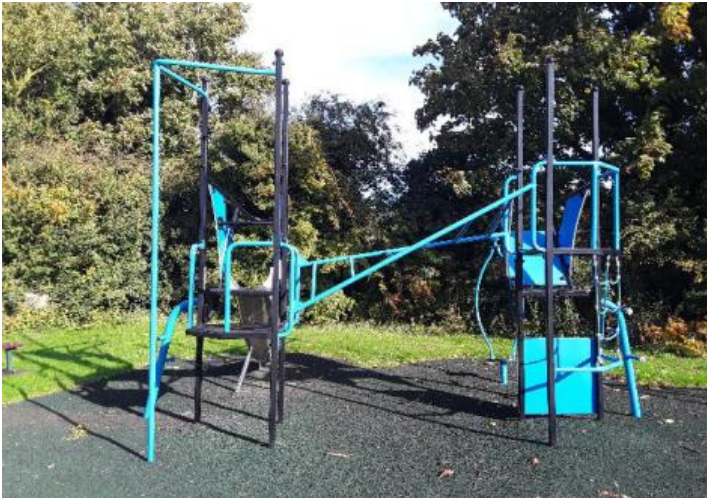
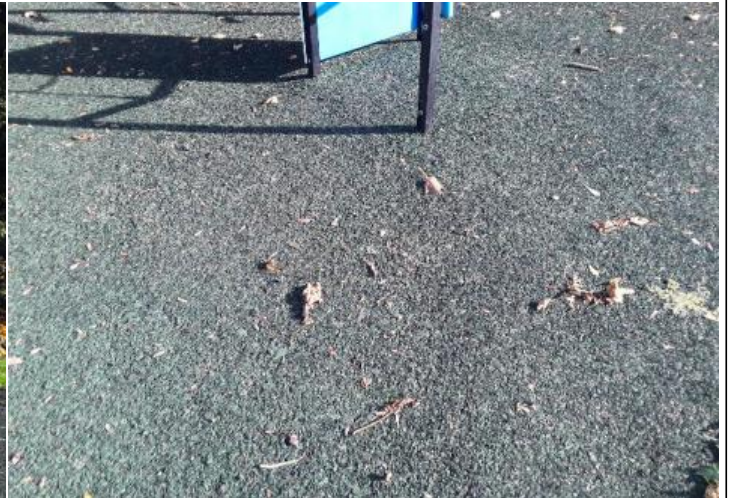
The surface has subsided in some areas - Monitor for any further deterioration and repair as required

**Finding:** The surface has subsided in some areas

**Action:** Monitor for any further deterioration and repair as required

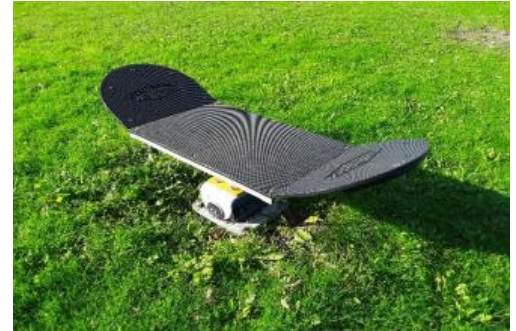
This item is satisfactory - no work required -

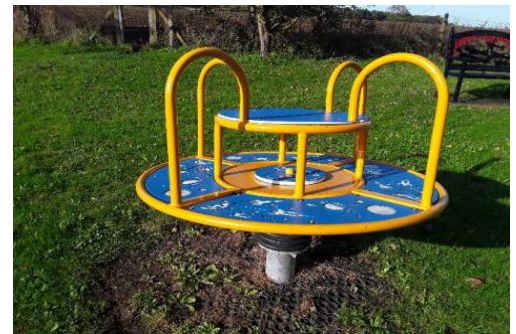
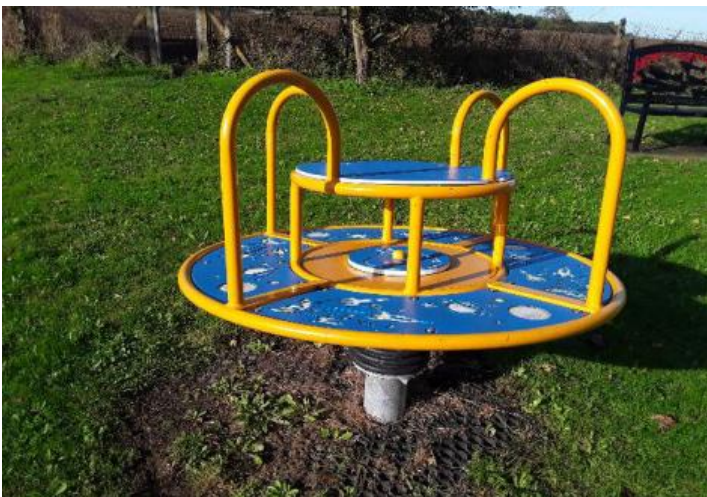
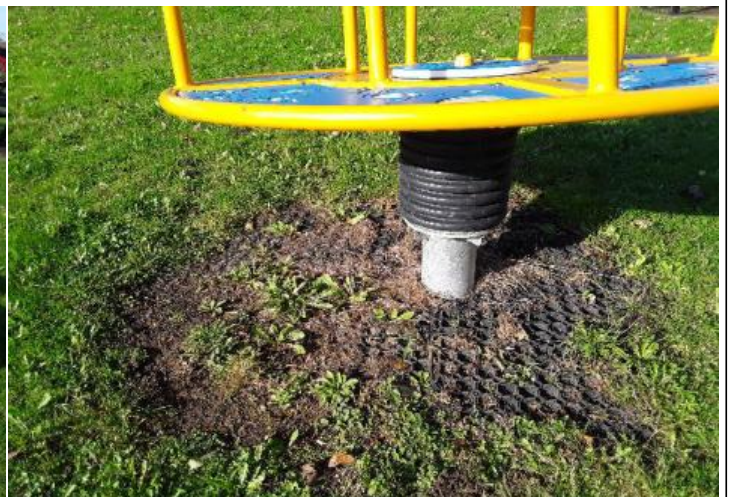
The bearing is showing signs of wear - Monitor for any further deterioration and replace as required

**Finding:** The bearing is showing signs of wear

**Action:** Monitor for any further deterioration and replace as required

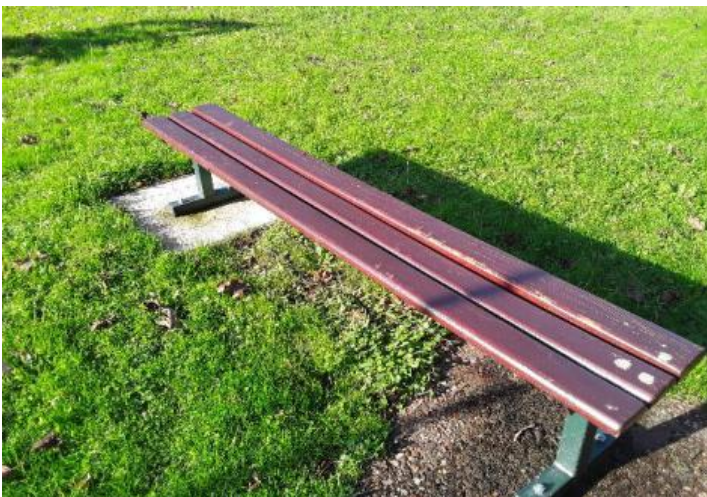
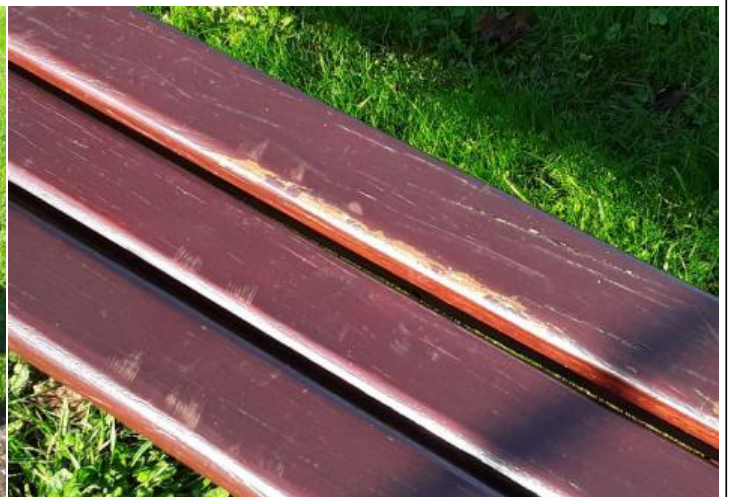
**Finding:** The timber stain is in poor condition

**Action:** Prepare all affected parts and re-stain with an appropriate preservative

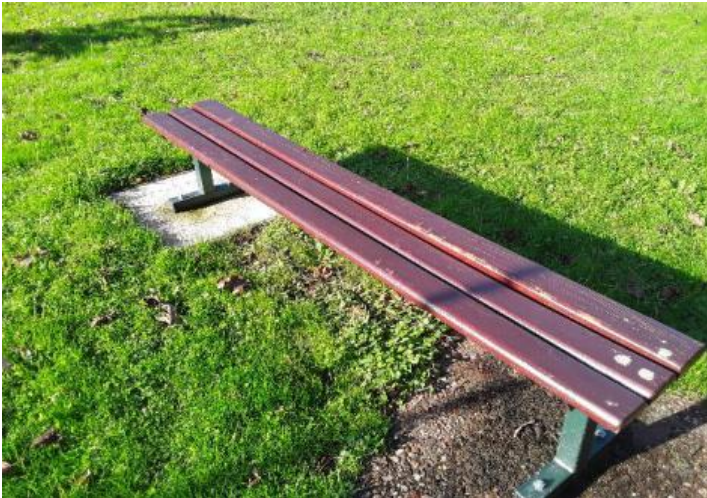
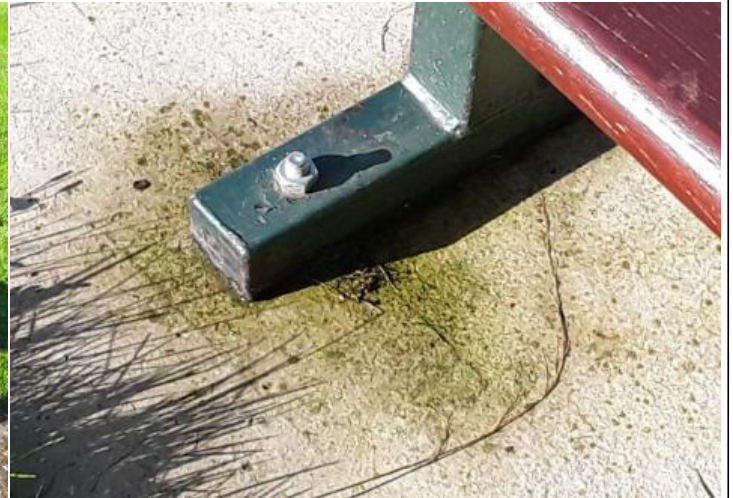
**Finding:** There are projecting bolt thread(s) present

**Action:** Remove excess thread length and deburr or provide cap

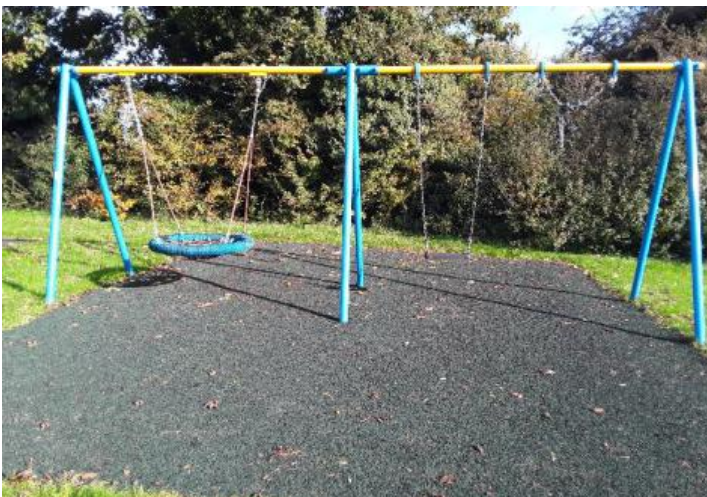
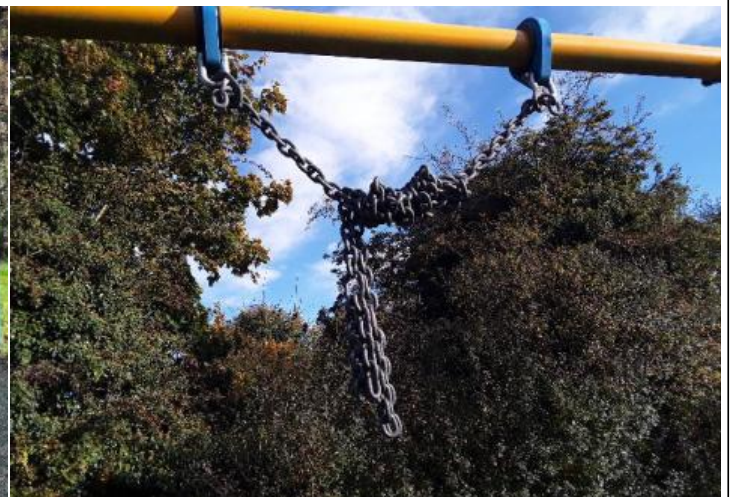
**Finding:** One seat has been removed and the chains wrapped to isolate from use however the area is still accessible and the means of isolation has either introduced additional hazards that may cause harm in the event of users accessing the area or is insufficient to stop users from accessing the chains

**Action:** Provide a more suitable isolation method

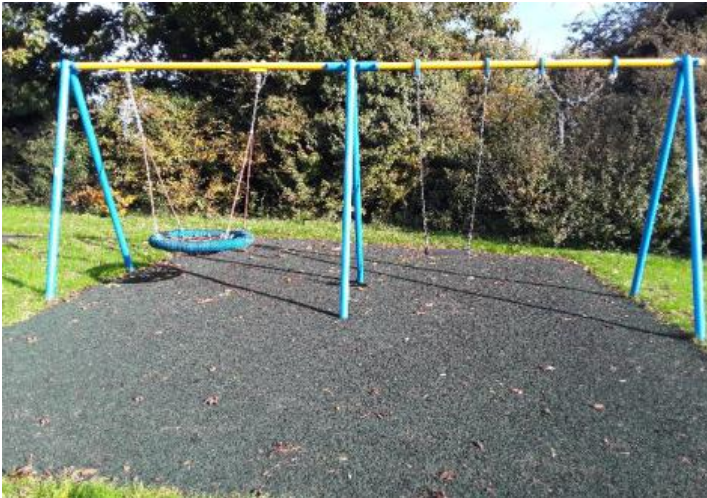
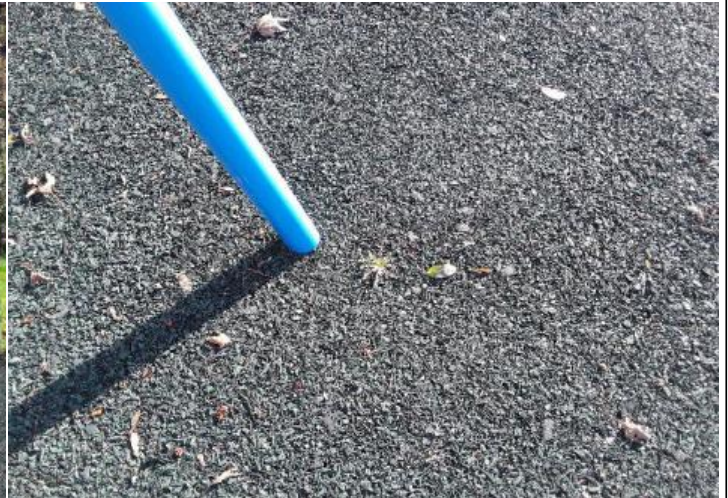
**Finding:** The surface has subsided in some areas

**Action:** Monitor for any further deterioration and repair as required

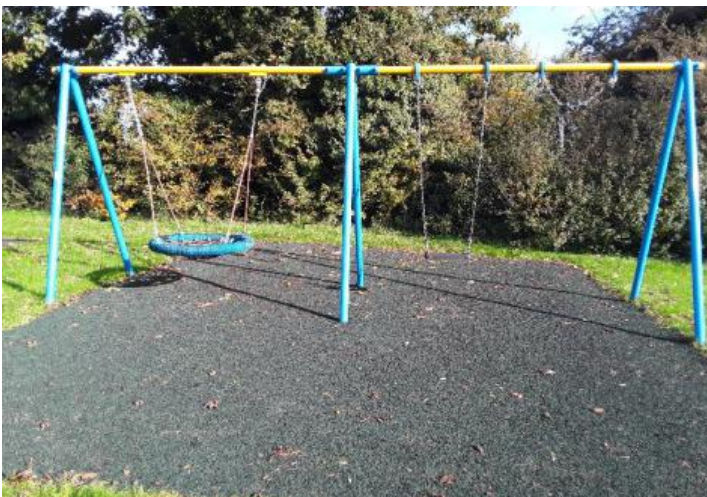
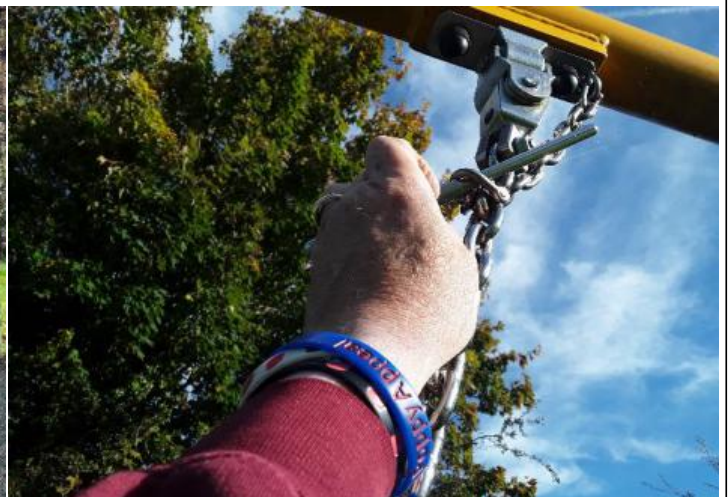
**Finding:** The connecting links are in excess of 8.6mm and less than 12mm and fail the requirements of BS EN 1176 Part 1; clause 4.2.13, Chains

**Action:** Monitor - No remedial work recommended
