the **play inspection** company

Annual Inspection

Colsterworth & District Parish Council

Old Post Lane Play Area

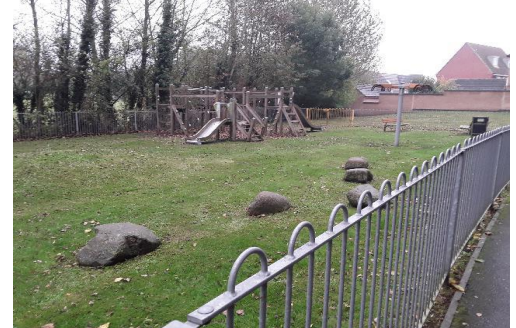
Item: Site General
Manufacturer: Owner/Operator
Surface Type: Grass
Item Quantity: 1
Equipment Compliance: N/A
Surface Area Compliance: N/A

There is tree debris on the surfacing - Remove and maintain

The grass mats are silted up, the soil is compacted and the area will become very slippery when the soil is wet. - Reinstate as required

There is algae or moss on the surface of the equipment - Clean and treat appropriately

There is some graffiti present - Remove the graffiti

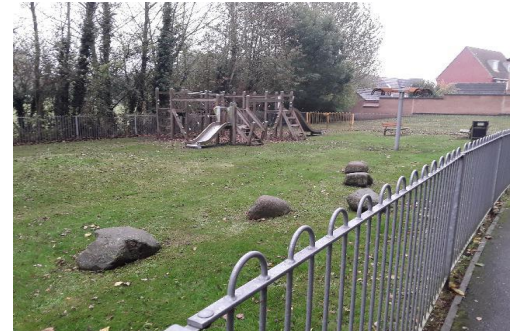
Item: Sign
Manufacturer: Not Applicable
Surface Type: N/A
Item Quantity: 1
Equipment Compliance: N/A
Surface Area Compliance: N/A

It is recommended that signage, with information including the site address, contact information for maintenance issues and emergency contact details are provided for the facility - Provide in accordance with the recommendations

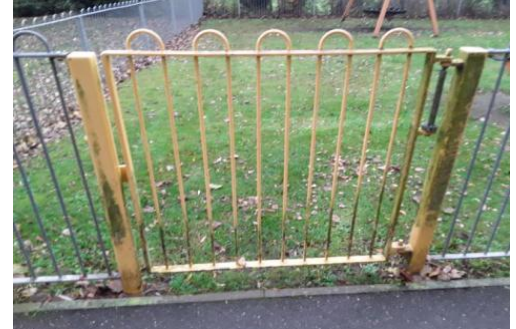
Item: Gate - Self Closing
Manufacturer: Not Identified
Surface Type: Grass
Item Quantity: 2
Equipment Compliance: N/A
Surface Area Compliance: N/A

There are trip hazards present over the edgings under the gate - Remove the trip hazard

The gate is not operating correctly - Take effective action to ensure the gate closes between 4 and 8 seconds

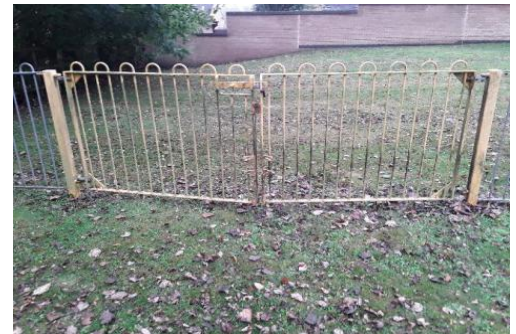
Item: Gate - Maintenance
Manufacturer: Not Identified
Surface Type: Grass
Item Quantity: 1
Equipment Compliance: N/A
Surface Area Compliance: N/A

The maintenance gate was correctly padlocked at the time of inspection, however this means that the inspector was unable to fully assess the gate - Ensure that there are 12mm gaps throughout the full range of motion on gate/s and between leaves where relevant

The gate has no drop bolt sleeves and/or drop bolts fitted - Provide drop bolt sleeves and/or drop bolts

The paint is flaking off the metalwork - Rub down and re-paint

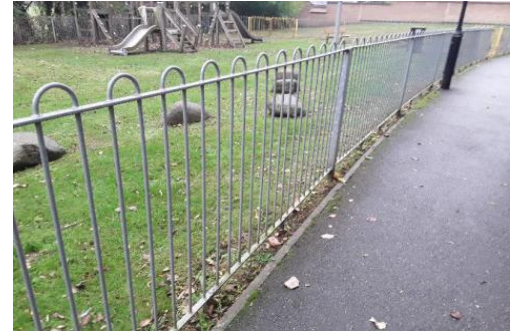
Item: Fence - Bow Top
Manufacturer: Unknown
Surface Type: Grass
Item Quantity: 1
Equipment Compliance: N/A
Surface Area Compliance: N/A

There is some damage to the fence sections - Monitor for any further deterioration and repair as required

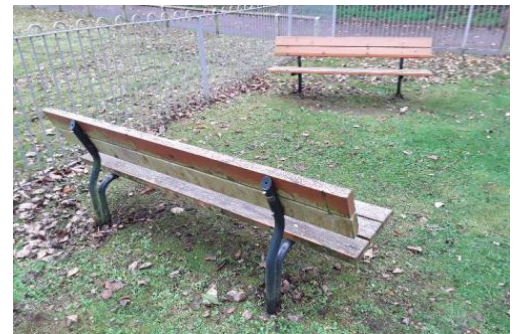
Item: Bench
Manufacturer: Unknown
Surface Type: Grass Matrix Tiles
Item Quantity: 1
Equipment Compliance: N/A
Surface Area Compliance: N/A

The timber stain is in poor condition - Prepare all affected parts and re-stain with an appropriate preservative

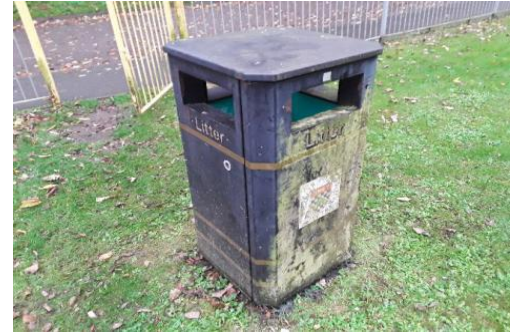
Item: Litter Bin
Manufacturer: Broxap
Surface Type: Grass
Item Quantity: 1
Equipment Compliance: N/A
Surface Area Compliance: N/A

There is surface corrosion / rust present on the item - Consider treating the item

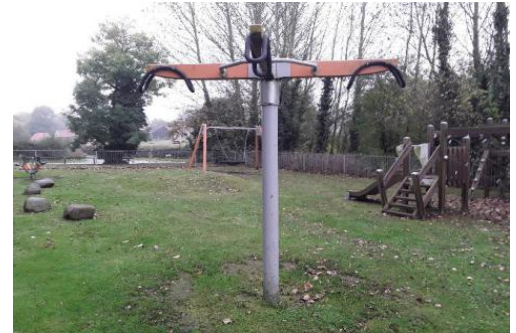
Item: Overhead Rotator
Manufacturer: Lappset UK Ltd
Surface Type: Grass Matrix Tiles
Item Quantity: 1
Equipment Compliance: Yes
Surface Area Compliance: No

BS EN 1176 Part 5 states that for Type C Carousels, an additional obstacle free space of at least 1.0m shall be provided from the edge of the free space / impact area and there is insufficient obstacle free space provided - Monitor - no remedial work recommended

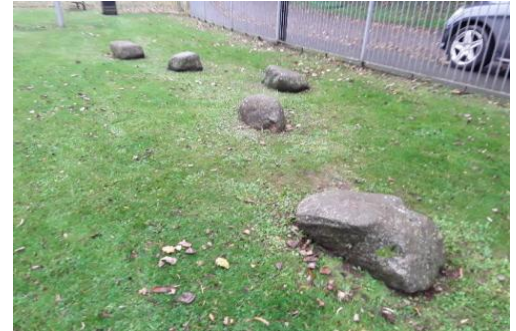
Item: Boulders
Manufacturer: Natural Feature
Surface Type: Grass
Item Quantity: 5
Equipment Compliance: N/A
Surface Area Compliance: N/A

The rocks and/or boulders have moss/algae growth apparent - Clean and maintain

The step between the items is quite large and users may not be able to complete the step without touching ground, the items could therefore be considered to be within the falling space of each other, however the intention of the play activity continuity is easily apparent and foreseeable to the user - Monitor - No remedial work recommended

The fence forms a hard object within the falling space of the boulders in contravention of the requirements of BS EN 1176 Part 1 - Monitor - No remedial work recommended

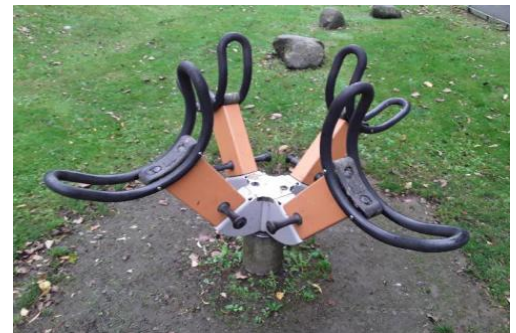
Item: Low Rotator
Manufacturer: Lappset UK Ltd
Surface Type: Grass Matrix Tiles
Item Part Number: 010624
Item Quantity: 1
Equipment Compliance: No
Surface Area Compliance: Yes
Total Findings: 1

There is/are finger entrapment/s in the structure and the item fails to meet the requirements of BS EN 1176 Part 1 4.2.7.6 Entrapment of fingers - Monitor - No remedial work recommended

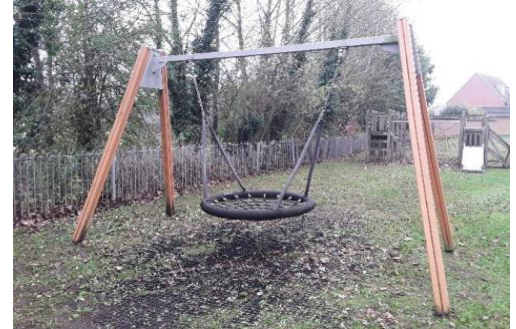
Item: Basket Swing - Type 1
Manufacturer: Lappset UK Ltd
Surface Type: Grass Matrix Tiles
Item Quantity: 1
Equipment Compliance: Yes
Surface Area Compliance: Yes

The grass mat surface is lifting at the edges and creating trip points - Repair the surfacing to remove trip points

The basket bushes are showing signs of wear - Monitor for any further deterioration and replace as required

The chain/rope covering is damaged - Monitor for any further deterioration and replace as required

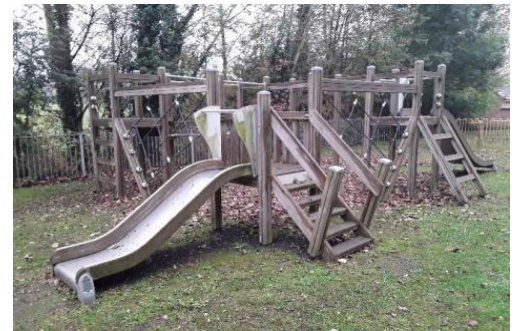
Item: Multi Play (Junior)
Manufacturer: Lappset UK Ltd
Surface Type: Grass Matrix Tiles
Item Quantity: 1
Equipment Compliance: No
Surface Area Compliance: Yes

The ropes/nets are worn/damaged in places - Monitor for any further deterioration and repair or replace as required

The item fails to meet the requirements of BS EN 1176 Part 1 4.2.7.2 for head and neck entrapment in the framework - Monitor - No remedial work recommended

There is/are finger entrapment/s adjacent to the slide entry and the item fails to meet the requirements of BS EN 1176 Part 1 4.2.7.6 Entrapment of fingers - Provide inserts to seal the redundant bolt holes

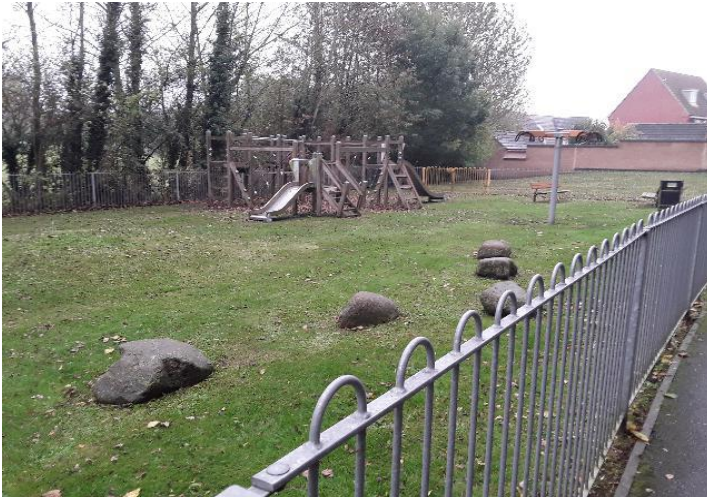
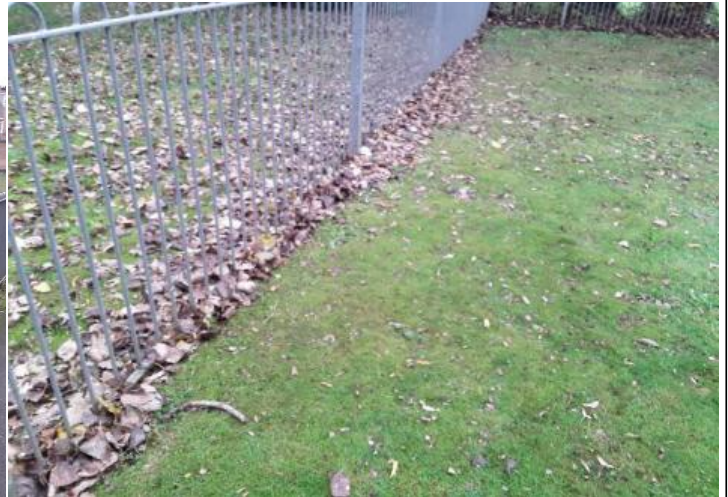
6 - Low Risk (Finding 1)

Finding: There is tree debris on the surfacing

Action: Remove and maintain

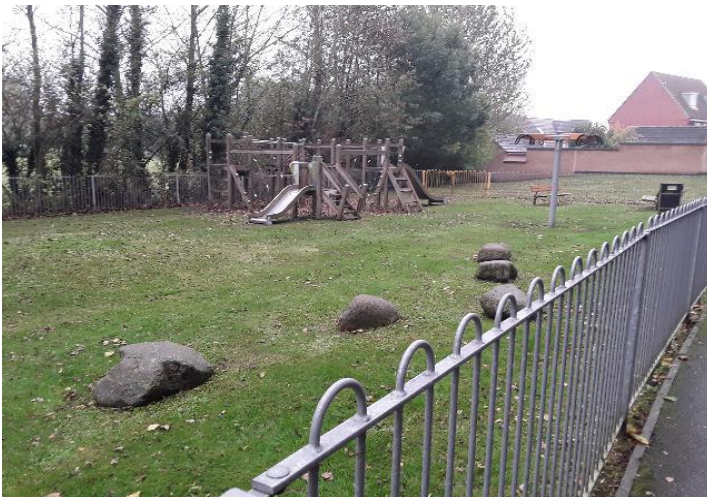
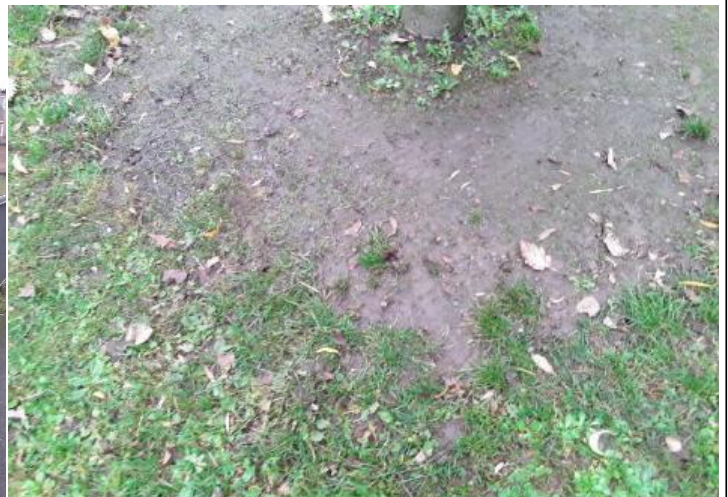
8 - Low Risk (Finding 2)

Finding: The grass mats are silted up, the soil is compacted and the area will become very slippery when the soil is wet.

Action: Reinstate as required

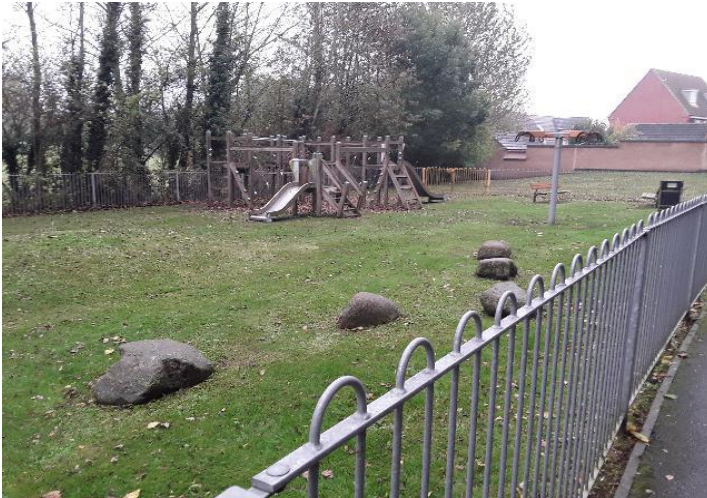
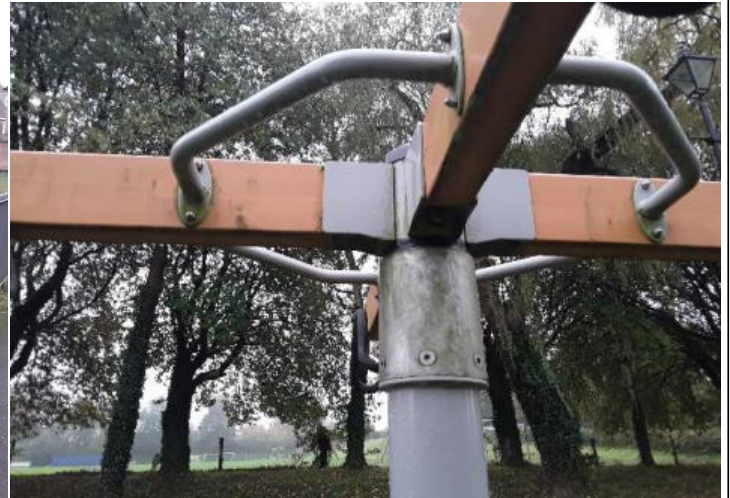
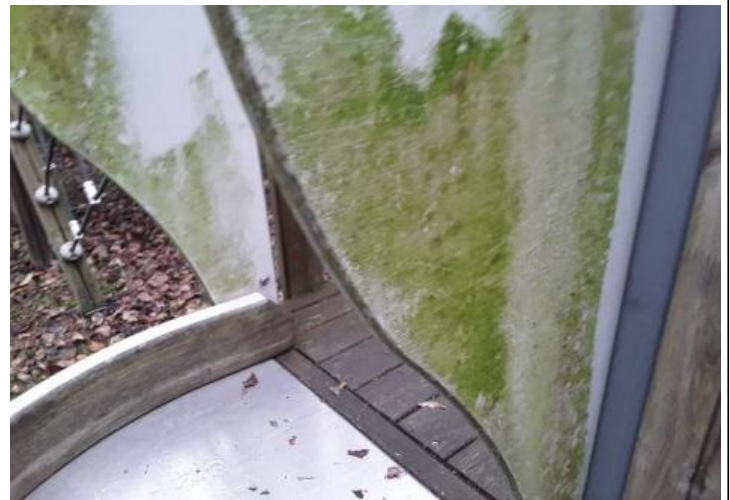
i 6 - Low Risk (Finding 3)

Finding: There is algae or moss on the surface of the equipment

Action: Clean and treat appropriately

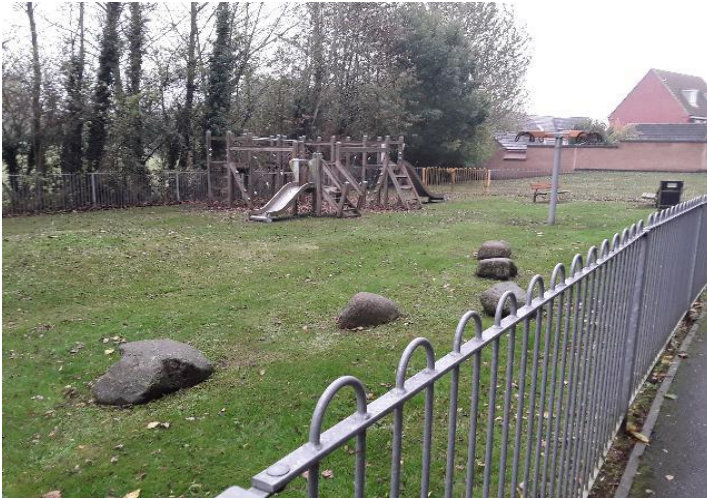
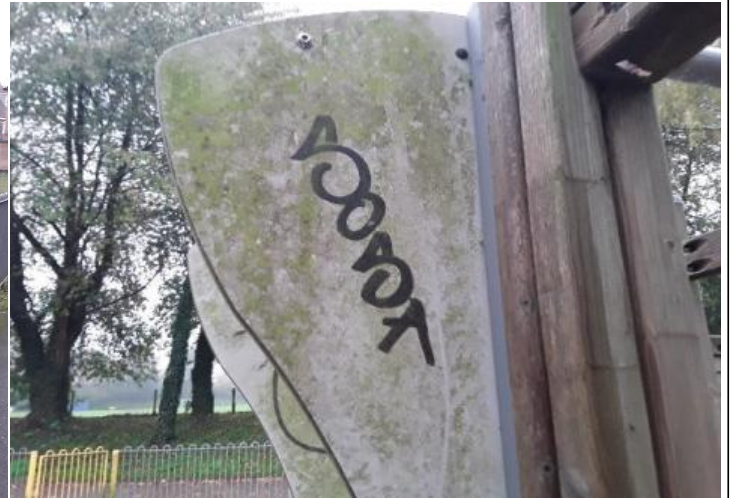
i 2 - Very Low Risk (Finding 4)

Finding: There is some graffiti present

Action: Remove the graffiti

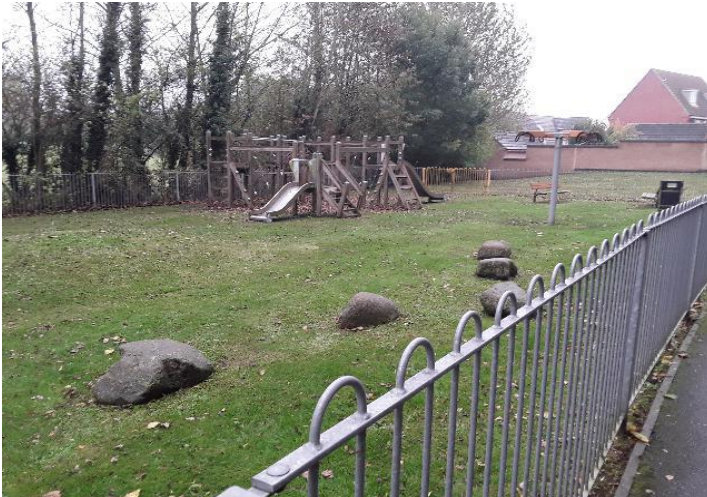
i 5 - Very Low Risk (Finding 1)

Finding: It is recommended that signage, with information including the site address, contact information for maintenance issues and emergency contact details are provided for the facility

Action: Provide in accordance with the recommendations

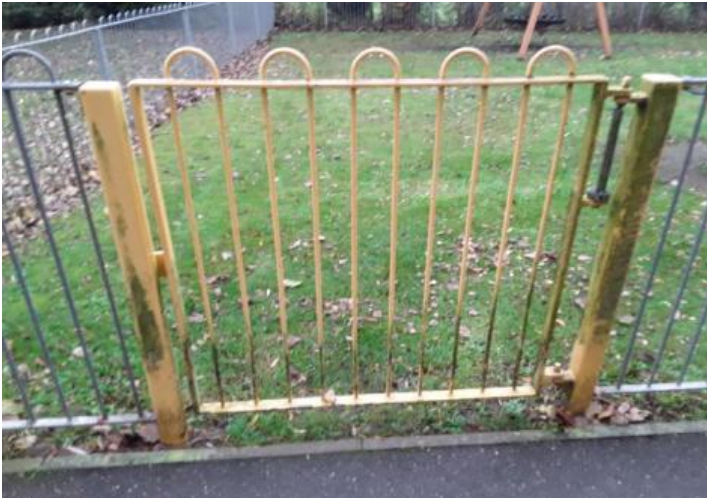
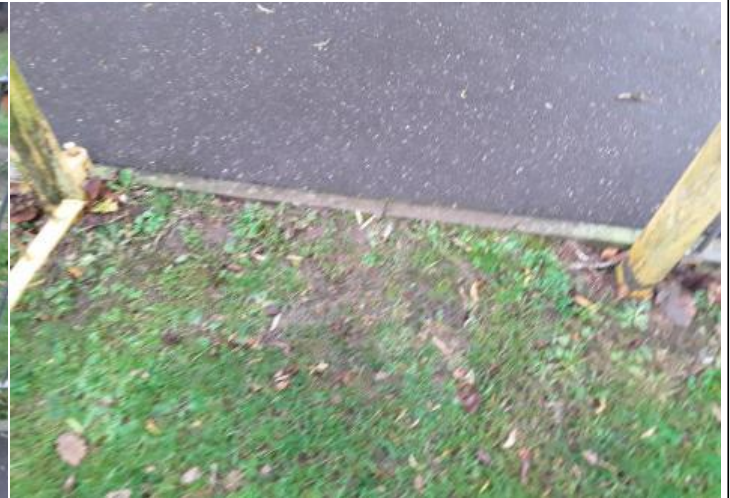
8 - Low Risk (Finding 1)

Finding: There are trip hazards present over the edgings under the gate
Action: Remove the trip hazard

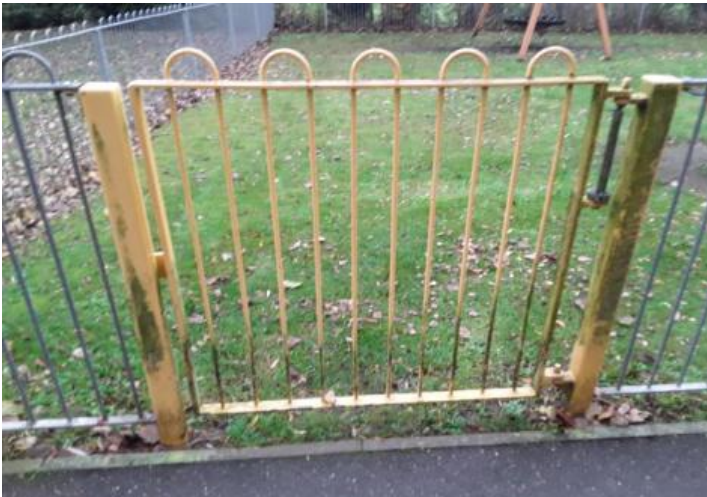
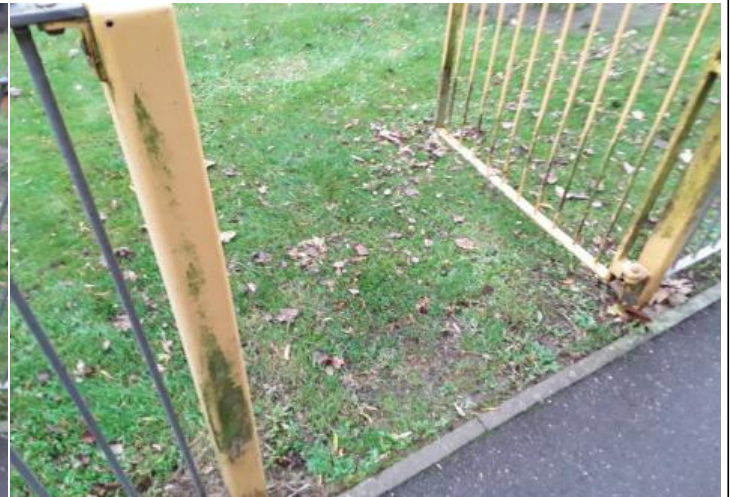
5 - Very Low Risk (Finding 2)

Finding: The gate is not operating correctly
Action: Take effective action to ensure the gate closes between 4 and 8 seconds

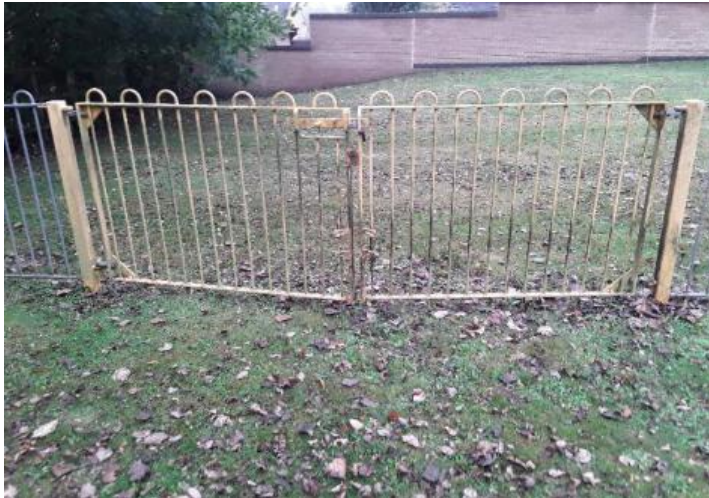
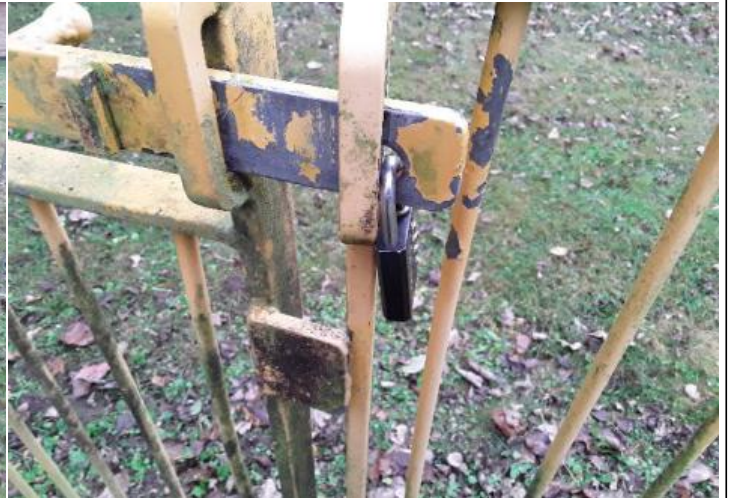
i 0 - Risk Assessment not Undertaken (Finding 1)

Finding: The maintenance gate was correctly padlocked at the time of inspection, however this means that the inspector was unable to fully assess the gate

Action: Ensure that there are 12mm gaps throughout the full range of motion on gate/s and between leaves where relevant

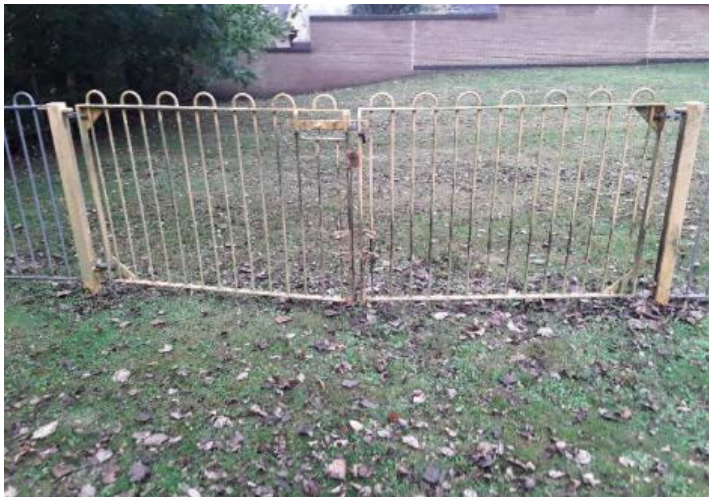
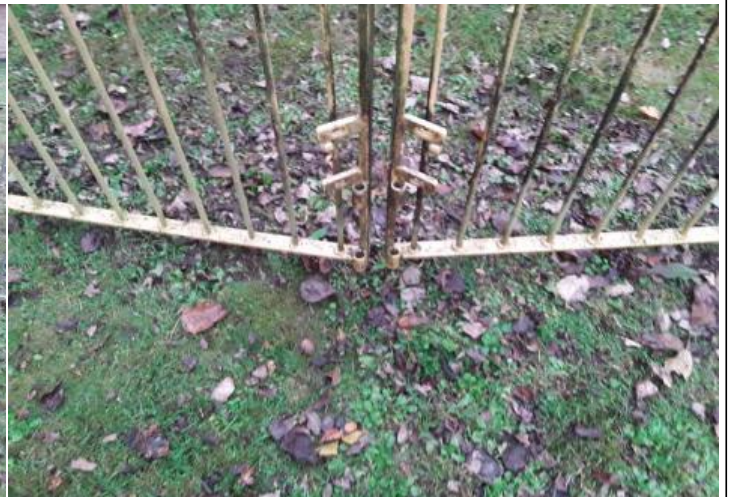
i 6 - Low Risk (Finding 2)

Finding: The gate has no drop bolt sleeves and/or drop bolts fitted

Action: Provide drop bolt sleeves and/or drop bolts

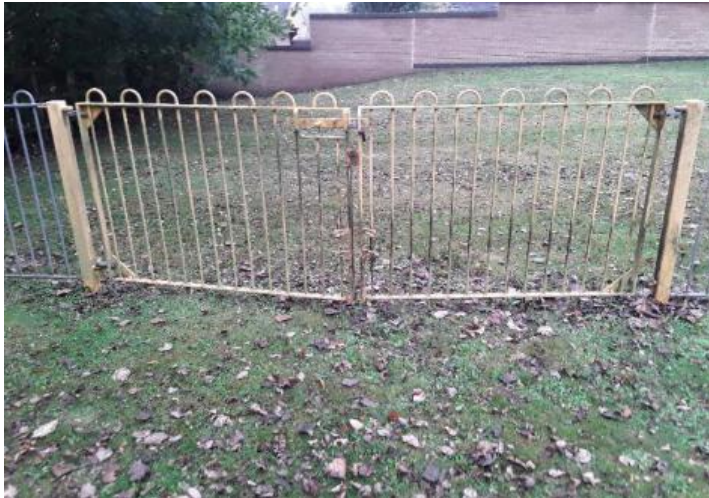
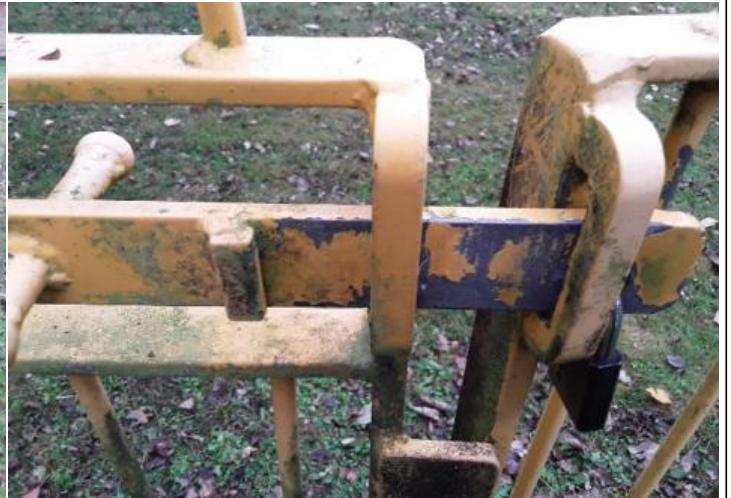
i 6 - Low Risk (Finding 3)

Finding: The paint is flaking off the metalwork

Action: Rub down and re-paint

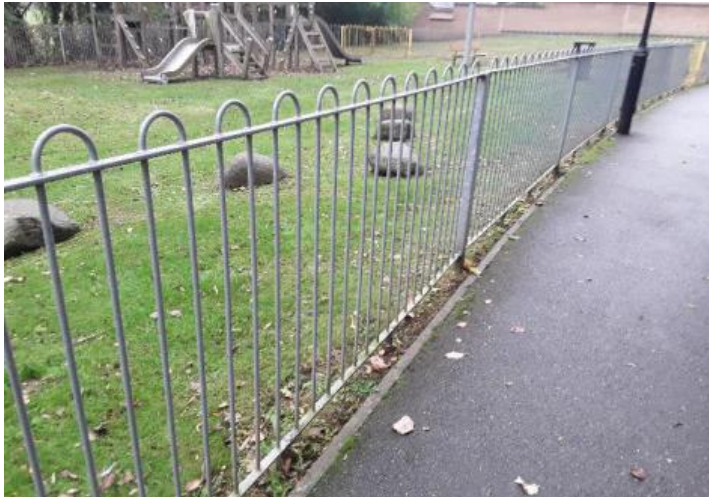
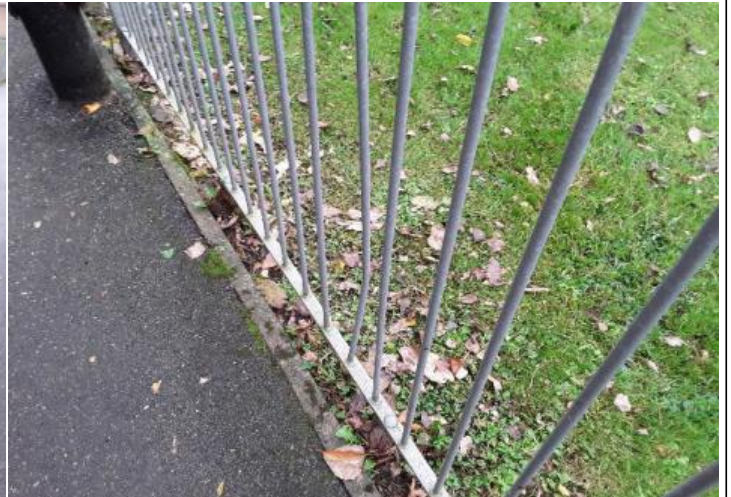
i 6 - Low Risk (Finding 1)

Finding: There is some damage to the fence sections

Action: Monitor for any further deterioration and repair as required

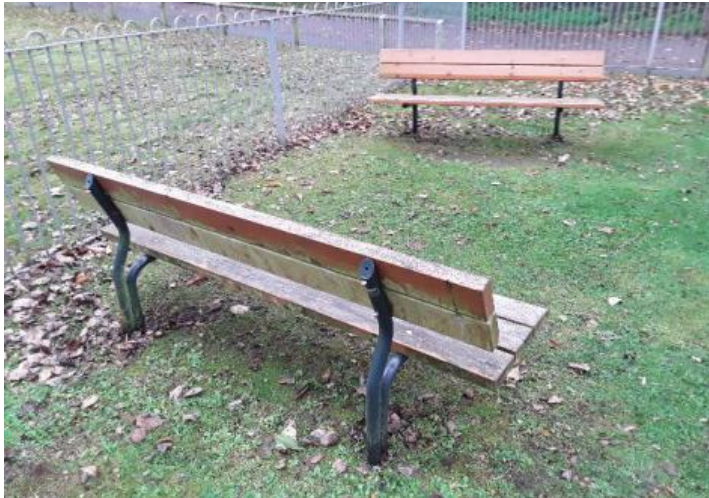
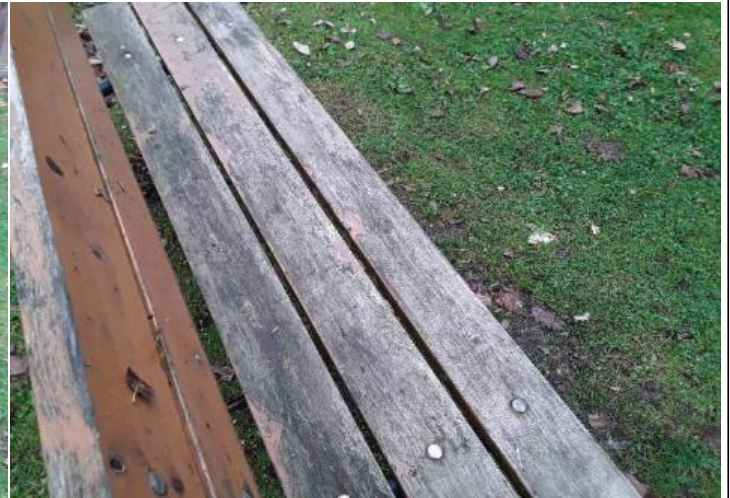
i 6 - Low Risk (Finding 1)

Finding: The timber stain is in poor condition

Action: Prepare all affected parts and re-stain with an appropriate preservative

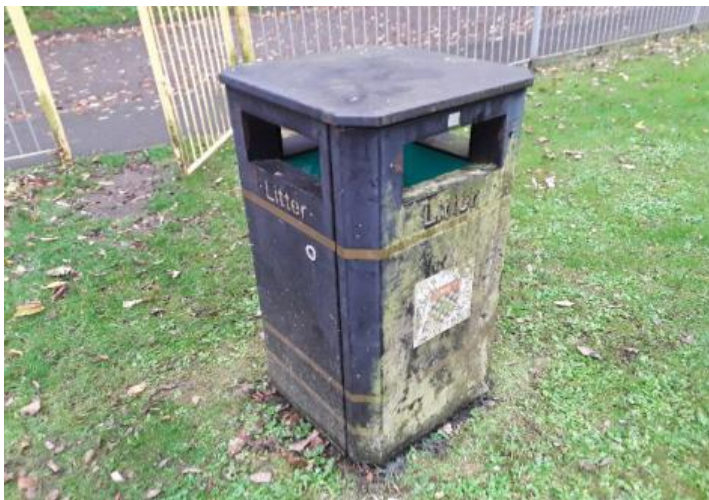
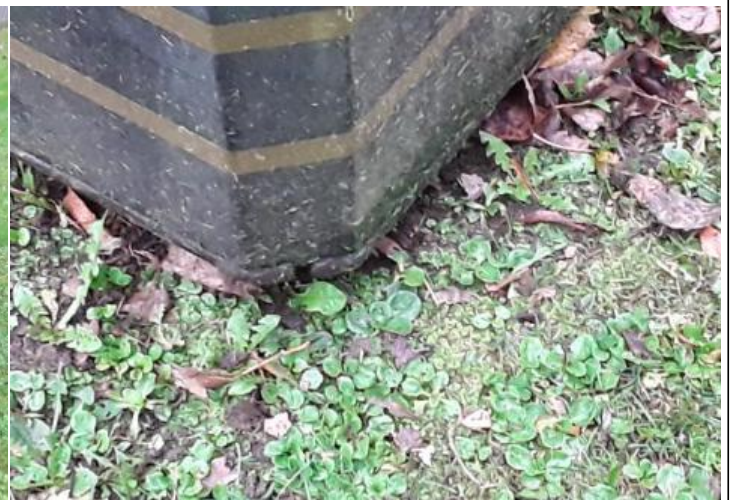
i 6 - Low Risk (Finding 1)

Finding: There is surface corrosion / rust present on the item

Action: Consider treating the item

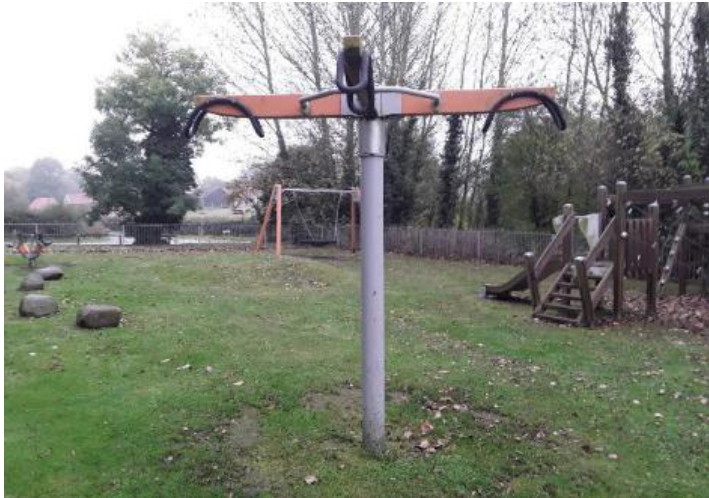
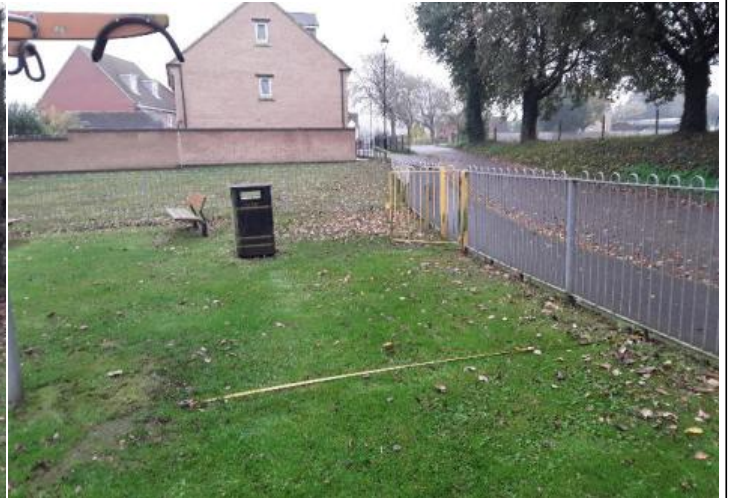
i 8 - Low Risk (Finding 1)

Finding: BS EN 1176 Part 5 states that for Type C Carousels, an additional obstacle free space of at least 1.0m shall be provided from the edge of the free space / impact area and there is insufficient obstacle free space provided

Action: Monitor - no remedial work recommended

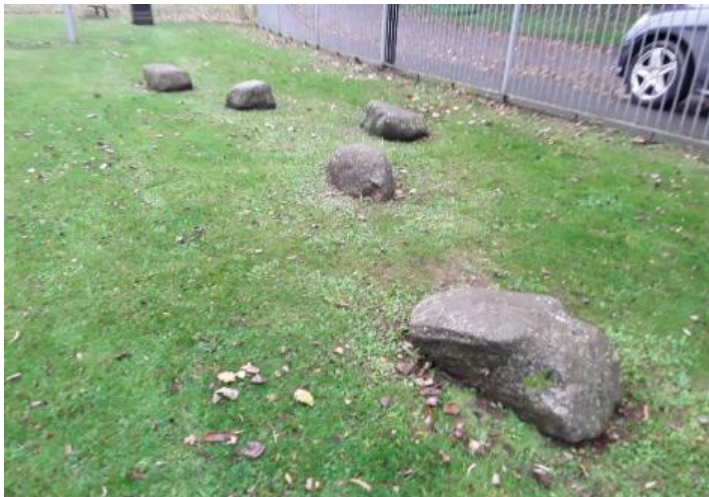
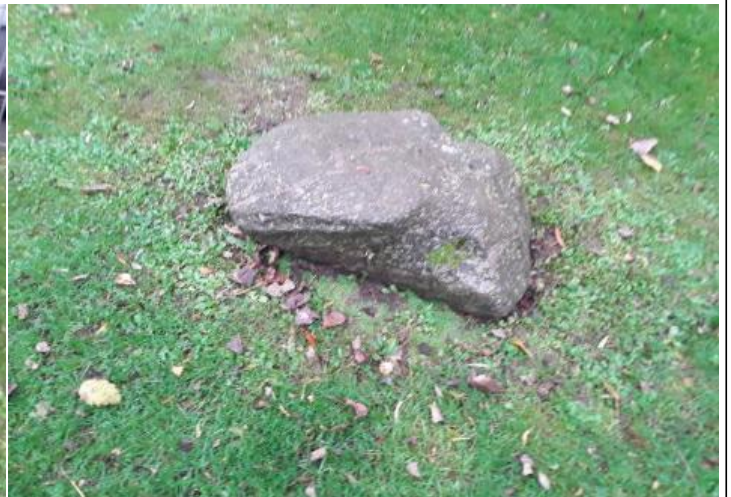
i 8 - Low Risk (Finding 1)

Finding: The rocks and/or boulders have moss/algae growth apparent

Action: Clean and maintain

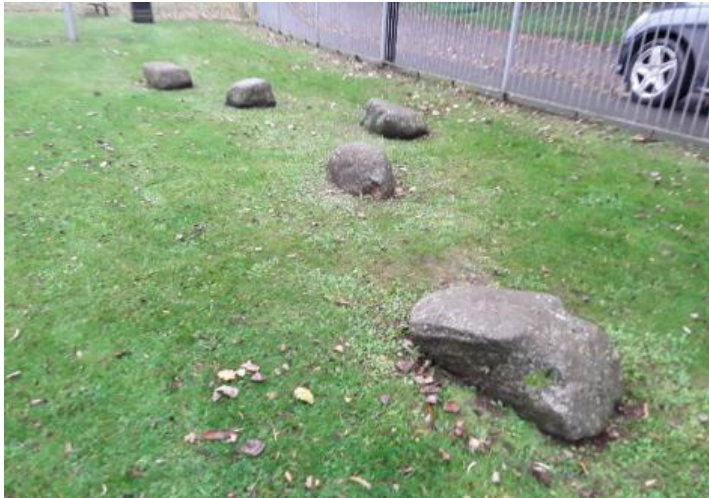
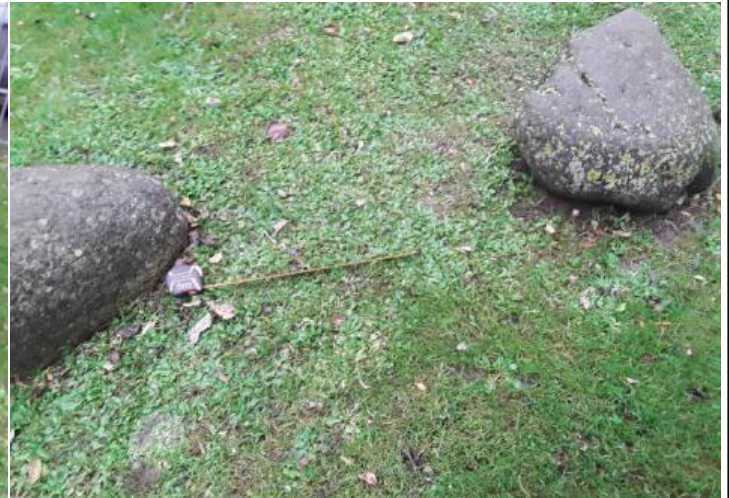
i 6 - Low Risk (Finding 2)

Finding: The step between the items is quite large and users may not be able to complete the step without touching ground, the items could therefore be considered to be within the falling space of each other, however the intention of the play activity continuity is easily apparent and foreseeable to the user

Action: Monitor - No remedial work recommended

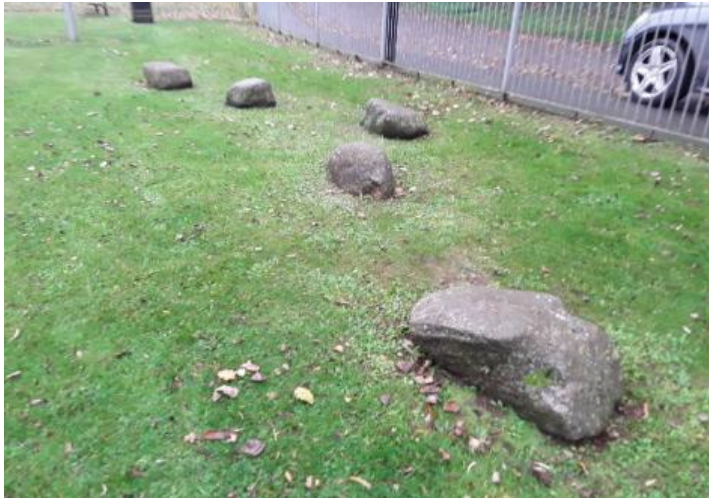
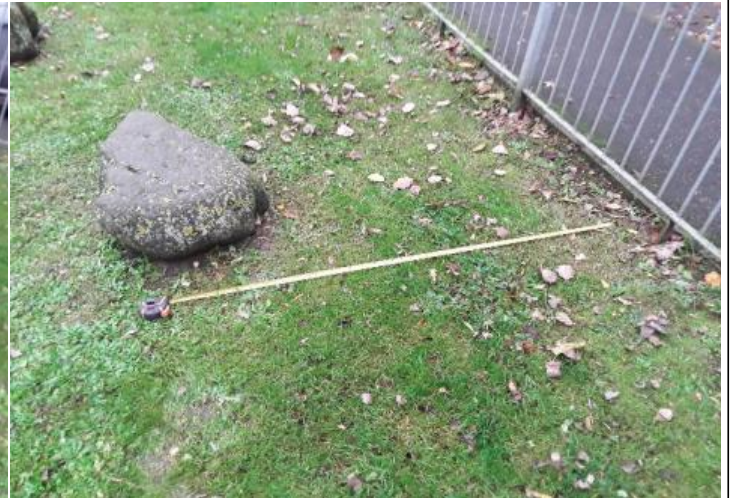
i 5 - Very Low Risk (Finding 3)

Finding: The fence forms a hard object within the falling space of the boulders in contravention of the requirements of BS EN 1176 Part 1

Action: Monitor - No remedial work recommended

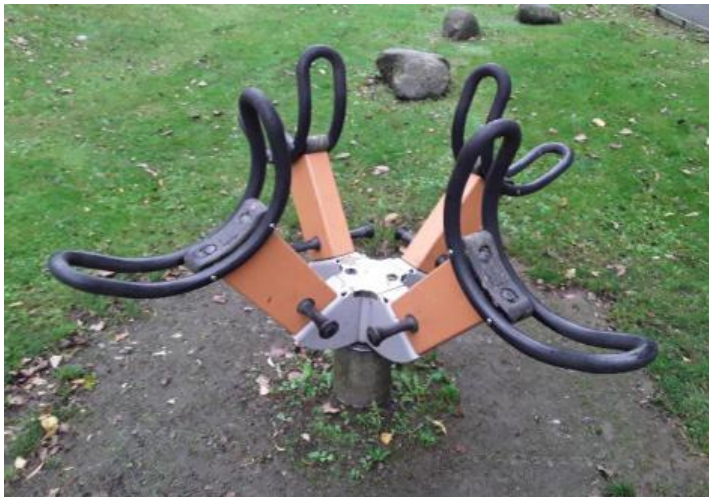
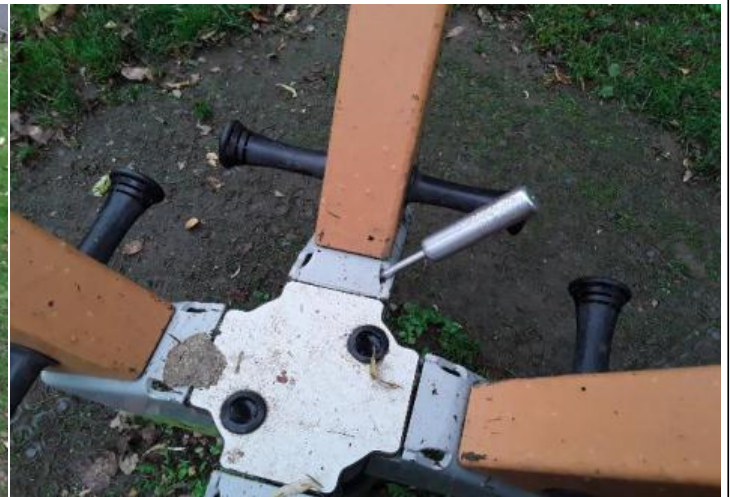
Finding: There is/are finger entrapment/s in the structure and the item fails to meet the requirements of BS EN 1176 Part 1 4.2.7.6 Entrapment of fingers

Action: Monitor - No remedial work recommended

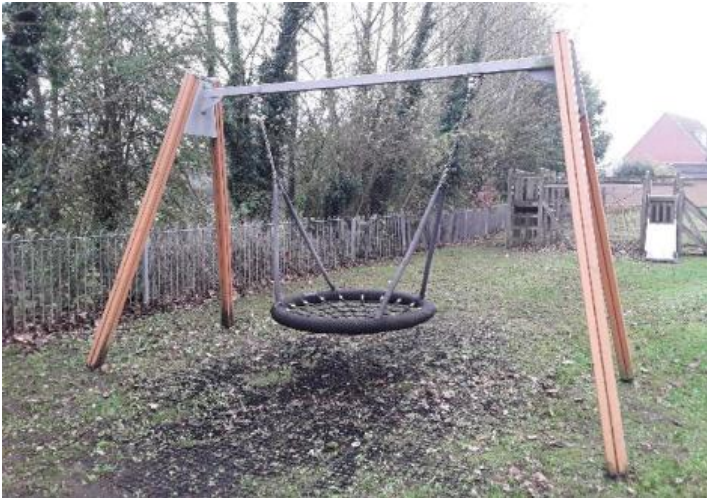
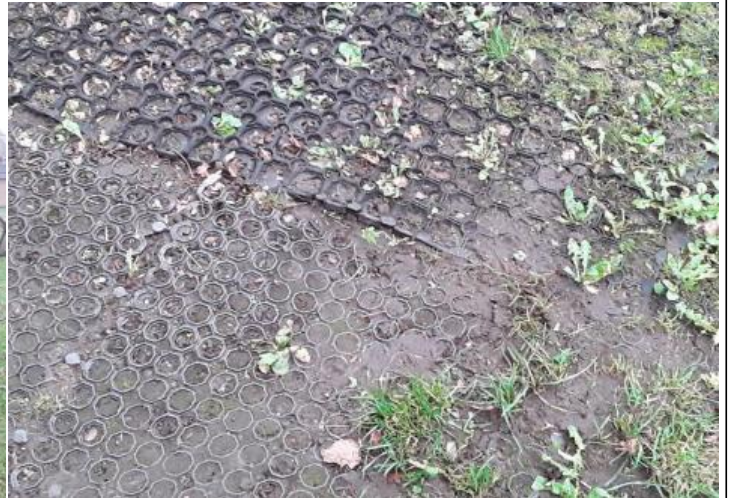
Finding: The grass mat surface is lifting at the edges and creating trip points

Action: Repair the surfacing to remove trip points

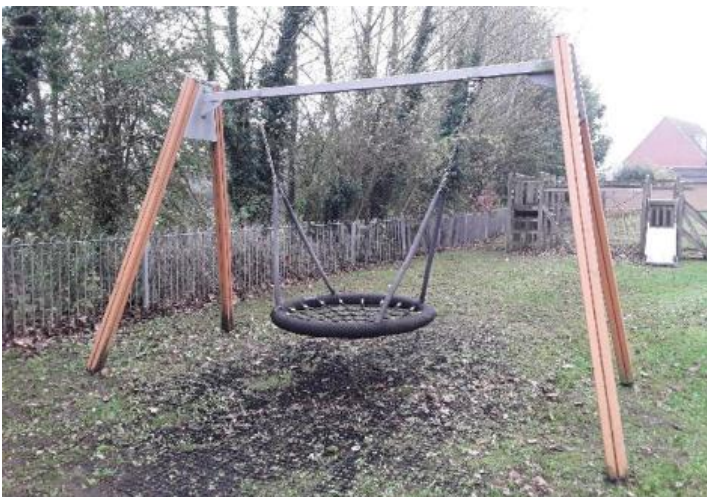
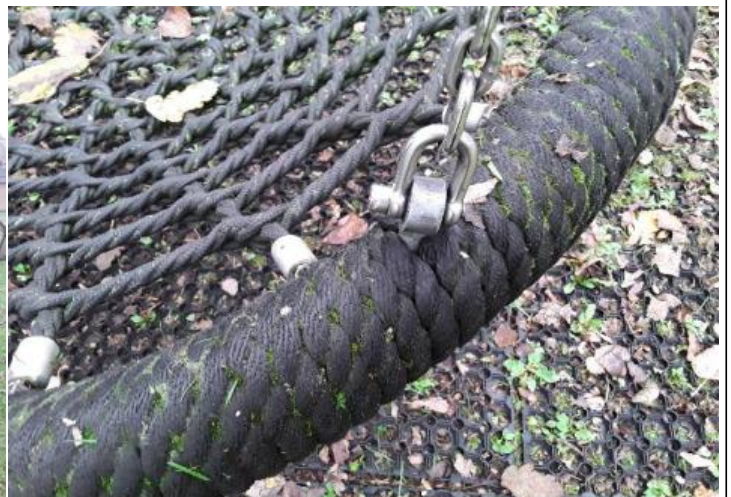
Finding: The basket bushes are showing signs of wear

Action: Monitor for any further deterioration and replace as required

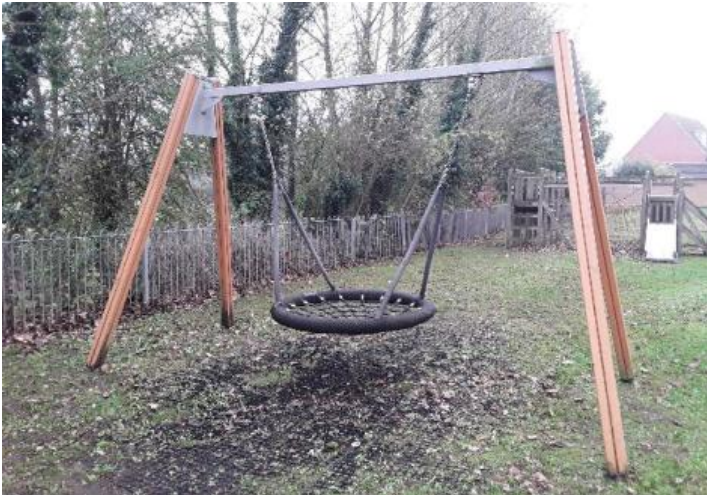
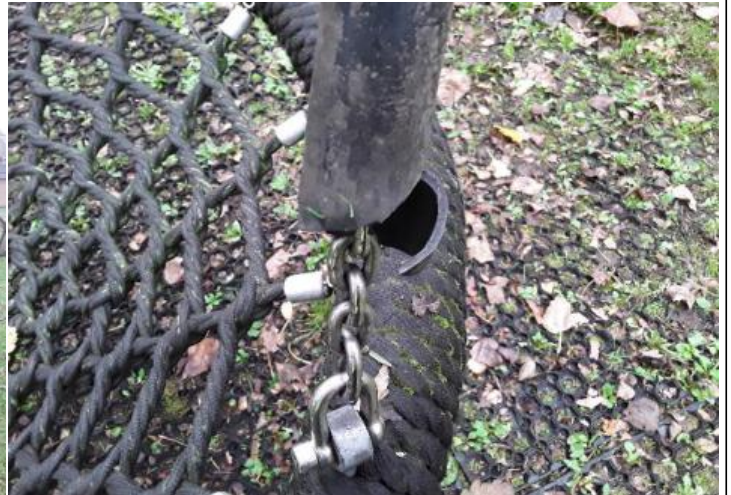
Finding: The chain/rope covering is damaged

Action: Monitor for any further deterioration and replace as required

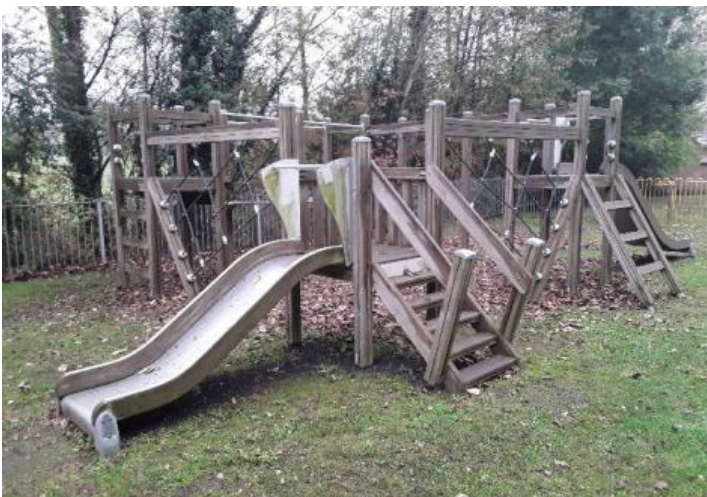
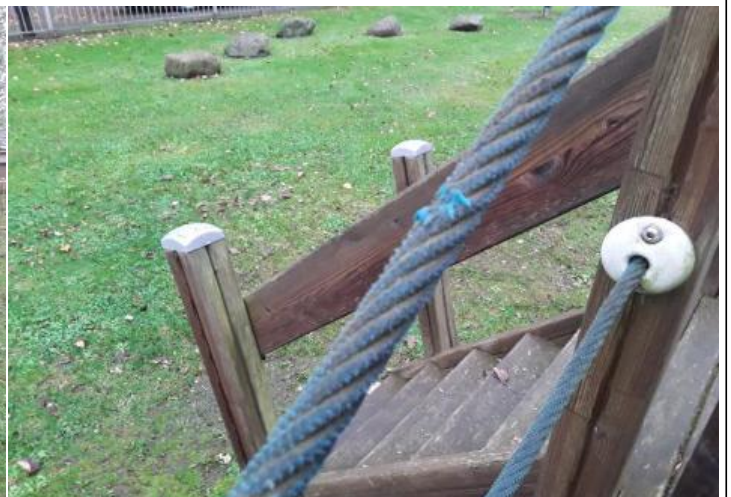
Finding: The ropes/nets are worn/damaged in places

Action: Monitor for any further deterioration and repair or replace as required

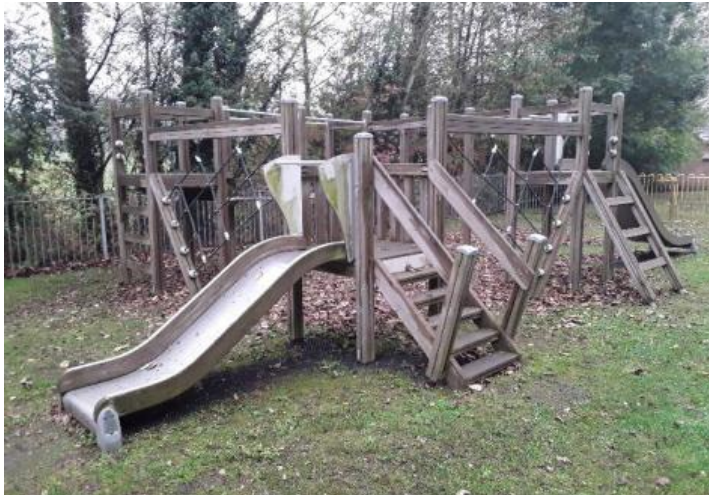
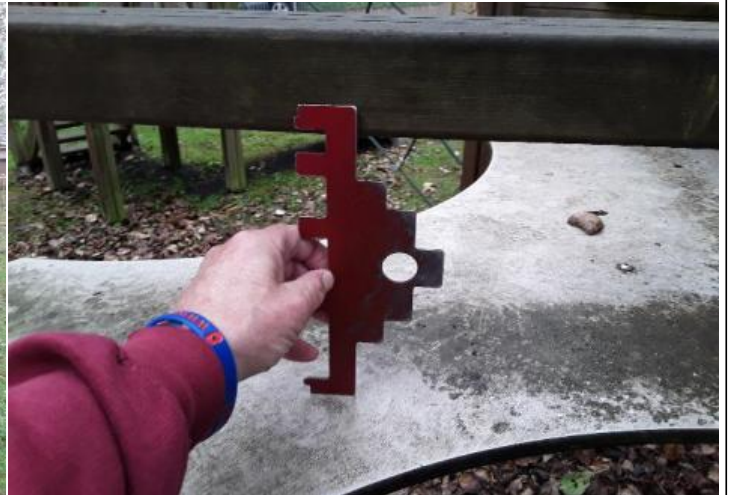
Finding: The item fails to meet the requirements of BS EN 1176 Part 1 4.2.7.2 for head and neck entrapment in the framework

Action: Monitor - No remedial work recommended

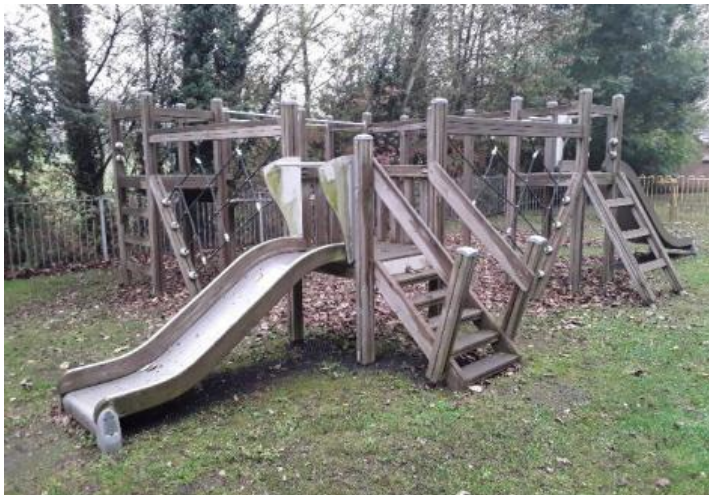
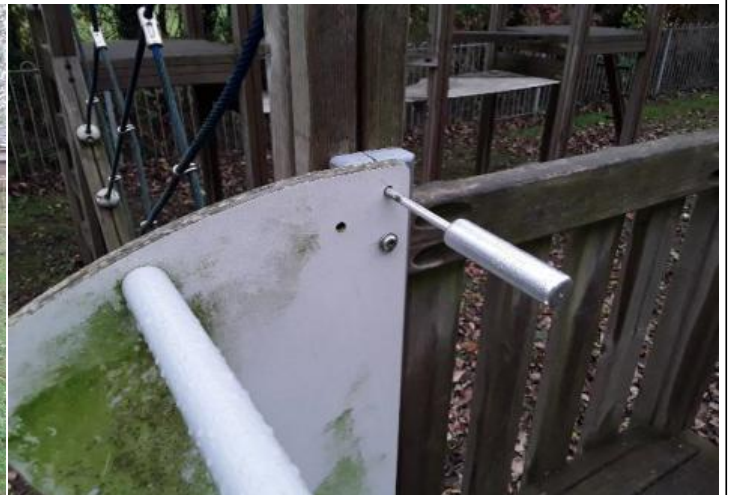
Finding: There is/are finger entrapment/s adjacent to the slide entry and the item fails to meet the requirements of BS EN 1176 Part 1 4.2.7.6 Entrapment of fingers

Action: Provide inserts to seal the redundant bolt holes
