Annual Inspection

Colsterworth & District Parish Council

Woolsthorpe By Colsterworth Play Area

Inspection Ref: 2514002

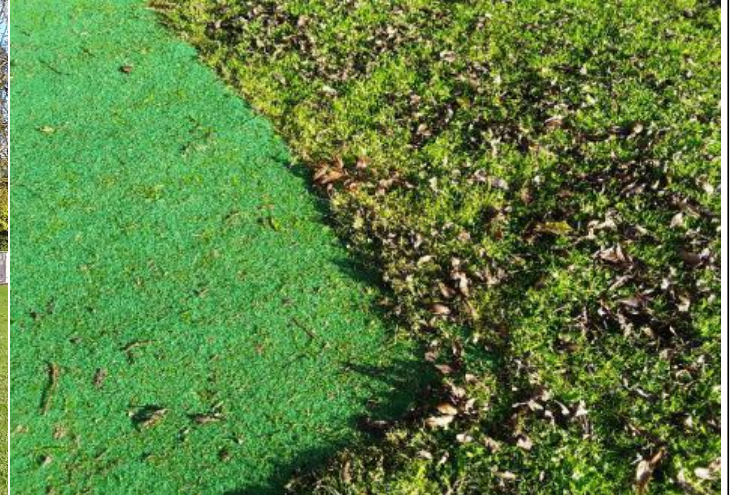
Finding: There is weed / vegetation growth on and around the surface
Action: Remove weed / vegetation growth

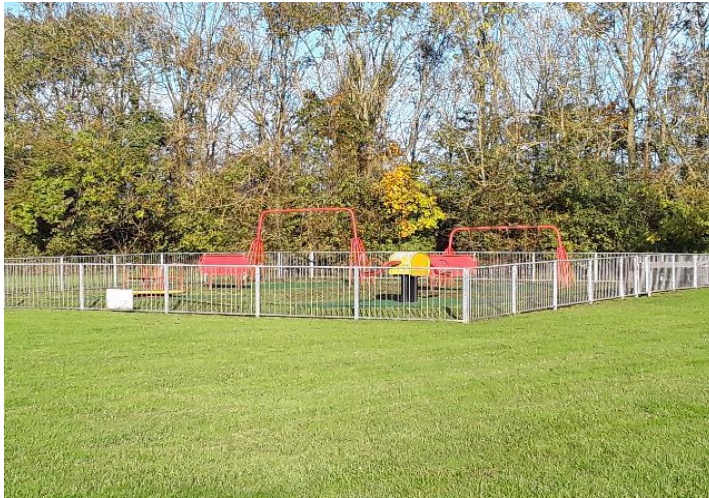
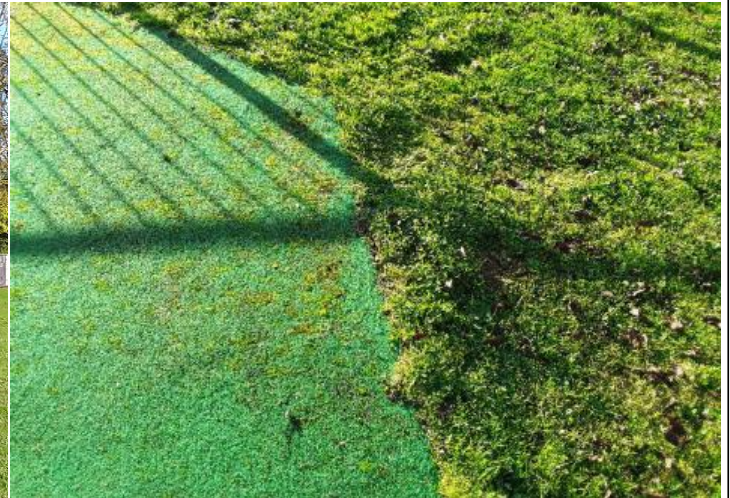
Finding: There is algae, silt or moss growth on the surface resulting in slippery conditions
Action: Clean and treat appropriately

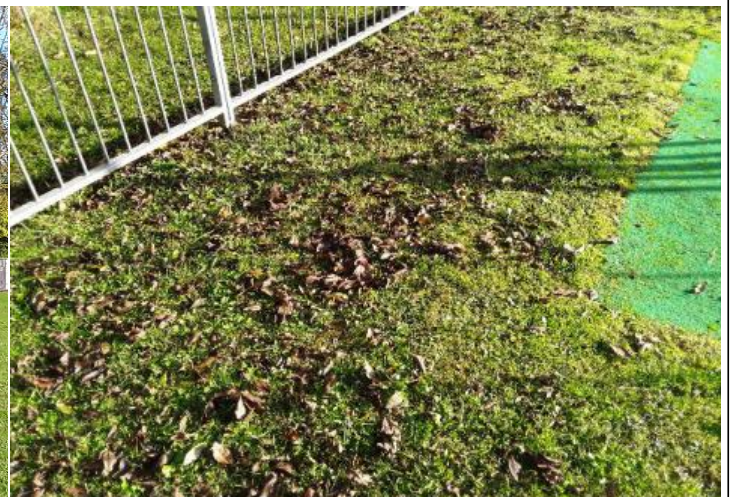
Finding: There is tree debris on the surfacing
Action: Remove and maintain

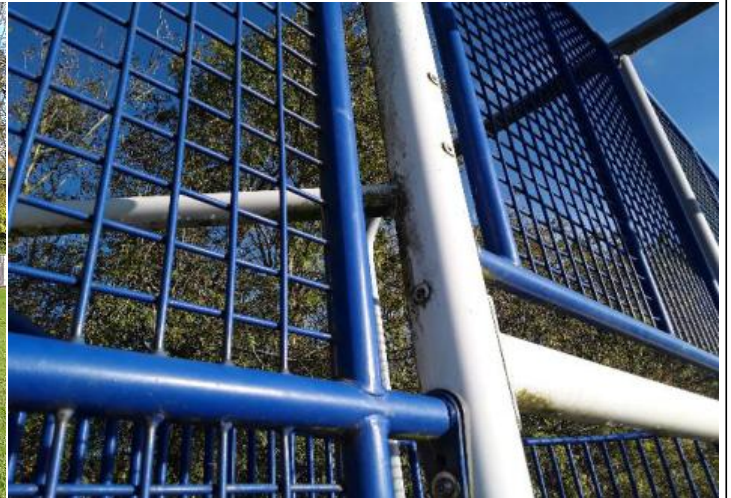
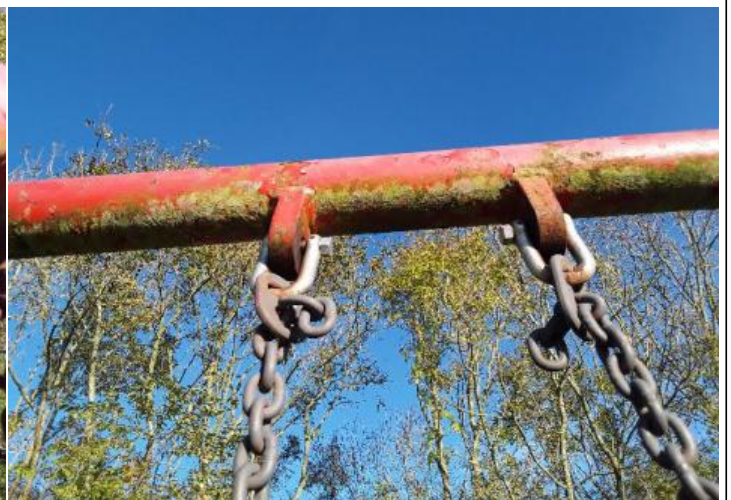
Finding: There is algae or moss on the equipment

Action: Clean and treat appropriately

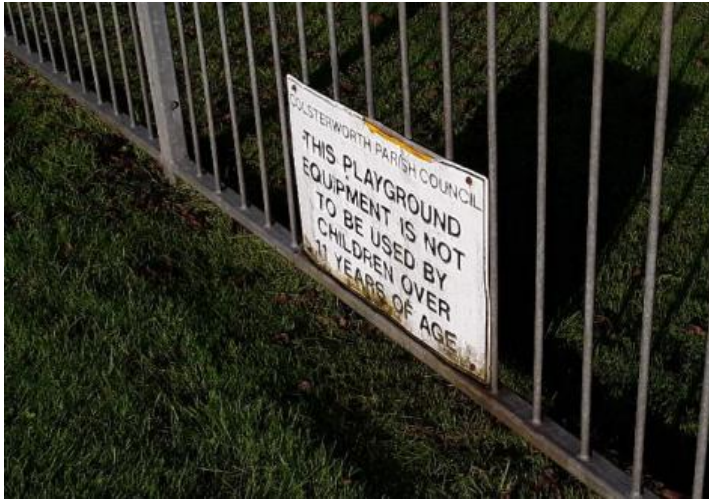
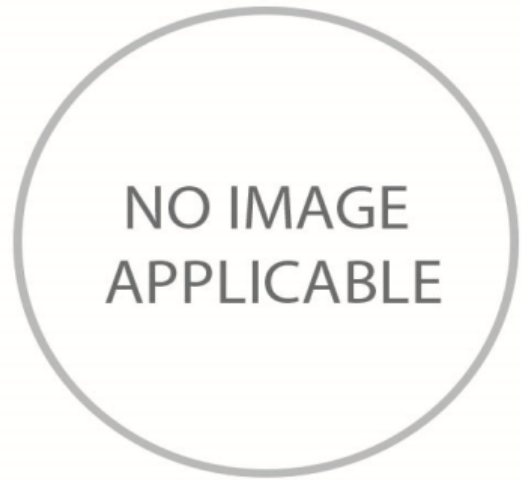
Finding: It is recommended that signage, with information including the site address, contact information for maintenance issues and emergency contact details are provided for the facility

Action: Provide in accordance with the recommendations

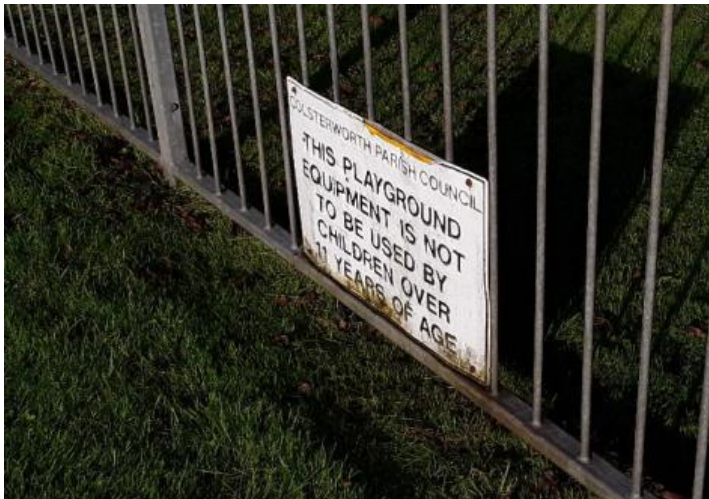
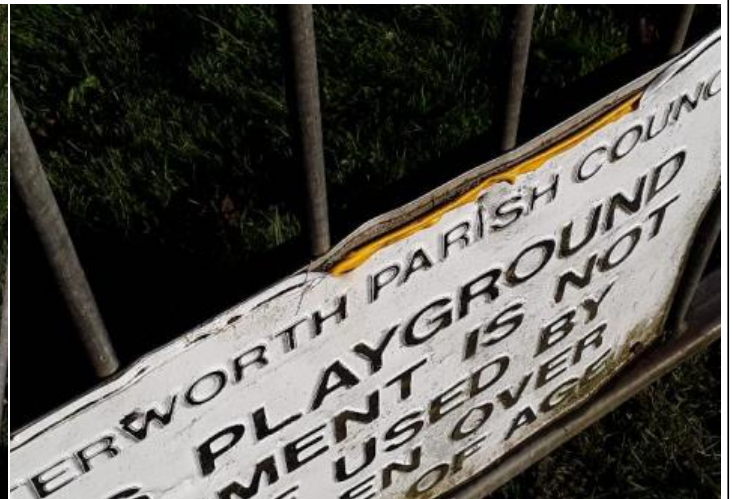
Finding: There is minor damage to the sign

Action: Monitor and replace if required

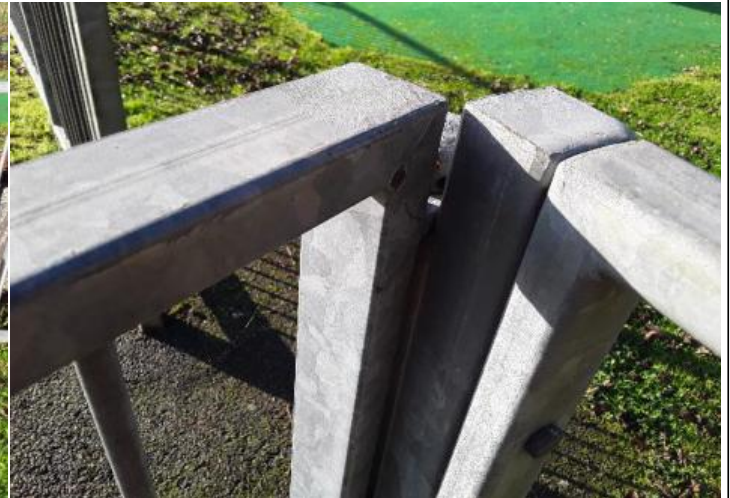
Finding: There are openings that are less than 12mm that could trap or crush fingers

Action: Provide a 12mm gap throughout full range of motion at both sides of gate

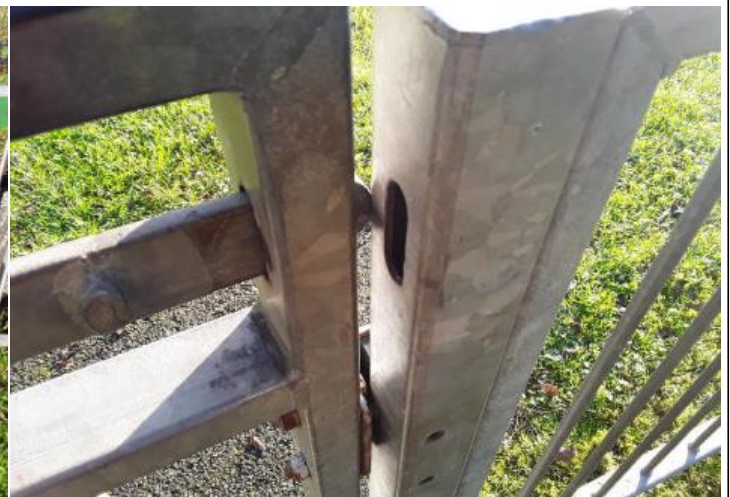
Finding: The gate latch doesn't line up with the slot

Action: Monitor and adjust the gate if required

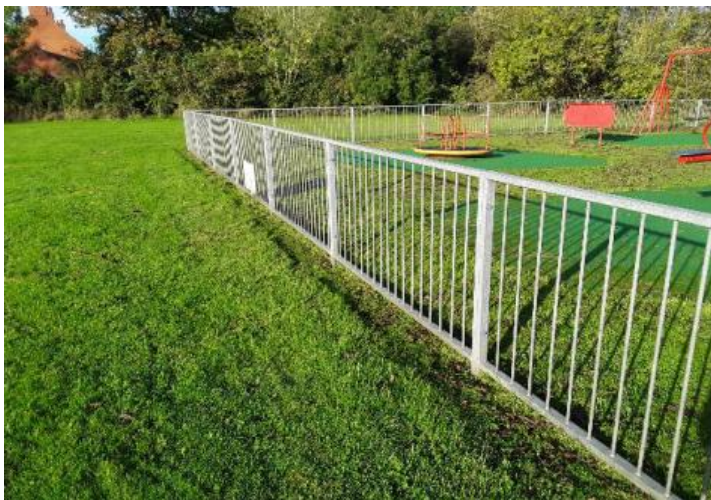
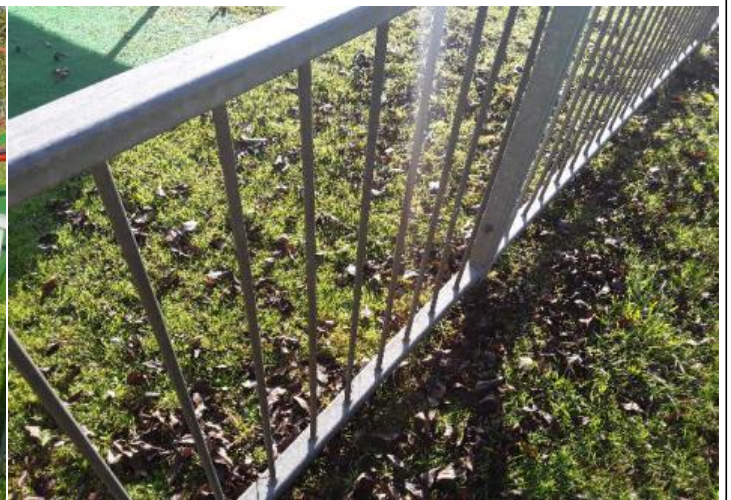
Finding: There is minor damage to the fence sections

Action: Monitor for any further deterioration and repair as required

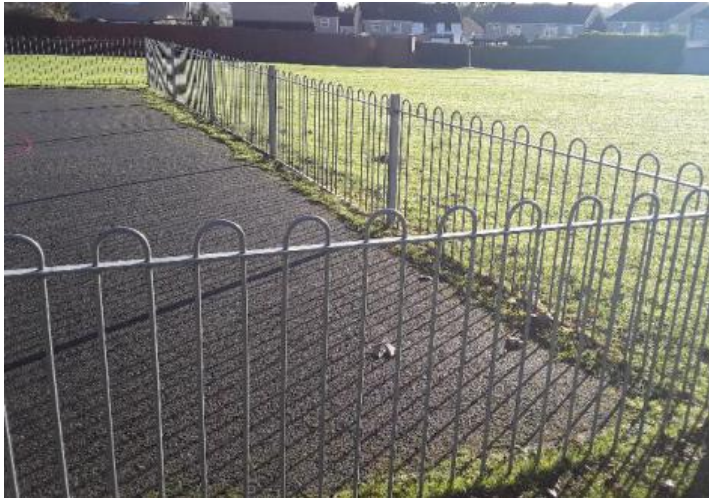
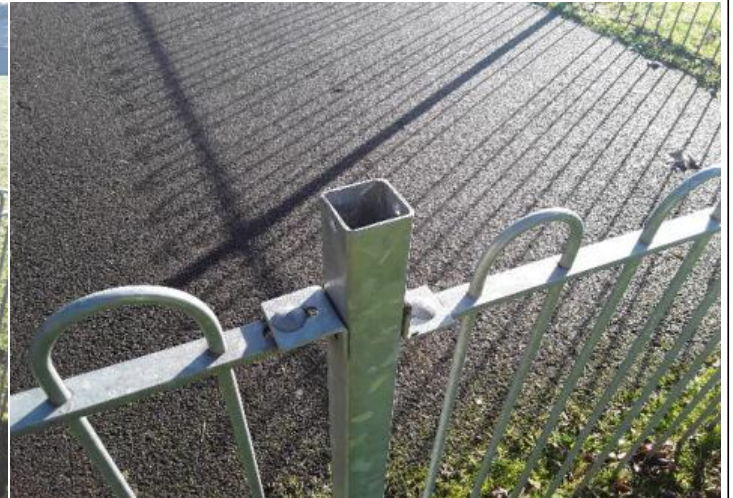
Finding: There is / are post caps missing or damaged on the fence

Action: Replace missing / damaged post caps

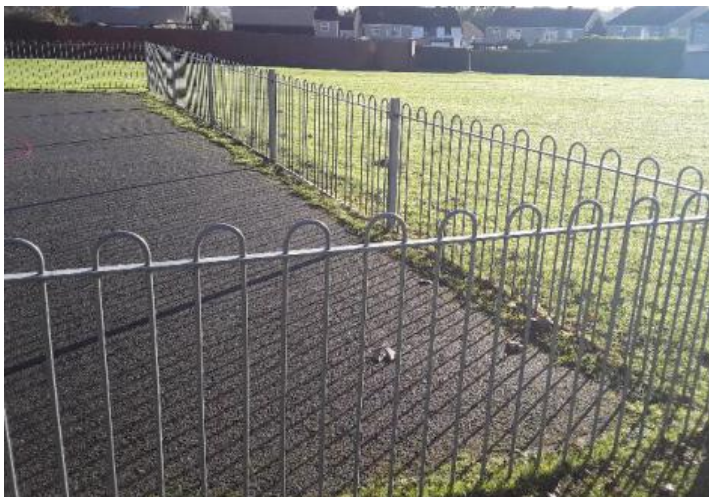
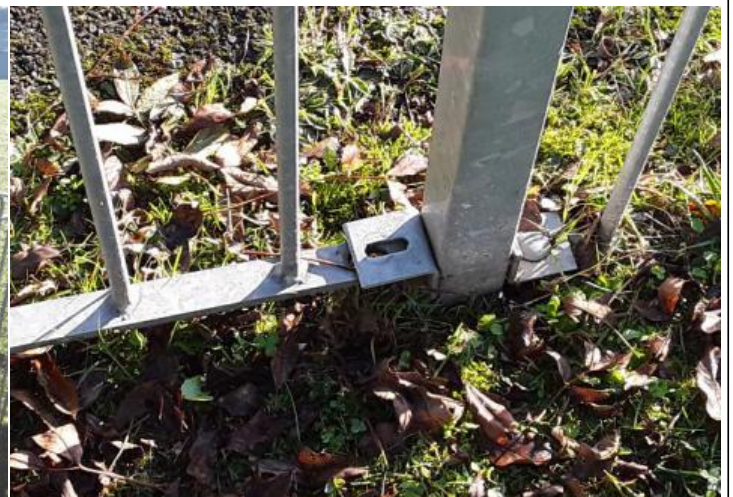
Finding: There is or are fixings missing on the item

Action: Replace all missing fixings

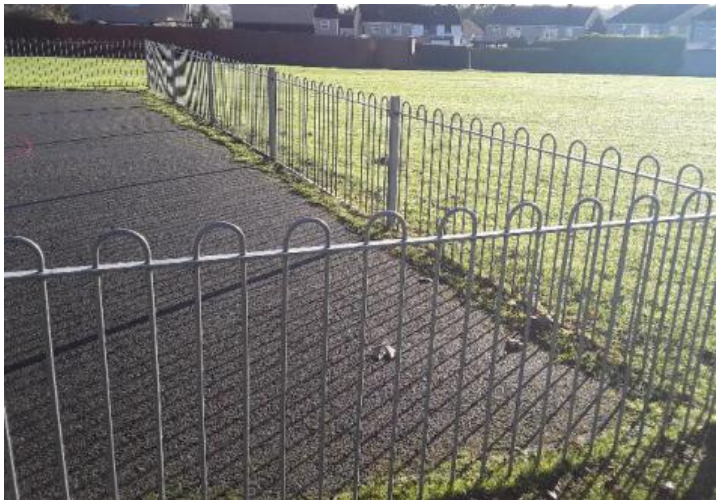
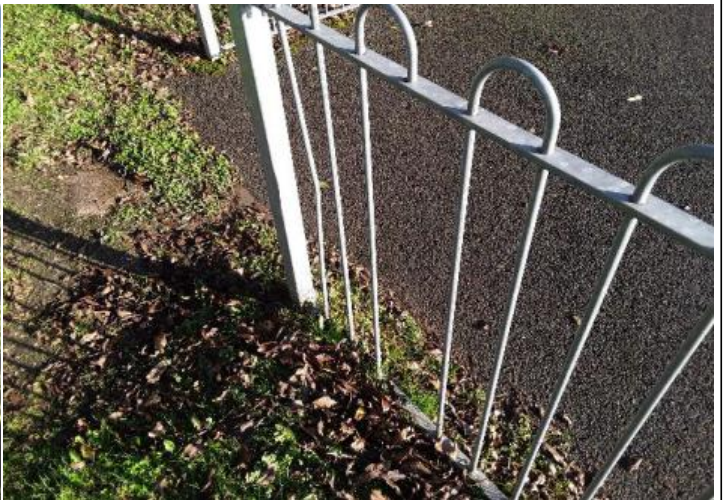
Finding: There is some damage to the fence sections
Action: Monitor for any further deterioration and repair as required

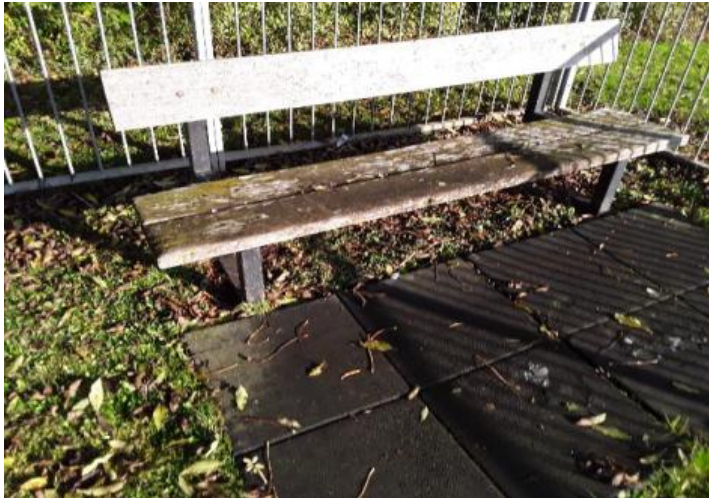
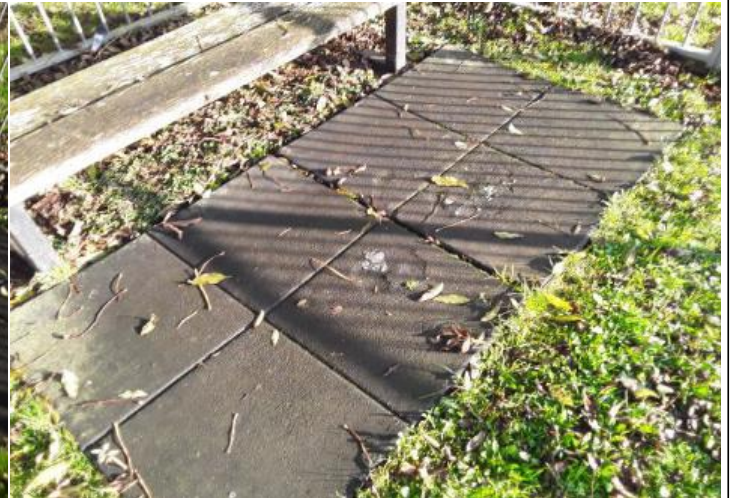
Finding: There are gaps opening in between the tiles

Action: Monitor for any further deterioration and repair as required

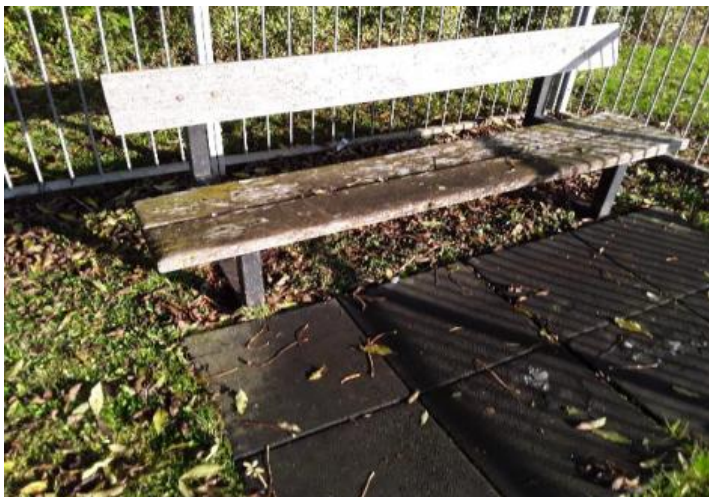
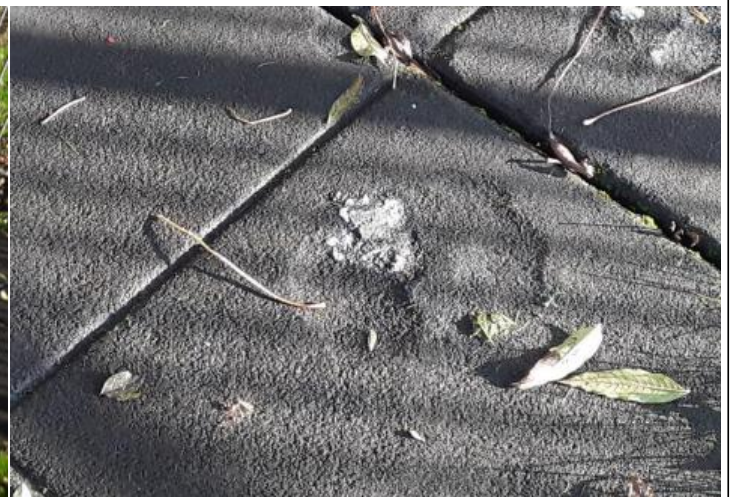
Finding: There is fire damage to the surfacing

Action: Monitor for any further deterioration and repair as required

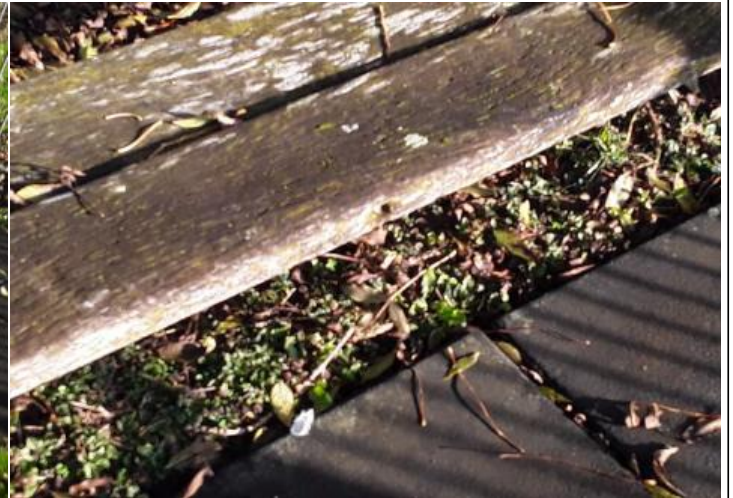
Finding: Parts of the timber are rough or splintered

Action: Remove all rough or sharp edges

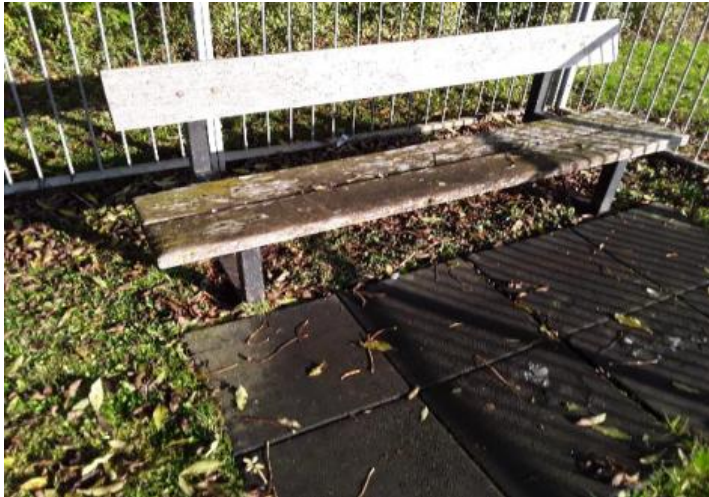
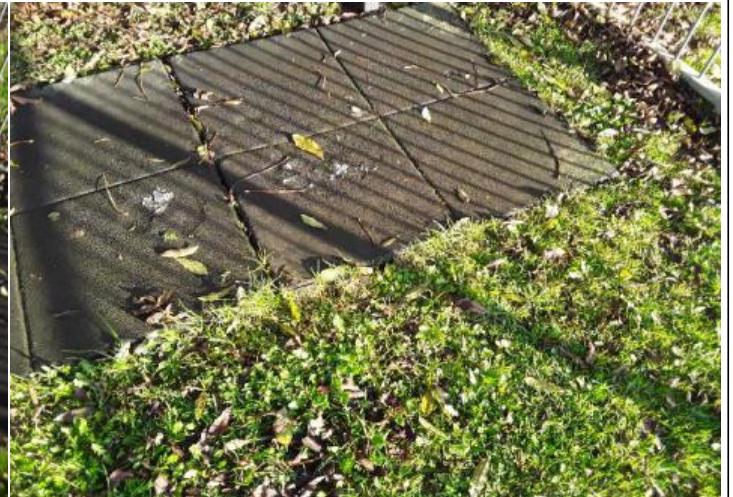
Finding: There are trip hazards at the edges of the tiled surface

Action: Remove trip hazard

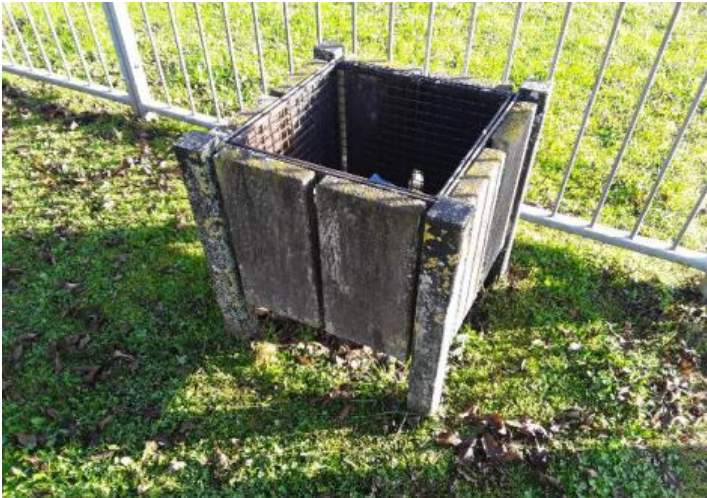
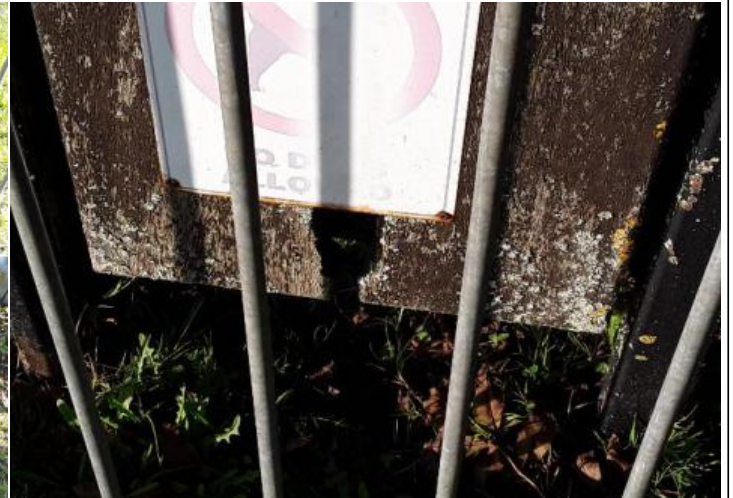
Finding: There is fire damage to the item

Action: Monitor for any further deterioration and repair as required

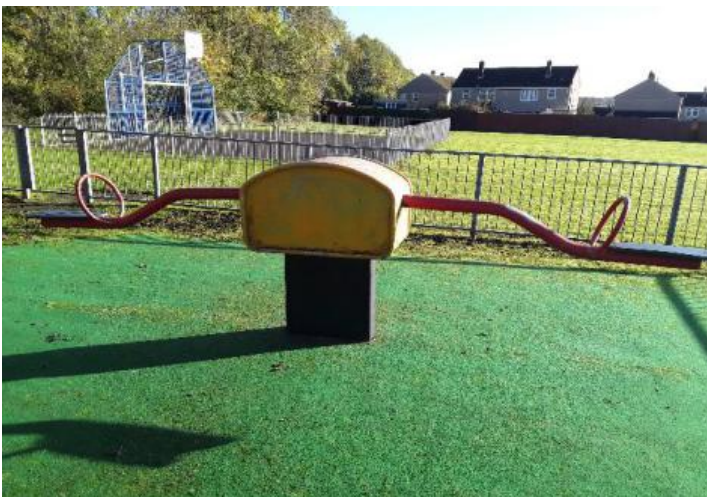
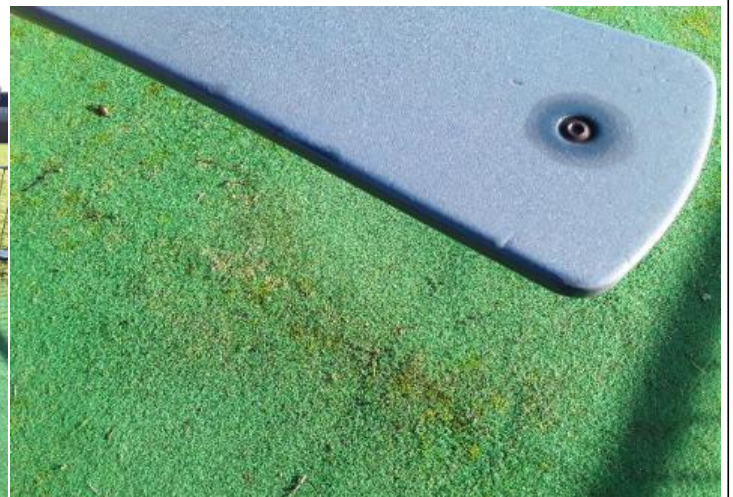
Finding: The seat has minor damage or wear

Action: Monitor for any further deterioration and replace as required

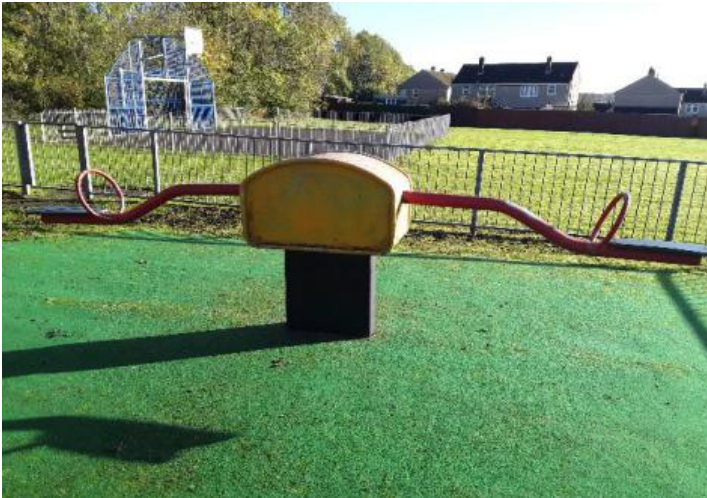
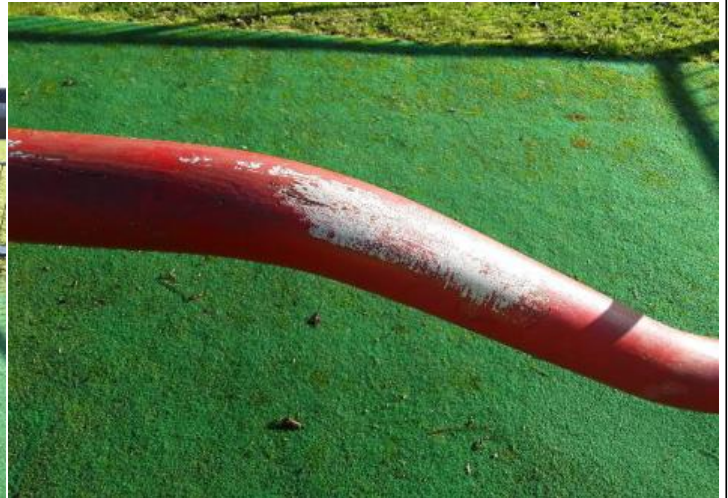
Finding: There is surface corrosion / rust present on the item

Action: Consider treating the item

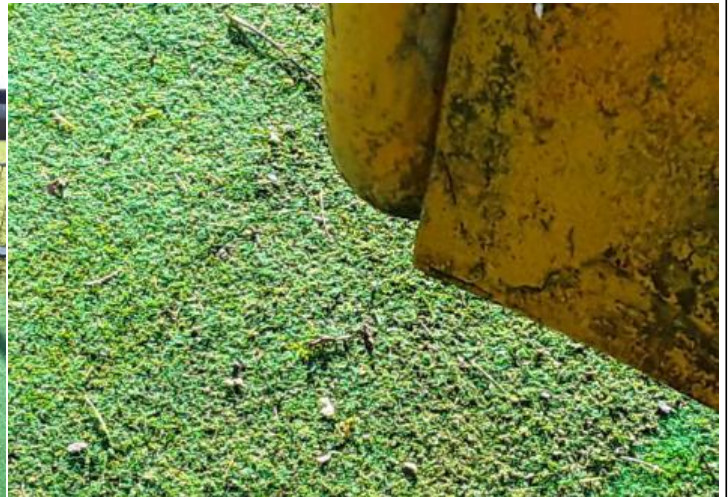
Finding: There is an exposed sharp corner on the shroud

Action: Remove the sharp corner

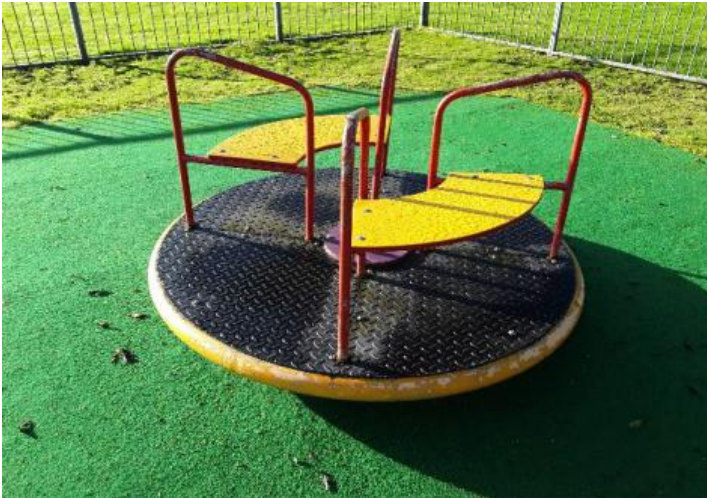
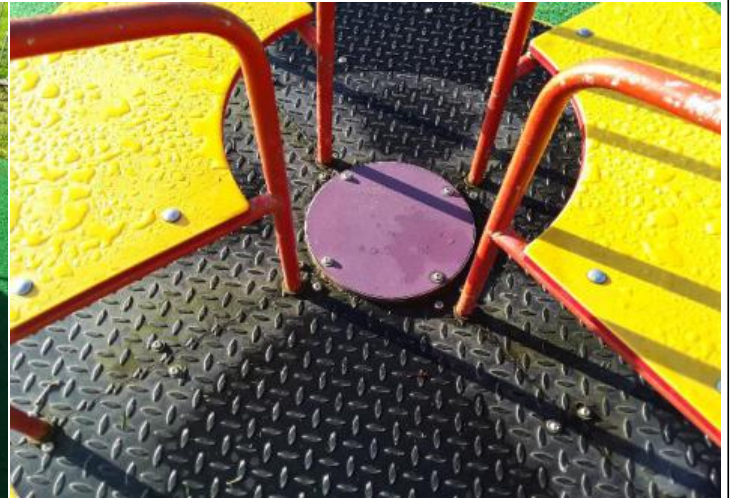
Finding: The bearing is showing signs of wear

Action: Monitor for any further deterioration and replace as required

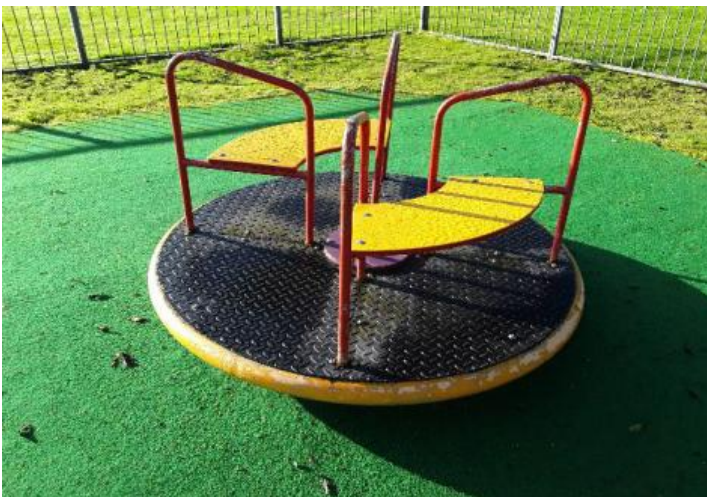
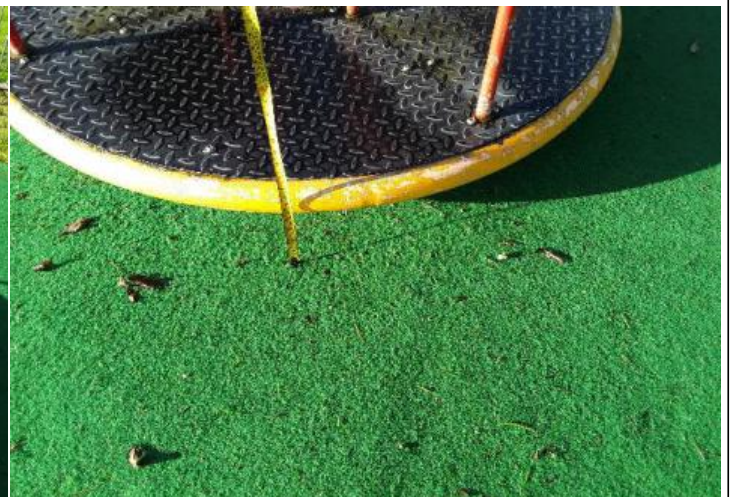
Finding: The distance between the underside of the roundabout platform and the playing surface is in excess of 110mm and contravenes the requirements of BS EN 1176 Part 5 which requires that the distance be maintained between 60mm-110mm - for the entire circumference of the roundabout

Action: Monitor - No remedial work recommended

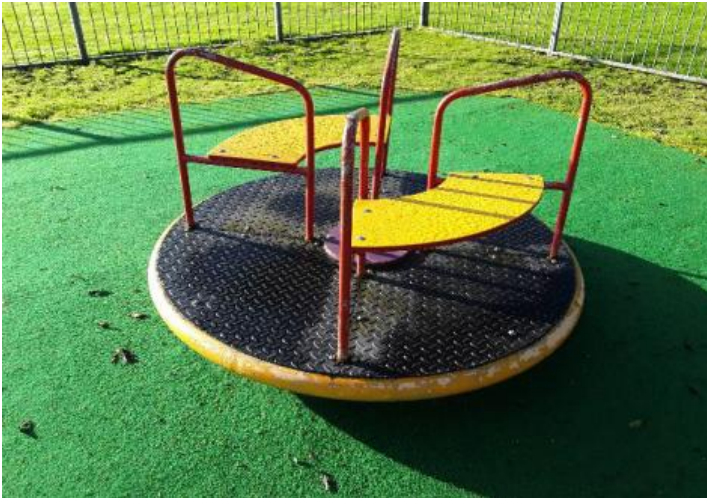
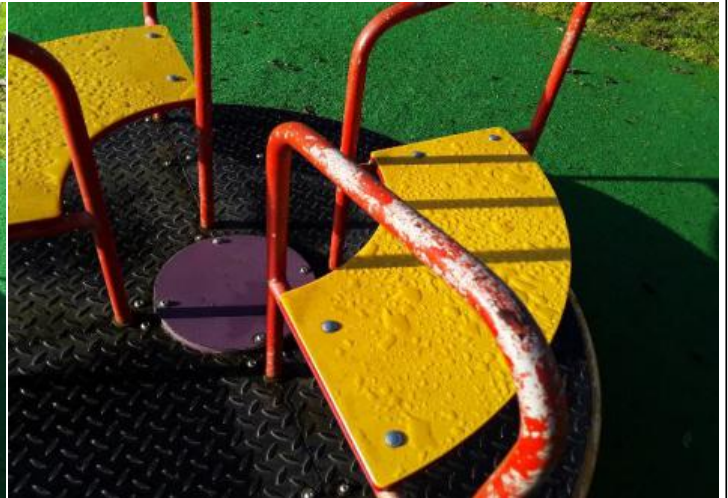
Finding: There is surface corrosion / rust present on the item

Action: Consider treating the item

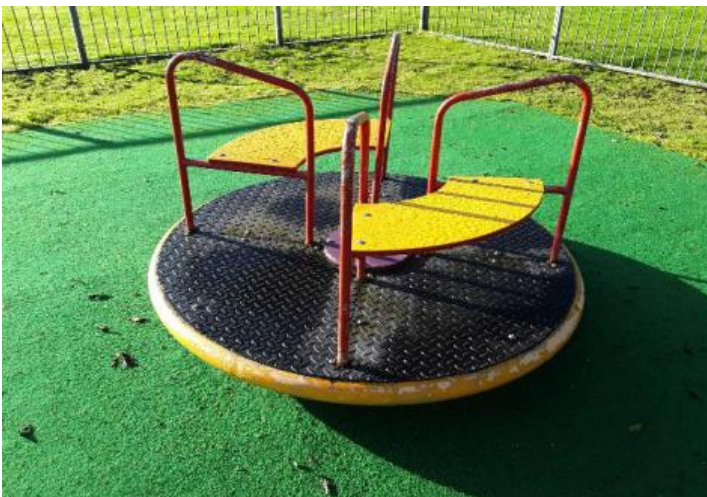
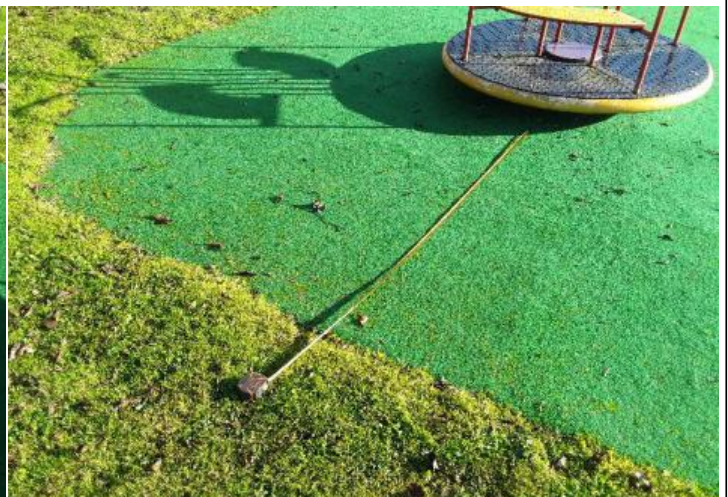
Finding: The surfacing dimensions are short and do not meet with the requirements of the current applicable standard

Action: Monitor - no remedial action recommended

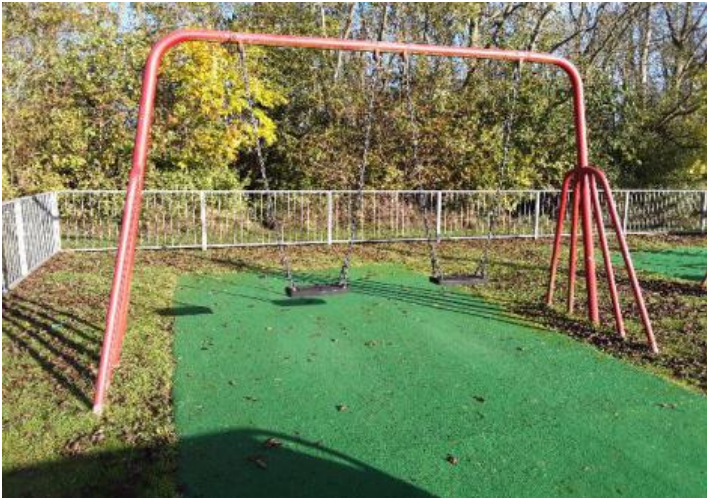
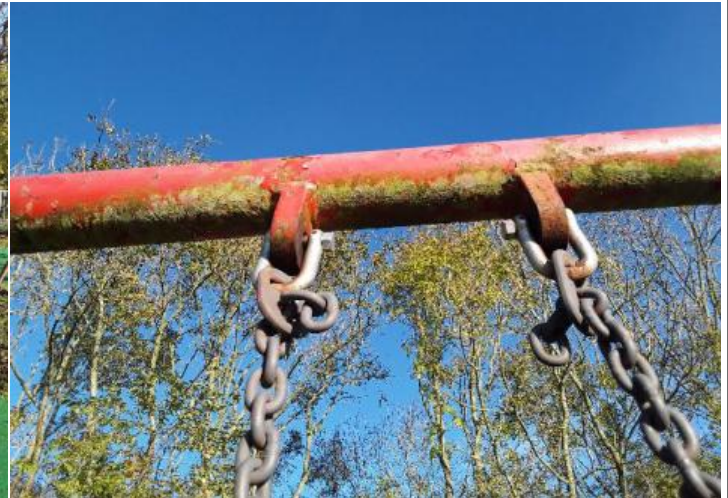
Finding: The bushes are showing signs of wear

Action: Monitor for any further deterioration and replace as required

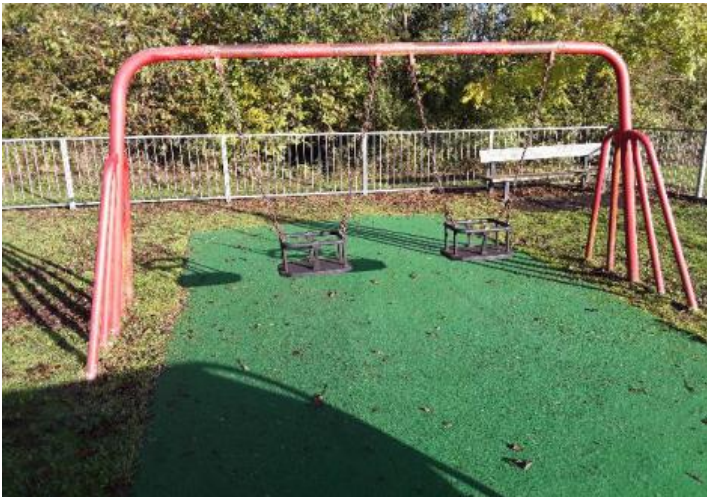
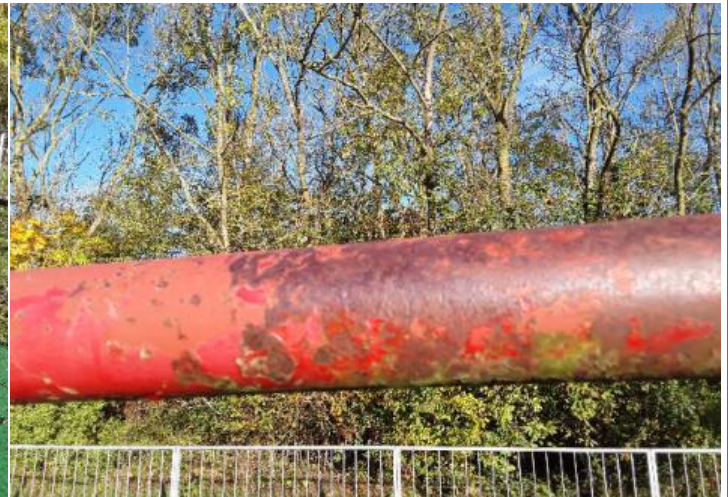
Finding: There is surface corrosion / rust present on the item

Action: Consider treating the item

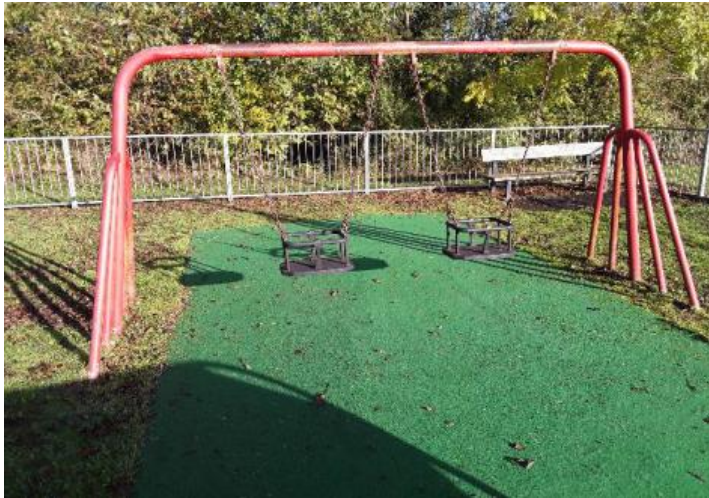
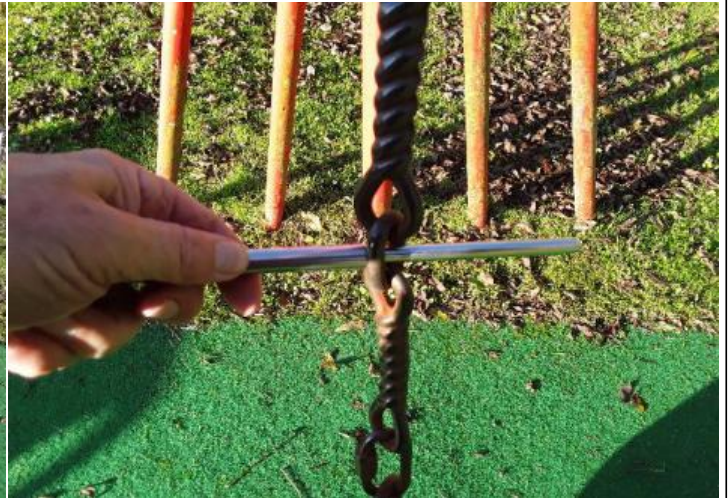
Finding: The chain openings are in excess of the 8.6mm as recommended by BS EN 1176
Action: Monitor - No remedial work recommended

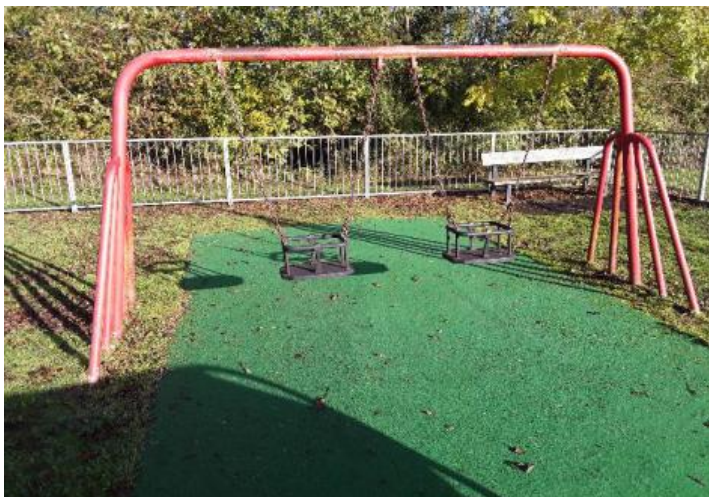
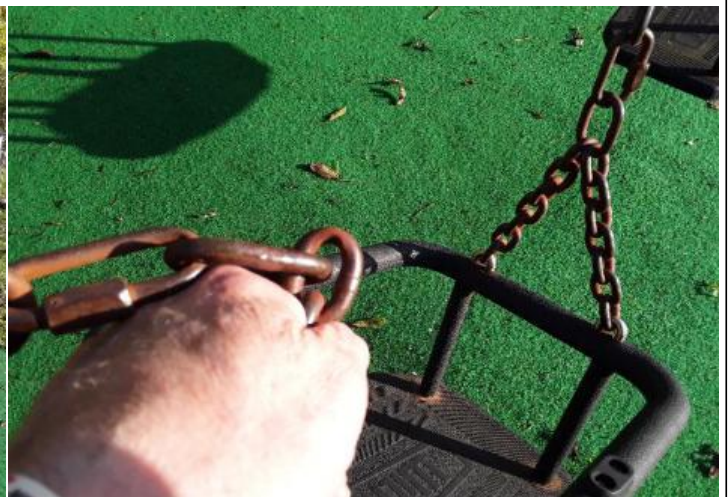
Finding: There is some notable evidence of chain wear
Action: Monitor for any further deterioration and replace when 40% worn

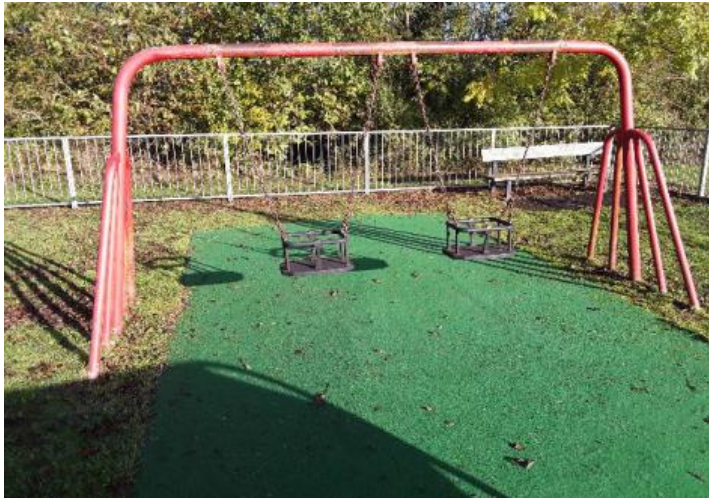
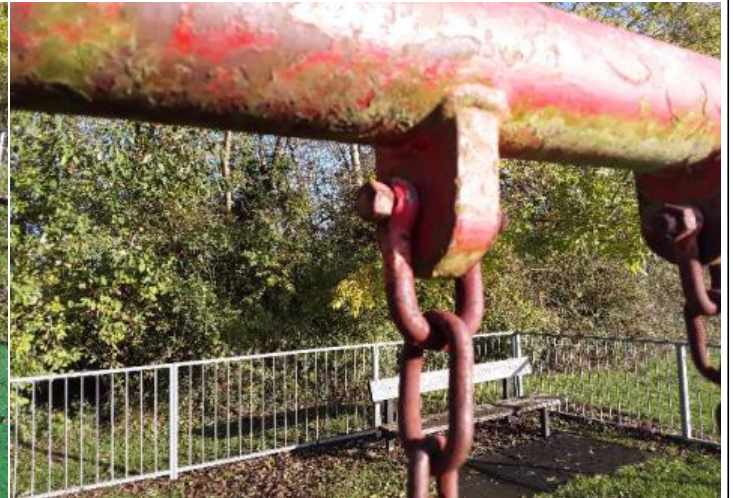
Finding: The bushes are showing signs of wear

Action: Monitor for any further deterioration and replace as required

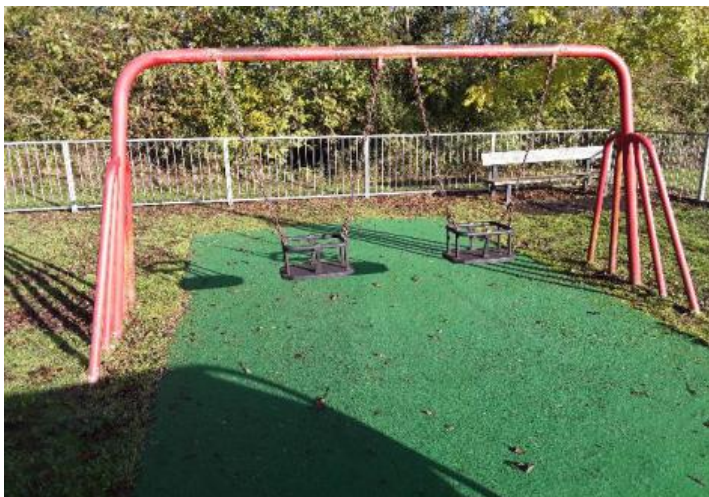
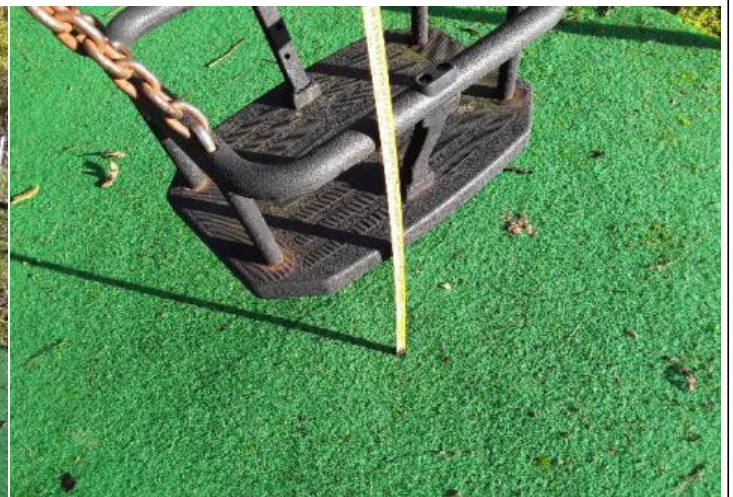
Finding: The seat clearance from finished surface level to the underside of the seat is too low and does not meet the requirements of BS EN 1176 Part 2 (350mm minimum clearance required)

Action: Adjust seat height/s (400mm-500mm is recommended)

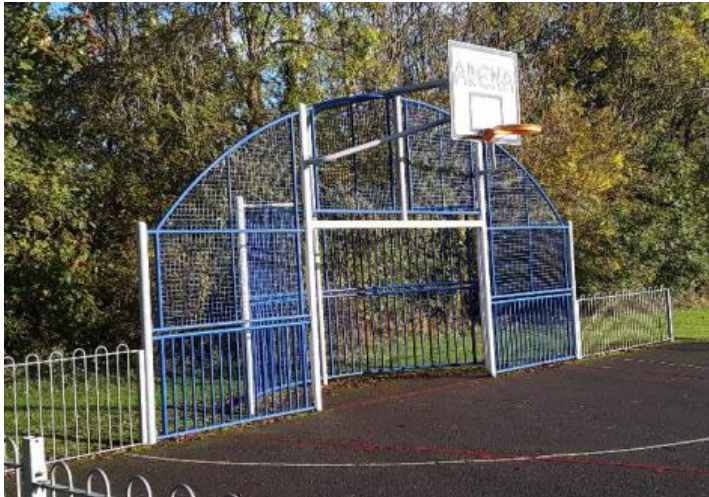
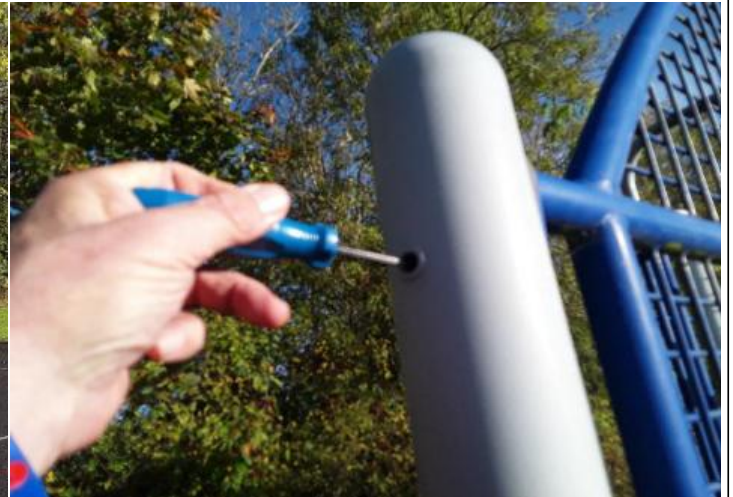
Finding: There is/are inserts missing

Action: Replace missing inserts

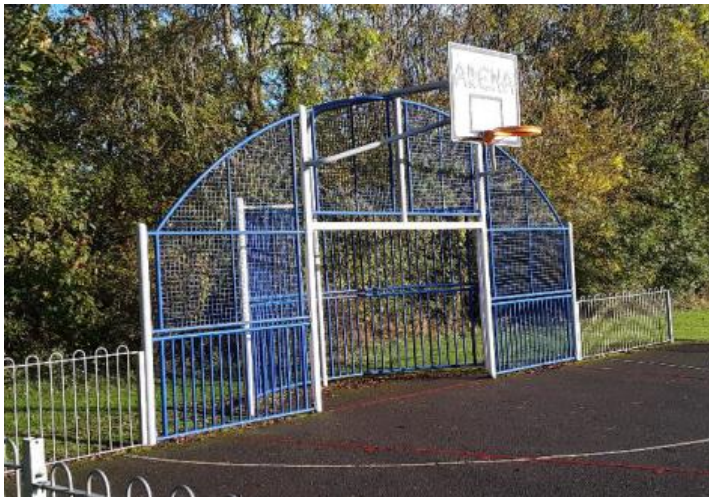
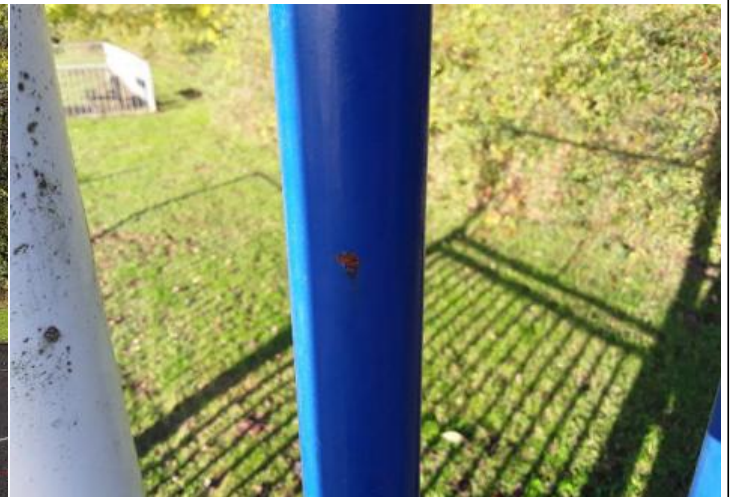
Finding: The paintwork on this item has been damaged or worn exposing the metal underneath which is rusting / corroding

Action: Treat affected areas and repaint

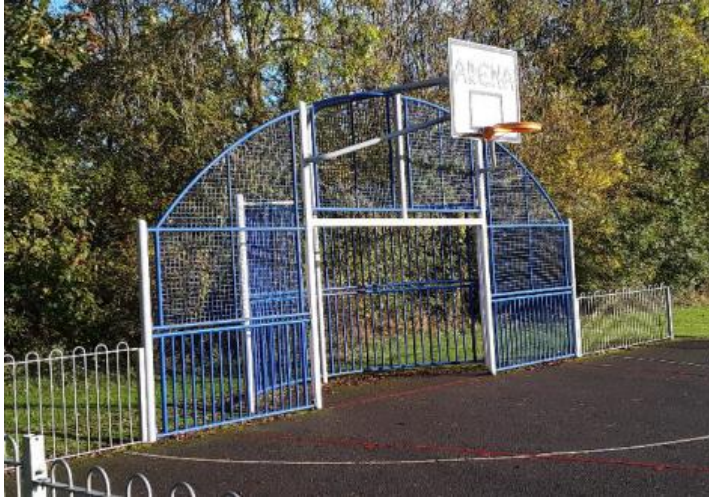
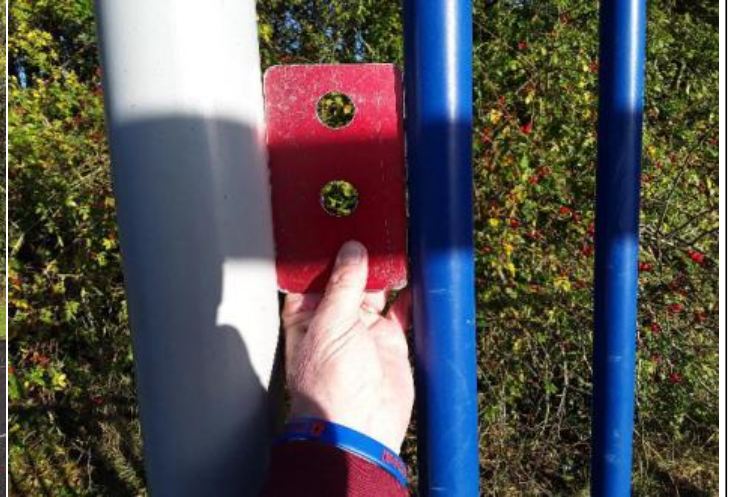
Finding: The item fails to meet the requirements of BS EN 15312 4.4.2.1 head and neck entrapment in the framework

Action: Monitor - No remedial work recommended
