Annual Inspection

Colsterworth & District Parish Council

Woolsthorpe By Colsterworth Play Area

Inspection Ref: 2514002

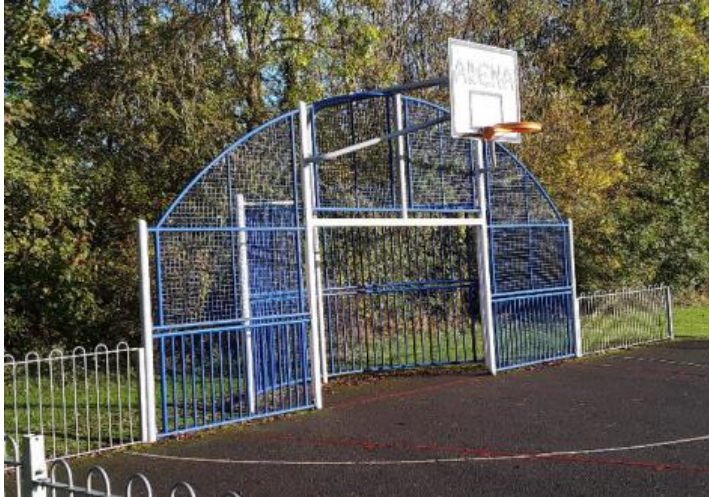
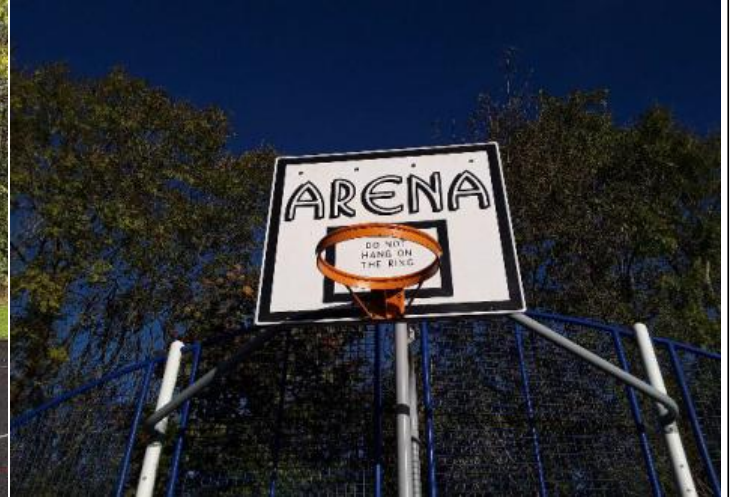
Finding: A clearly visible facility sign should be provided in a prominent position with the wording as detailed BS EN 15312- the equipment is not intended for children less than 3 years old- the warning - Do not climb on the framework or nets- the warning - Do not hang on the ring (if provided)- the warning - Do not wear rings or other jewellery- name and telephone number of the administrator- number to call in case of accident

Action: Provide signage to BS EN 15312

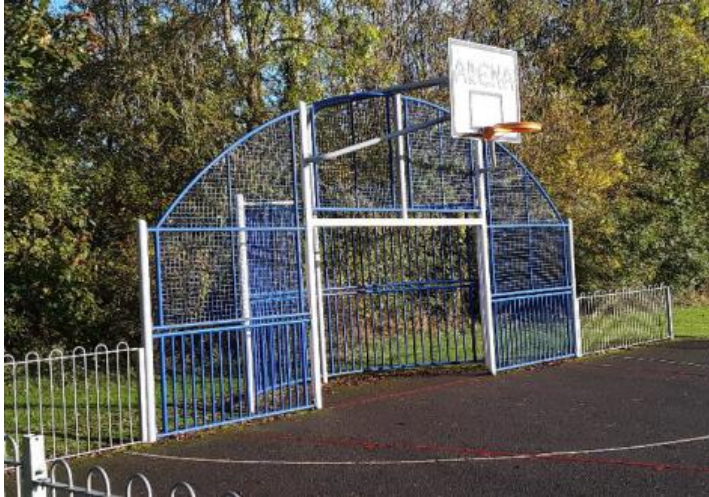
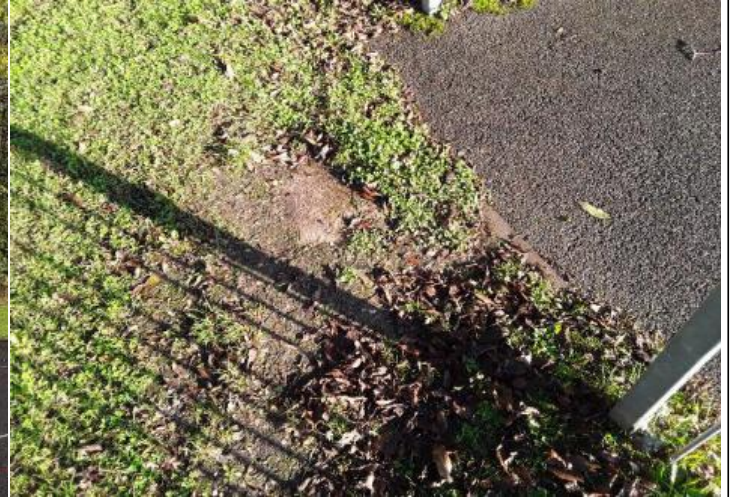
Finding: The surface has eroded around the entry points and may be slippery in wet conditions

Action: Reinstate the surface
