## COLSTERWORTH WAR MEMORIAL DESIGN ACCESS AND HERITAGE STATEMENT

June 2021

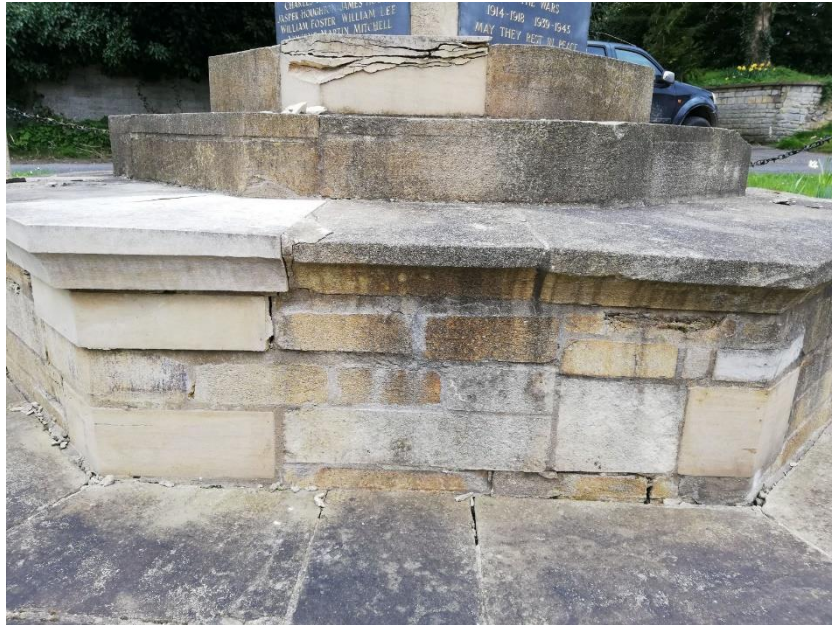
*Fig. 2: The Northwest plinth elevation (side B on plans) with failing Ancaster stone to step 3 of the base plinth.*

The majority of the failing stonework is the replacement Ancaster, which should not have been used in the first place as the memorial appears to have been constructed of Clipsham Stone. The latter has fared generally better, although this also shows areas of deterioration from retention of moisture.

All seriously deteriorated new Ancaster stone, as well as any deteriorated older Clipsham stone, will have to be replaced with new Clipsham stone to match closely the original stone of the monument in colour and texture. The sample provided for inspection by the Architect before any such works proceed will have to be sourced carefully as current stone samples ordered appeared to differ significantly to the stone used on the Memorial. Individual fractures to stone can be repaired with a suitable lime grout and pins if required, whereas any other localised defects will be addressed with smaller scale repairs (stone tile or indent repairs or plastic repairs to a lesser degree) to avoid an extensive loss of historic fabric.

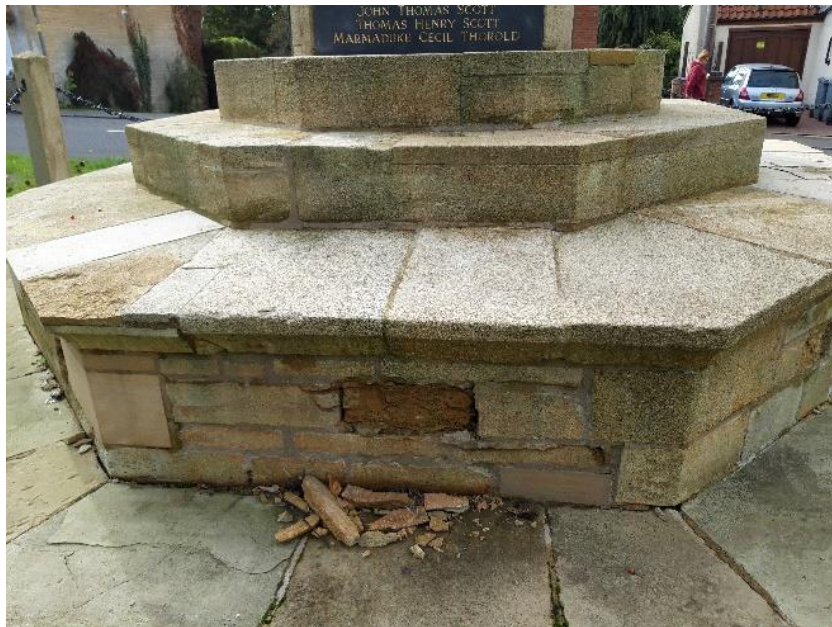
*Fig. 3: The East plinth elevation before the investigative section.*

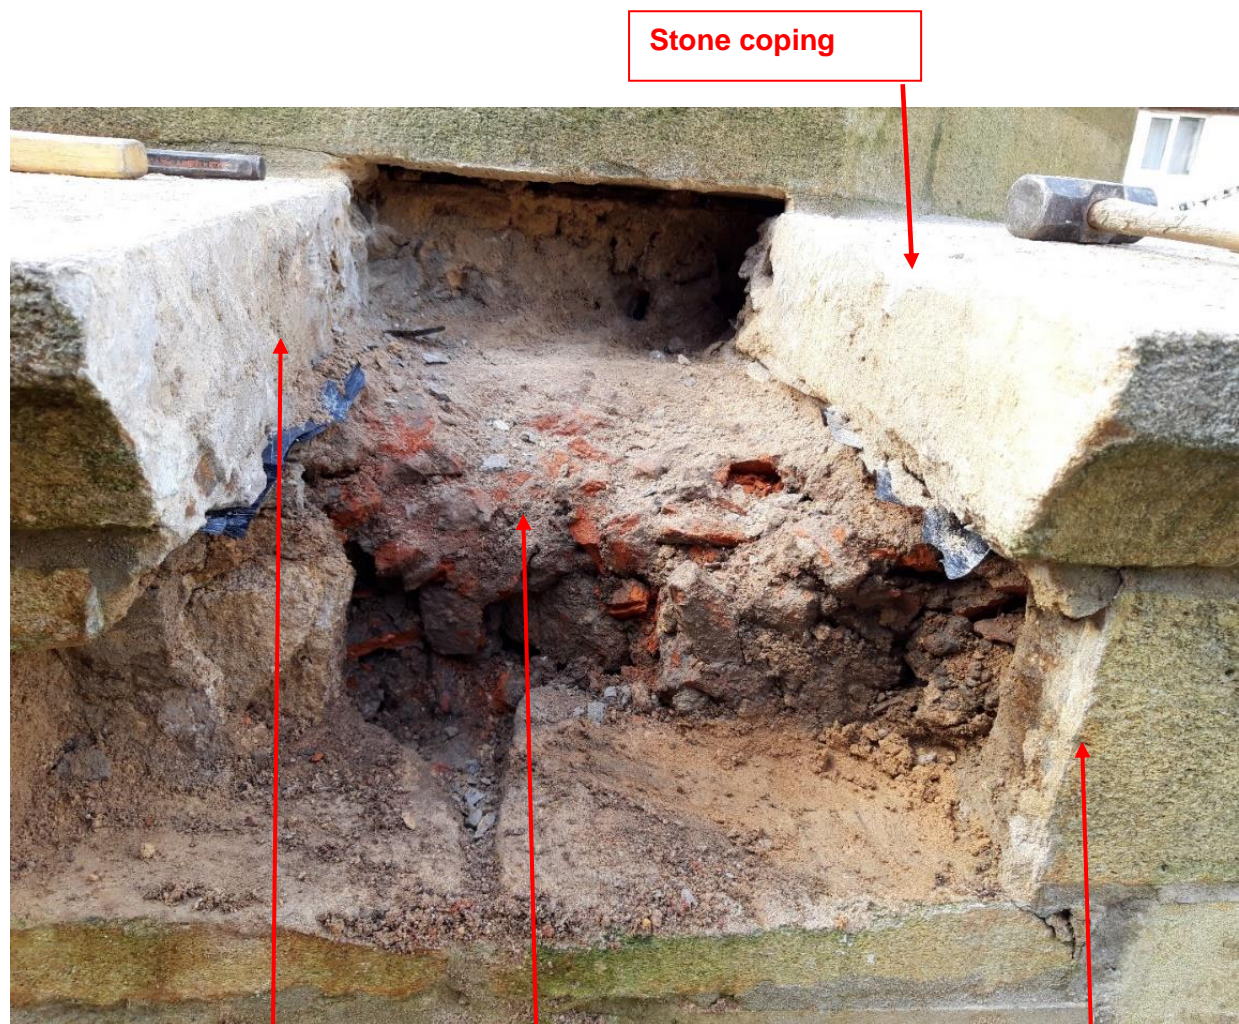
The structure revealed that the octagonal stone wall is back filled with a rough rubble mix made of brick and crushed stone and bound together with an early 20<sup>th</sup> c. cementitious binder. The rubble binding material provides support for the copings and next step of

From this opening up it was deduced that the War Memorial had been re-built at least once before. The coping stones were bedded in hard cementitious mortar over a damp proof membrane and this suggests that invasive works had previously taken place at some point within the last 40 years and certainly before the 2010 repairs, most probably also before 2000.

*Fig. 4: Picture of the War Memorial structure after the investigative section.*

**Damp proof course and hard concrete mortar bedding to coping (cut away to allow access to material below)**

**Bound rubble infill**

**Stone walling**

The DPM inserted under the coping stones of the first step is trapping moisture and prevents the principal function of the stone masonry to expel moisture to the air, which is why it will have to be carefully removed. Similarly, the cementitious bedding remaining under the coping stones is further impeding the ability of the monument to release moisture and will therefore have to be also completely removed.

The work will be carried out in stages to avoid any disturbance to the central shaft, carefully taking apart one section removing the old mortar and damp-proof course, replacing any stone and reconstructing using a lime rich mortar. It will also have to be established if the upper steps contain any DPM or cementitious material by making a single section to each step at a suitable area to cause the least disturbance to the building and its fabric. If this is found to be the case, these steps will also require staged dismantlement and remedial work in a similar methodology followed for the first step.

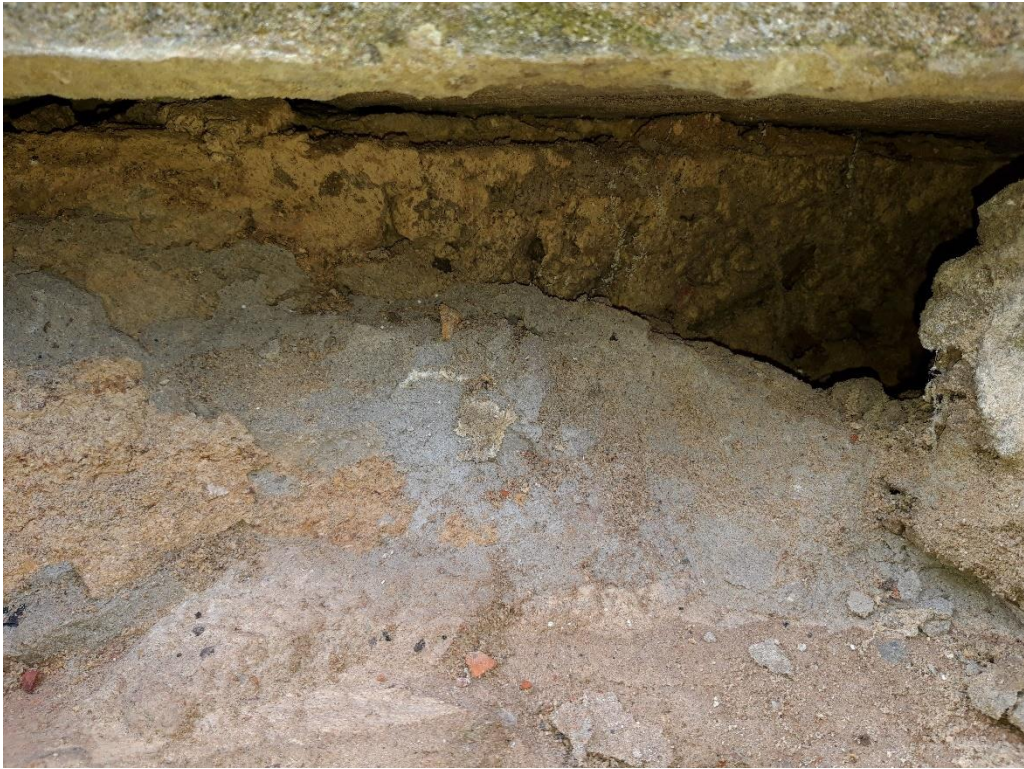
*Fig. 5: The grey hard cement used to bed coping stone in a previous phase of repairs needs to be removed.*

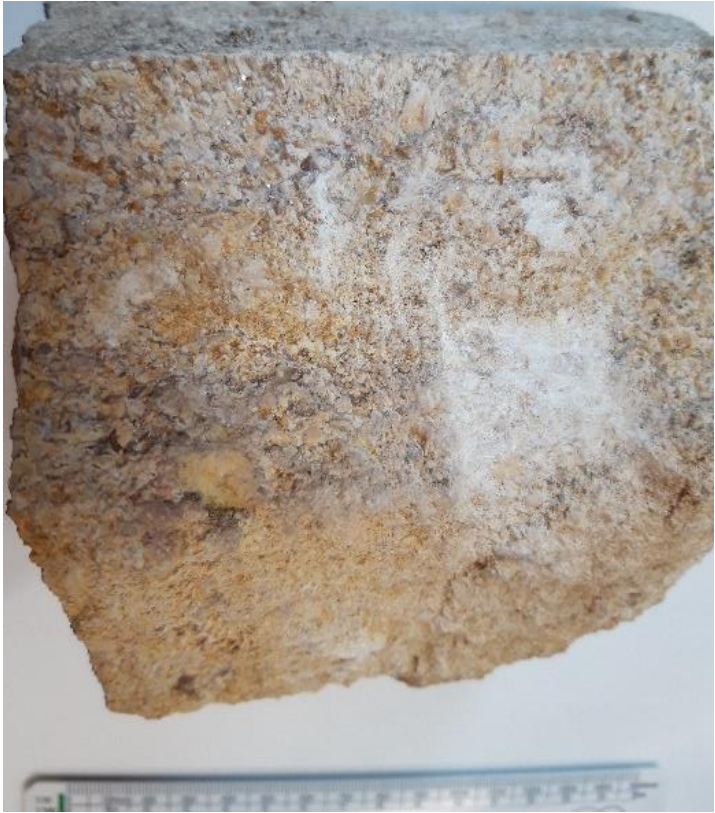
*Fig. 6: Sample of stone taken from the War Memorial*

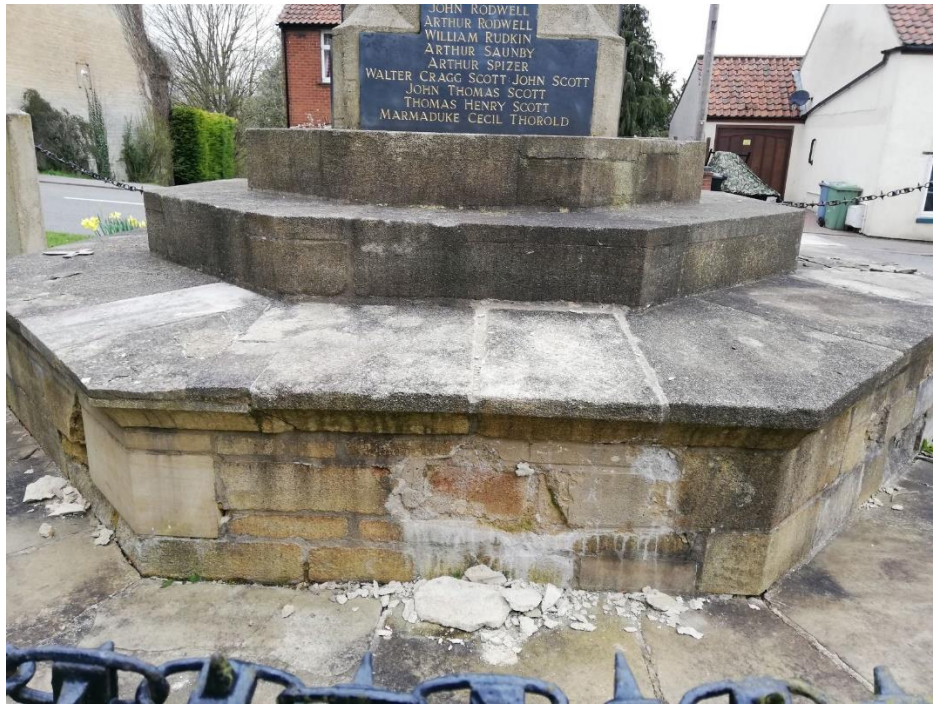
The memorial was visited from the writer just over a year after the investigative section had taken place and the plastic repairs made to the disturbed stone were found to have already fallen off, which is a clear sign of the high water retention inside the stone plinth.

*Fig. 7: The East side as found at a site visit over a year after the investigative section: the plastic repairs to the stone have already fallen off which is an indication of the high water retention inside the plinth*

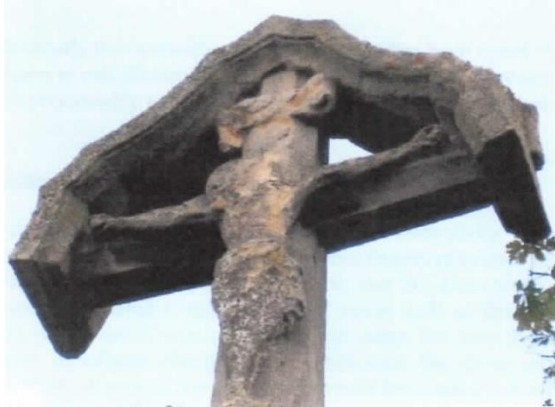
*Fig 8: The crucifix prior to work in 2009*

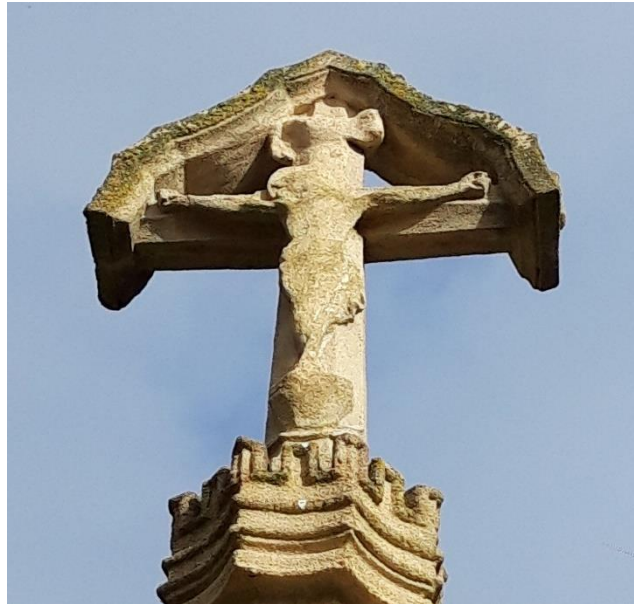
This is the most exposed element of the monument and also its most elegant feature, which requires protection to avoid any further fabric loss. The shelter coating of 2010 appears to have been rather effective in this aspect as there has only been a small amount of further stone loss (located above Christ) and this could be attributed to the mortar repair failure. There has also been some moss growth on the cross weathering.

*Fig 9: Crucifix December 2019*

The shelter-coat has now completely weathered away and needs to be renewed, otherwise the cross is at risk of accelerated stone loss and weathering. Small mortar repairs are to be carried out and the moss removed prior to the application of the shelter coat. The mix should be carefully tested to ensure a good colour match is found. It is crucial that the Lime shelter coating is carried out every five years to ensure its effectiveness.
