INVESTIGATION REPORT

COLSTERWORTH WAR MEMORIAL

March 2020

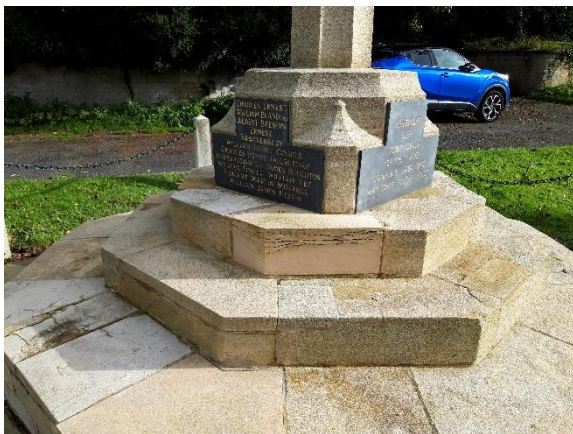
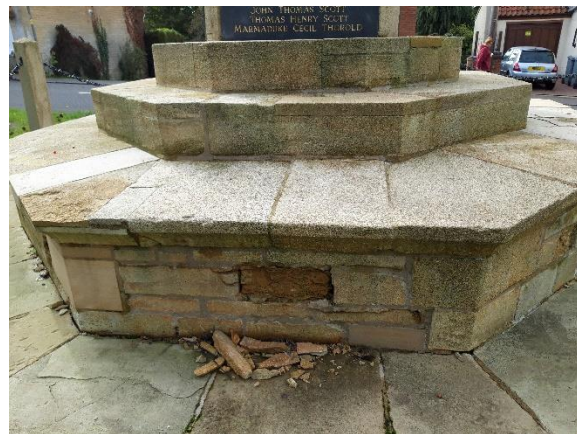
Over the last 10 years the repairs carried out in 2010 have deteriorated at unexpected speed. New Ancaster stone has failed and there appears to be water leaching from the base of the memorial.

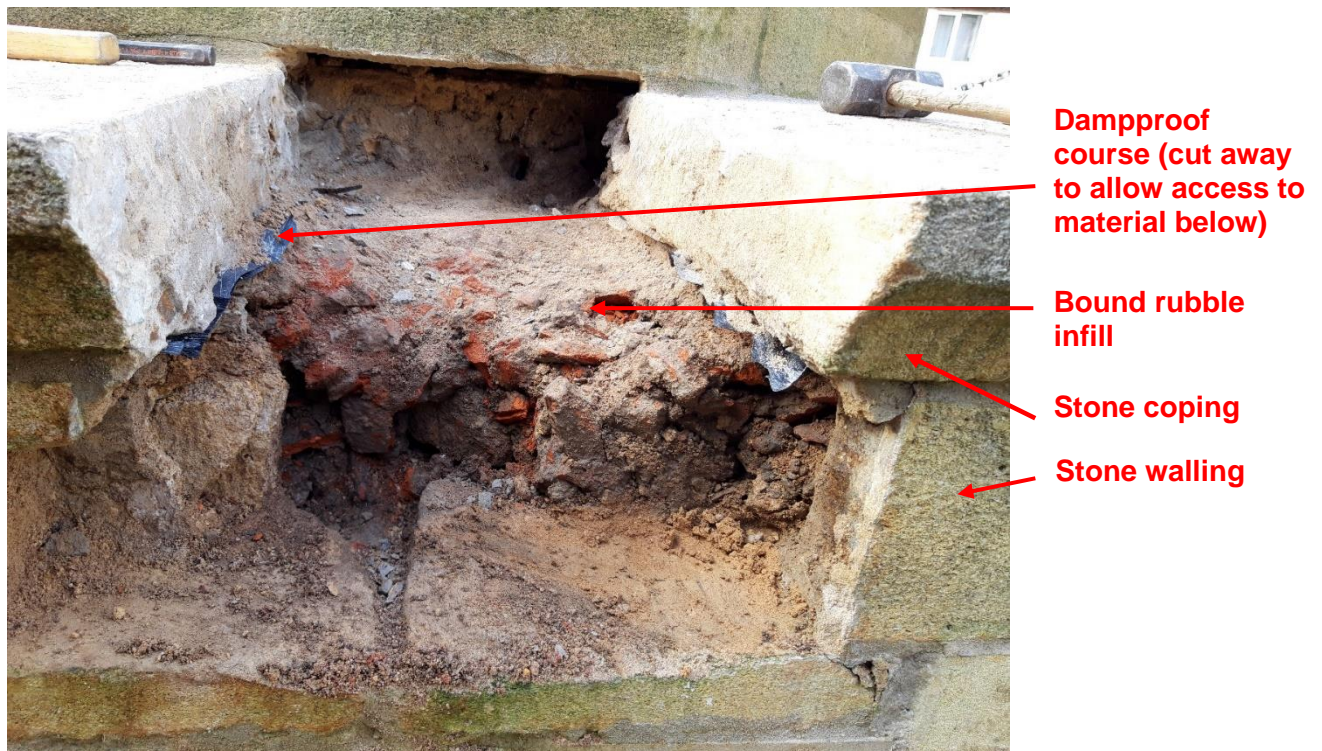
Opening up of War Memorial

The structure seemed to be composed of an octagonal stone wall back filled with a rough rubble mix, with a cementitious binder. The rubble binding material provides support for the copings and next step of stonework. It is assumed that this infill also provides support for the central column although this was not verified.

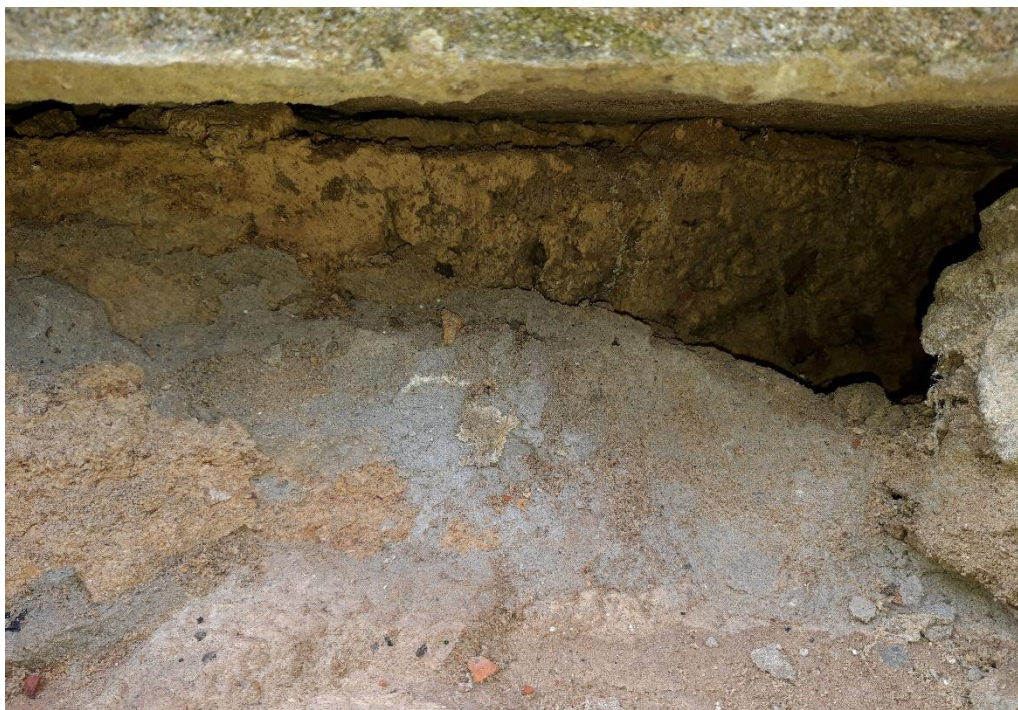
Grey Hard Cement used to bed coping stone in a previous phase of repairs

It was clear from the opening up, that the War Memorial has been re-built at least once before. The existence of the damp proof membrane and hard cementitious mortar suggests that previous invasive works have previously taken place. This damp proof course and grey cementitious mortar pre-date the 2010 works, however, given the type of materials used it would be reasonable to suggest that this work was carried out within the last 40 years.

It is clear that at some point the memorial has undergone a significant rebuild which included the insertion of the damp proof course. At this time the coping stones have been re-bedded using a cementitious mortar. We know that in the 2010 repairs cementitious mortar was removed from the bed joints and the structure was re-pointed in Naturally Hydraulic Lime Mortar. It was perhaps not clear in 2010 that the past rebuilding had meant that this cementitious mortar was used throughout the structure as a bedding material and not just in a past phase of re-pointing. Unfortunately, cementitious mortar does not allow for the passage of moisture through stonework to evaporate in the atmosphere and can cause the deterioration of stone through trapped moisture and freeze thaw action.

The use of cementitious mortar has been detrimental to the structure. There is no moisture transfer though cementitious mortar which means moisture becomes trapped within the stone. The repointing in 2010 will have helped by removing some of the cementitious material, but our investigations show that the mortar has been used throughout the structure including for bedding. In addition over the last 10 years there has been significant research into NHL mortars by Historic England with the result that softer lime putty or hot lime mortars have gained favour.

All the damp proof course should be removed from the structure along with the cementitious mortar. This work should be carried out without fully dismantling the memorial and disturbing the central shaft. The work should be carried out in stages, carefully taking apart one section removing the old mortar and damp-proof course, replacing any stone and reconstructing using a hot lime mortar. The upper steps of the memorial will need to be carefully dismantled (starting with a single section) to establish if the damp proof course is prevalent in the upper sections of the base. If this is found to be the case (and for pricing purposes it should be assumed it is) then these sections will also require staged dismantlement and remedial work. This solution will take some time as lime mortar can be slow to set and so the work may need to be carried out over some weeks.

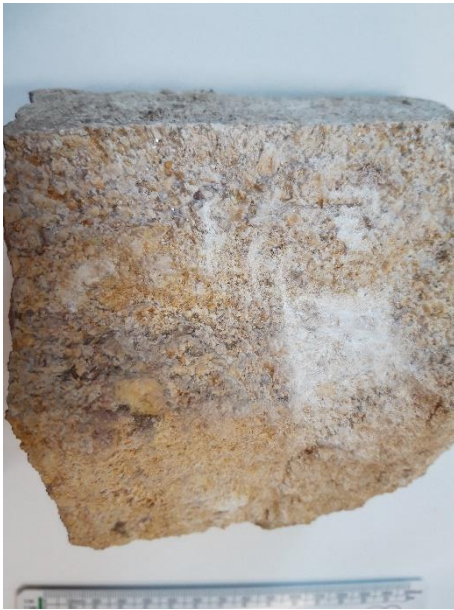
The original stone is not the Ancaster hard white used in previous repairs, but, is a coarse grained stone containing quartz grains.

Sample of stone taken from the War Memorial

investigation there was some doubt that the stone was indeed Clipsham as modern samples of Clipsham Stone are much lighter in colour and are finer grained. However, having now consulted Dr David Jefferson of Jefferson Consulting we understand the current Clipsham quarry is producing stone from beds that are much closer to the surrounding Lincolnshire Limestone beds and there is a significant variation in colour and grain of stone. Petrographic analysis could still be undertaken, but given written sources and current discussion it would seem that the stone is a buff coloured large grained Clipsham Stone.

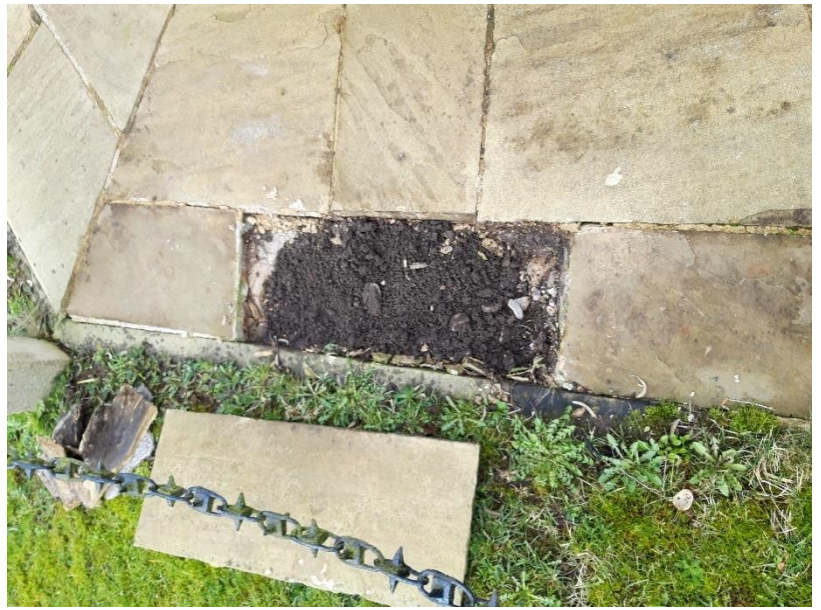
Lifted flag stone

The flagstones are faring well and appear to have been simply bedded on the earth and pointed in a cementitious mortar. Given their lack of firm bedding they may drain reasonably effectively, which is important given the sloping nature of the site. However, they do abut the stone of the Memorial and therefore, it would be useful to consider providing some separation to ensure that there is adequate drainage of the structure and ensure that water is not being held against stone.

This should be lifted and a well-draining subbase should be installed and the paving should be re-laid. The flags closest to the memorial should be cut and a 100mm gravel margin installed around the base of the memorial to prevent water being held against the base of the stone.

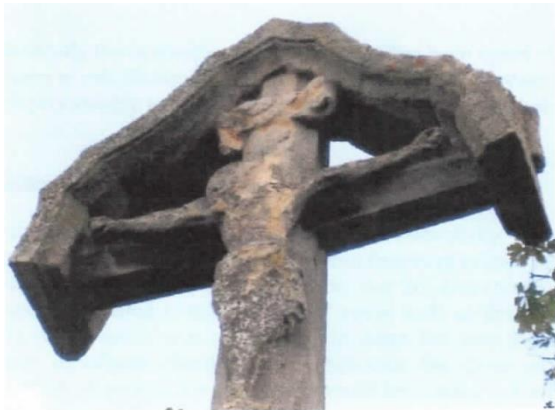
The crucifix prior to work in 2009

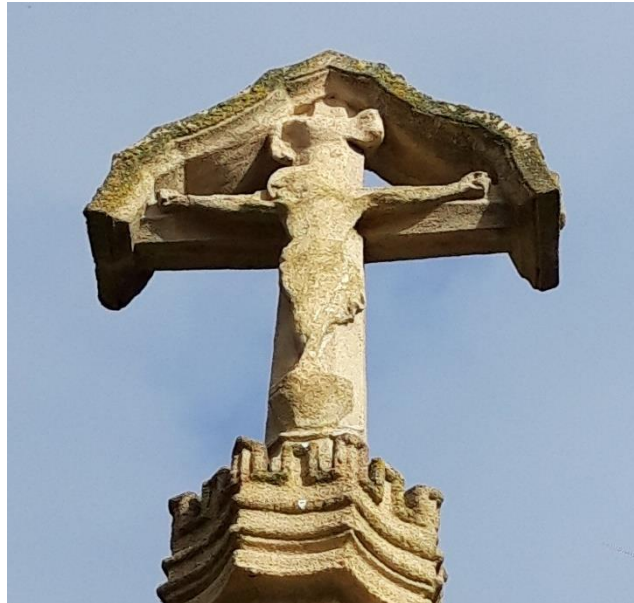
December 2019

This has clearly deteriorated and some of the detail of the crucifixion has been lost. The works in 2010 which included some repairs and shelter coating of the crucifixion carving. At the time it was recommended that the lime shelter coat was renewed every 10 years. It would appear that this sheltercoat has completely weathered away.

The shelter coating seems to be very effective as there has only been a small amount of further stone loss (above Christ) and this may be as a result of the mortar repair failure. There has also been some moss growth on the cross weathering. The Shelter coat has now completely weathered away and the cross is at risk of accelerated stone loss and weathering.

The Shaft is in good condition and requires no work for the time being. The Parish Council will need to review the options available for works to the cross and crucifixion. However, the recommendation of this report is that the cross including the crenelated base are lime shelter coated. Small mortar repairs should be carried out and the moss removed prior to the application of the shelter coat. The mixes should be carefully tested to ensure a good colour match is found. It is crucial that the Lime shelter coating is carried out every five years to ensure its effectiveness.

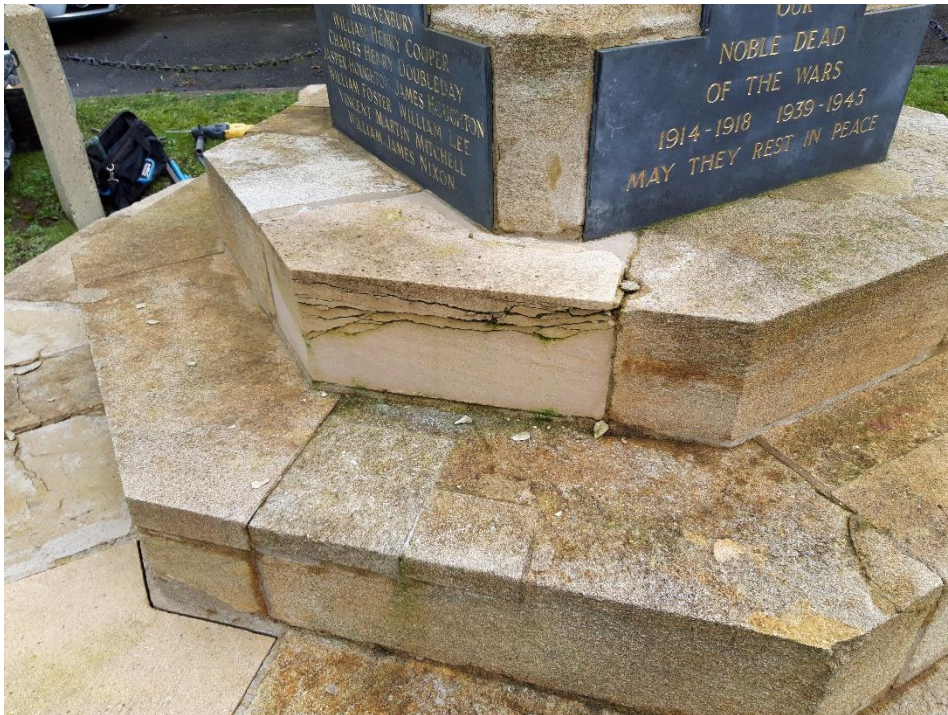
Although there has been some failure of the Clipsham stone, the main areas of failure are those which have been replaced in Ancaster Weatherbed. Ancaster is a hard stone, however it does not appear to have weathered as well as the Clipsham.

The majority of the failing stonework is the replacement Ancaster. This stone should not have been used as the memorial appears to have been constructed of Clipsham Stone. This stone has fared better, although has suffered in some places from retention of moisture. However, current stone samples of Clipsham do differ in colour and texture to the stone used on the Memorial. It will be crucial to ensure that replacement stone is a good match.

Failed Ancaster Stone

All fractured Ancaster should be replaced with Clipsham, however where the Ancaster is holding up is should be left for now. It may require replacing at a later date but there is little to be gained from disturbing the structure more than is necessary. Any fractured Clipsham should be replaced with Clipsham Stone. When sourcing replacement stone it will be crucial that the Stonemason visits the Quarry and selects similar stone. If the quarry beds are inappropriate it may be possible to track down stored lump Clipsham Stone of a similar colour and texture.

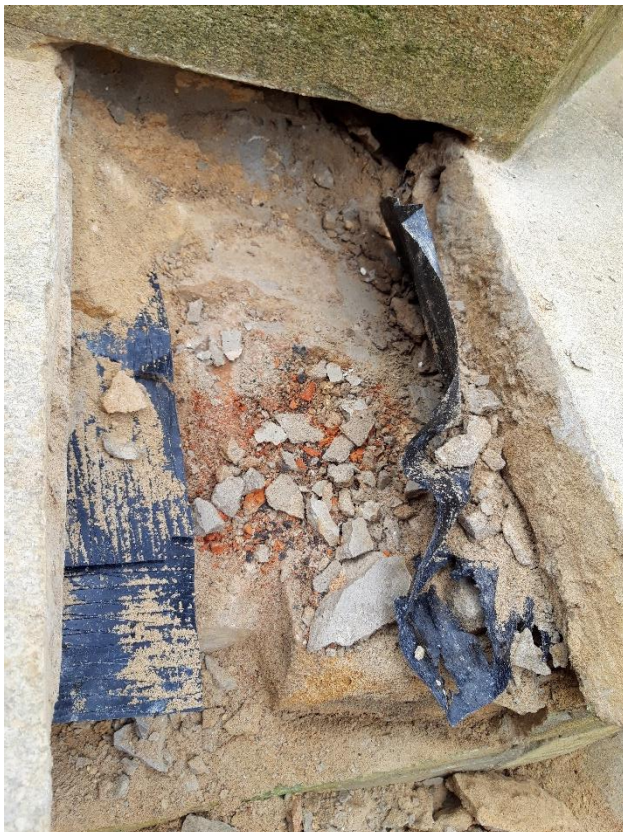
The damp proof course may be the source of some of the current issues. It will certainly be holding moisture against the stone in places, and that coupled with the cementitious mortar may well mean that moisture is unable to escape from the structure. Only the lower 'step' of the memorial was dismantled, but it seems reasonable to conclude the plastic damp proof course may have been installed throughout the rest of the structure.

The damp proof course inserted in a previous rebuild has trapped moisture within the structure and unless removed will continue to cause moisture to be held within the stone. Stonework needs to be able to expel moisture to air. This takes place through breathable (lime mortar) joints and a damp proof membrane will prevent this moisture transfer from taking place.

Damp proof course following removal of the coping

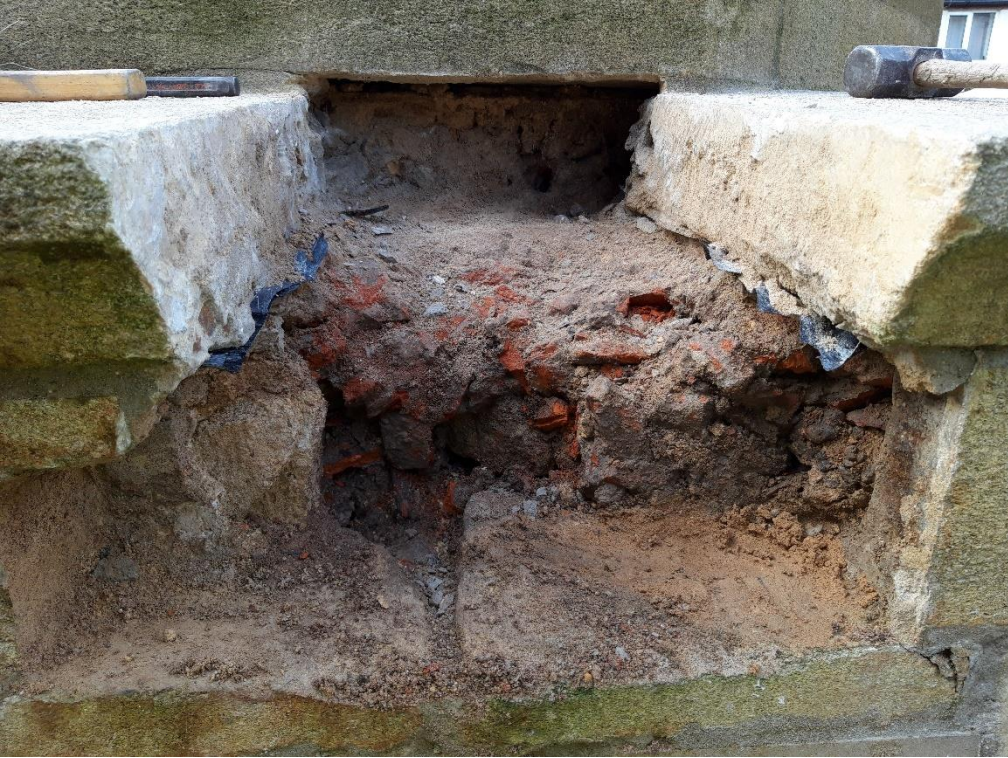
This appears to be original and is very rough. The rubble elements appear to be brick and crushed stone, of which some elements are quite large. The binder appears to be cementitious in nature, although probably an early 20th century mix. Although there is a cementitious nature to this infill, it would seem likely that its rough and porous nature makes it unlikely to hold water in a way which would be damaging to the stone.

Rough bound rubble core

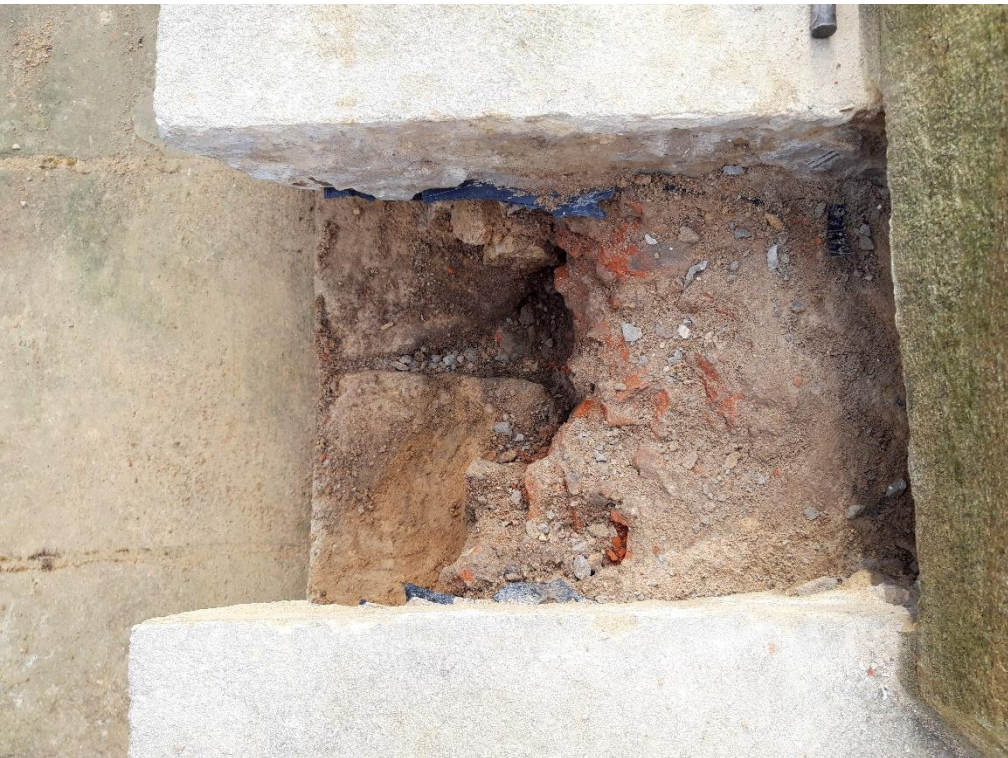
Rubble core and outer stonework
