## Annual Inspection

Colsterworth & District Parish Council

Colster Way Play Area

Inspection Ref: 2184915

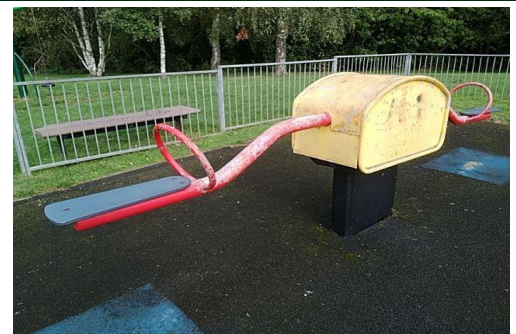
Parts of the steel on this item have corroded excessively and the metal has perforated in places at the base of the main stanchion - Replace the main stanchion

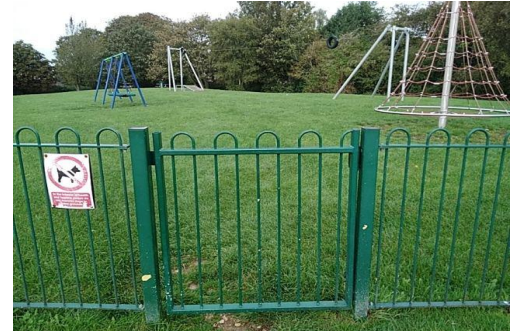
1 cap is missing. - Replace the missing cap - refer to the manufacturers for replacement parts.

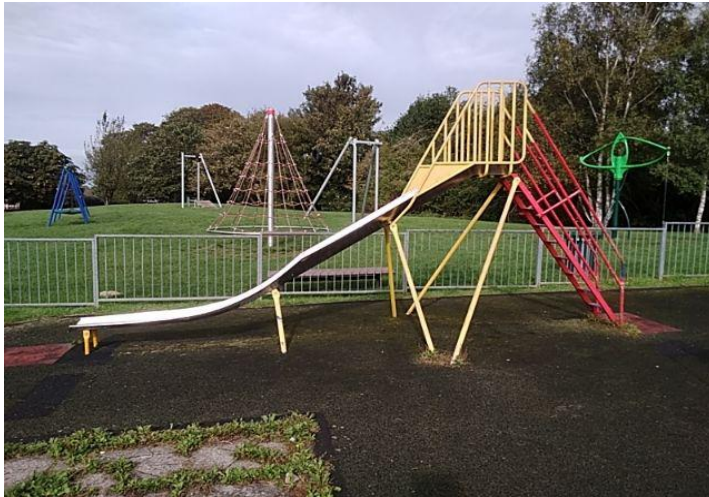
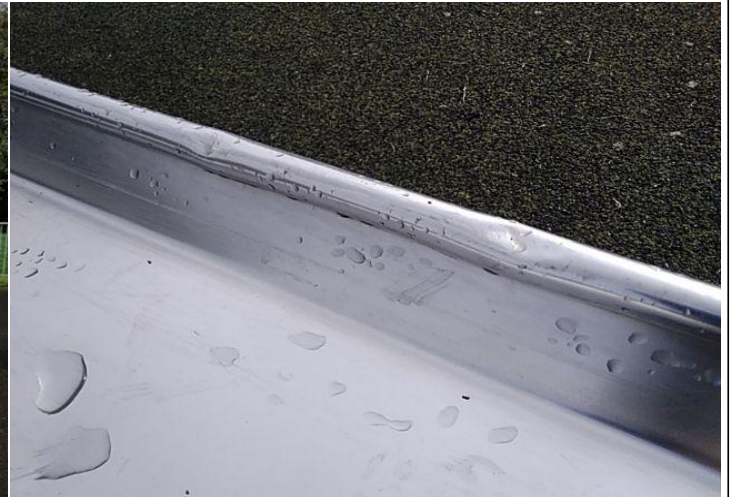
**Finding:** Minor damage to the safety edge of the slide chute.

**Action:** Monitor

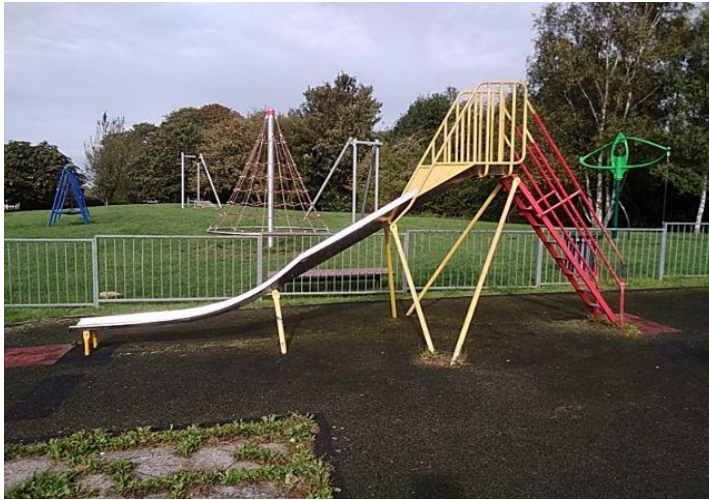
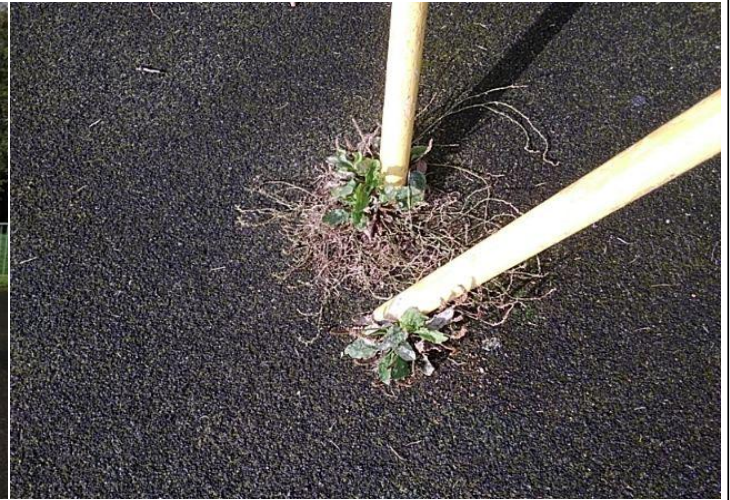
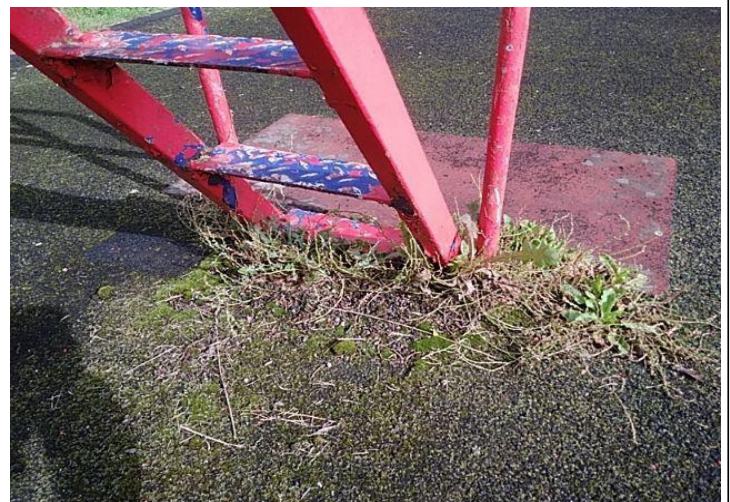
**Finding:** There are weeds/vegetation growth between or around the edges of the surfacing

**Action:** Remove weeds/vegetation growth

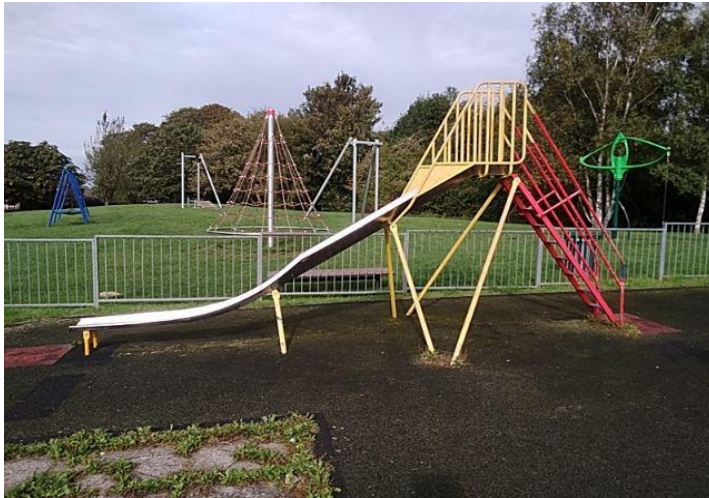
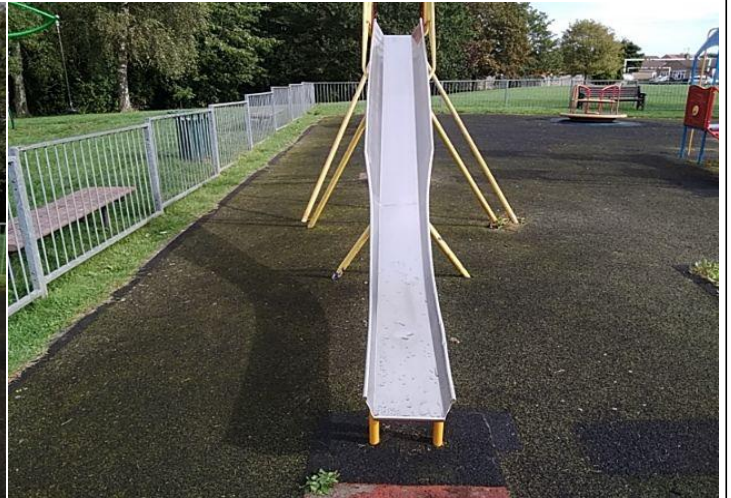
**Finding:** The slide is predominately south facing and will catch the majority of the sun's heat during the day. Slide surfaces can become very warm during periods of sustained sunny weather

**Action:** Monitor - No remedial work recommended

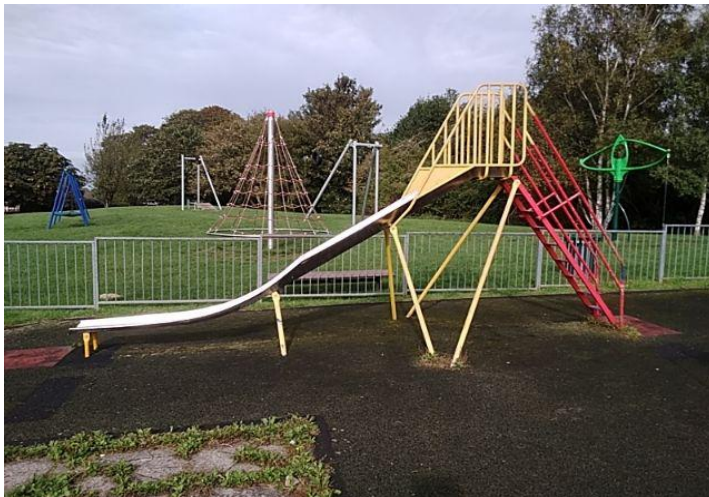
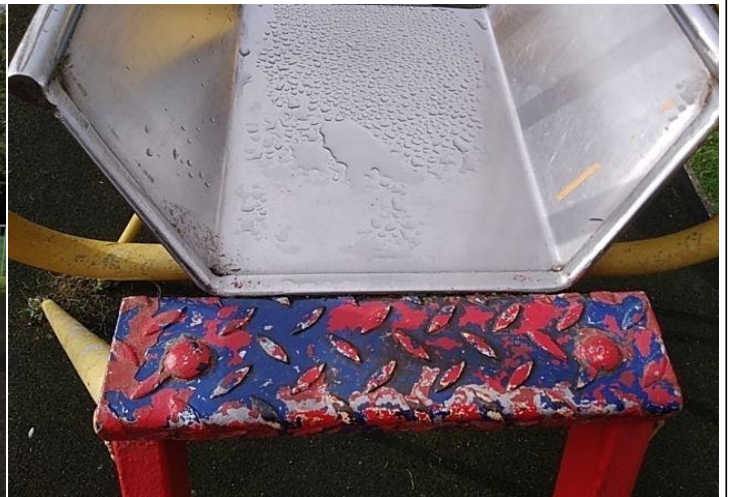
**Finding:** There is / are toggle entrapment/s present in contravention of the recommendations set out in BS EN 1176 Part 3

**Action:** Monitor - no remedial work recommended

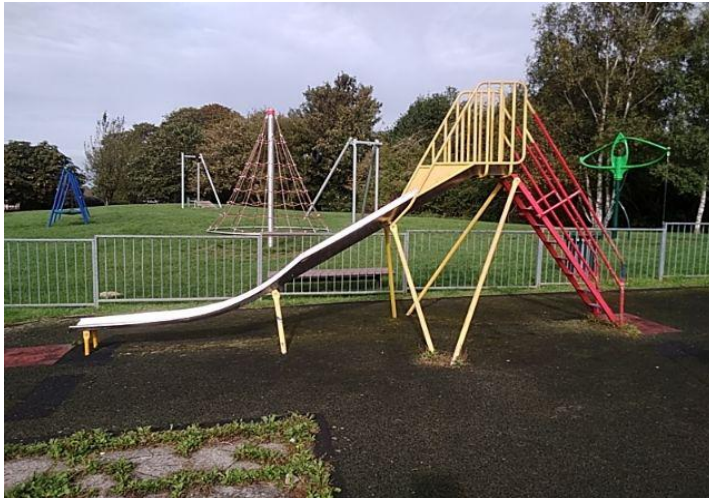
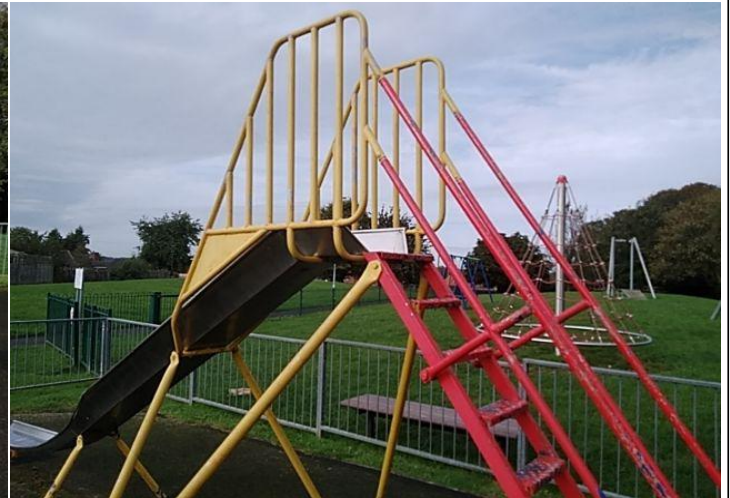
**Finding:** The item fails to meet the requirements of BS EN 1176 Part 1 4.2.7.2 head and neck entrapment in the barriers and/or steps  
**Action:** Monitor - No remedial work recommended

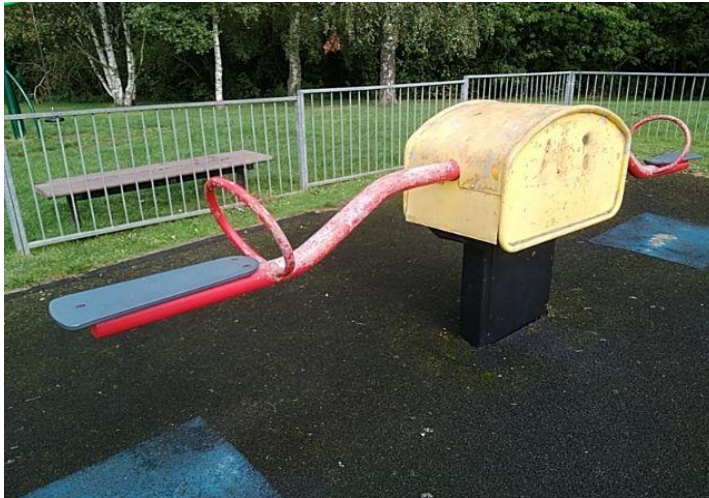
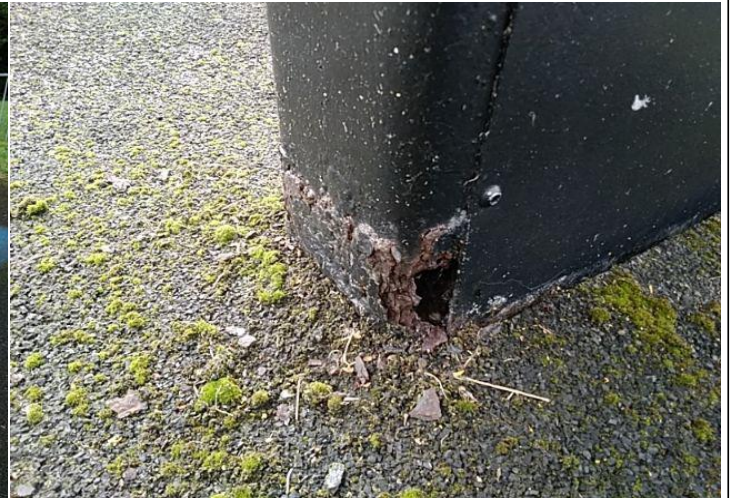
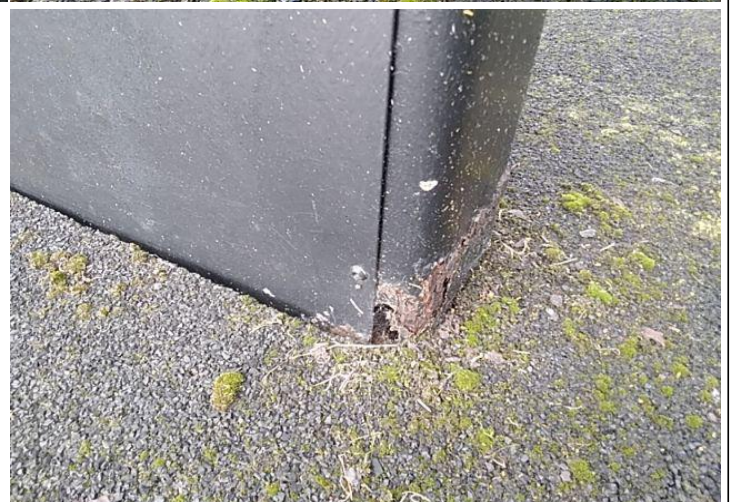
**Finding:** Parts of the steel on this item have corroded excessively and the metal has perforated in places at the base of the main stanchion

**Action:** Replace the main stanchion

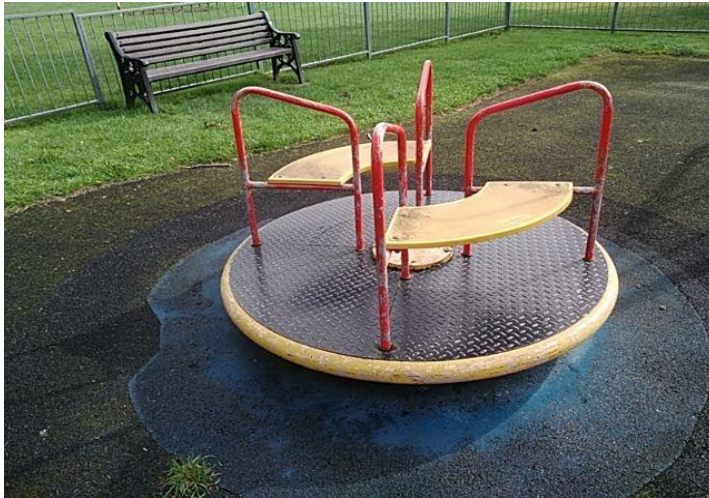
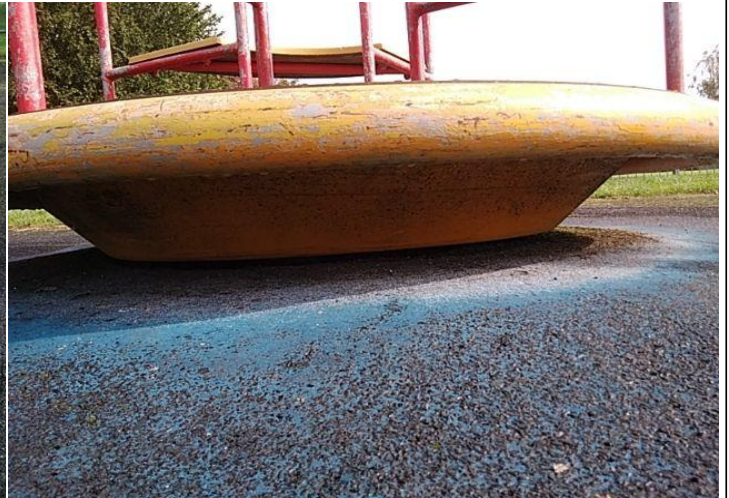
**Finding:** The distance between the underside of the roundabout platform and the playing surface is in excess of 110mm and contravenes the requirements of BS EN 1176 Part 5 which requires that the distance be maintained between 60mm-110mm - for the entire circumference of the roundabout.

**Action:** Monitor - No remedial work recommended

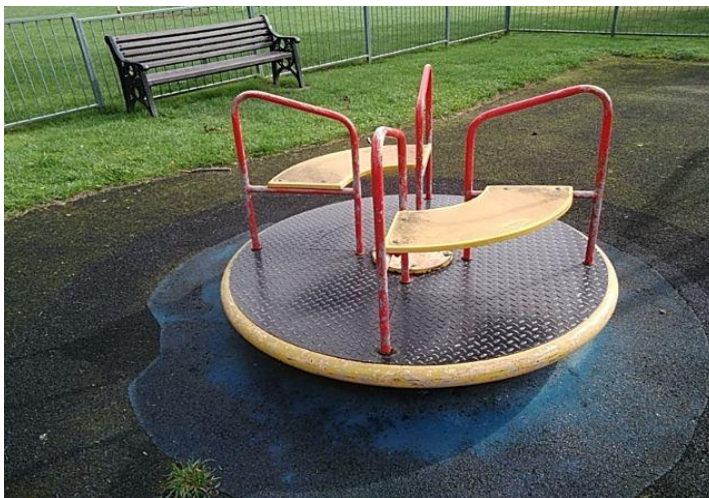
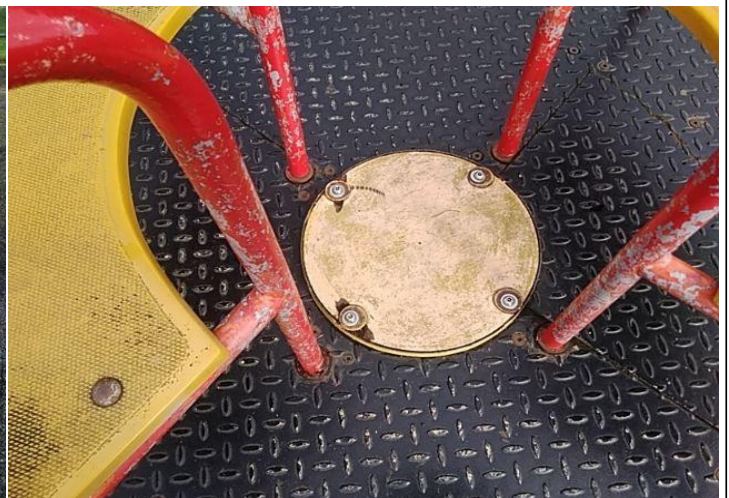
**Finding:** Slight vertical movement in the platform may be due to wear in the bearings.

**Action:** Monitor. Grease the bearings annually in accordance with the manufacturer's specification.

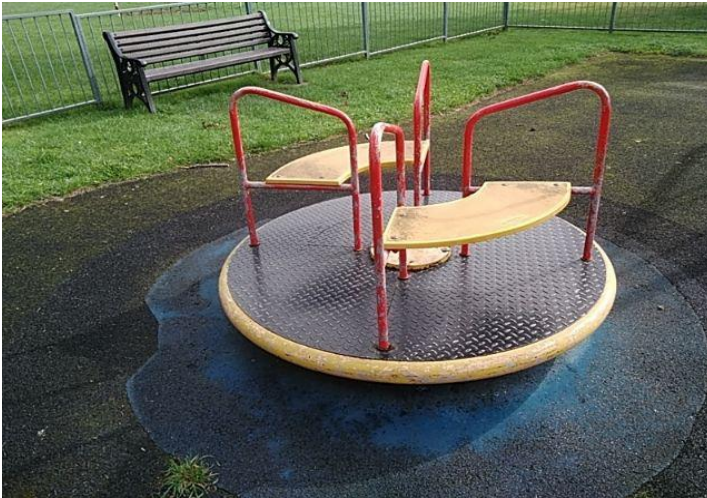
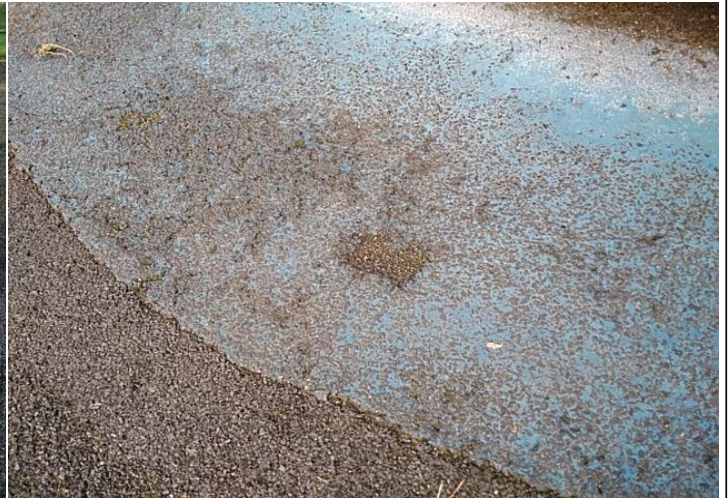
**Finding:** The safety surface under or around this unit has been damaged

**Action:** Monitor for any further deterioration and repair as required

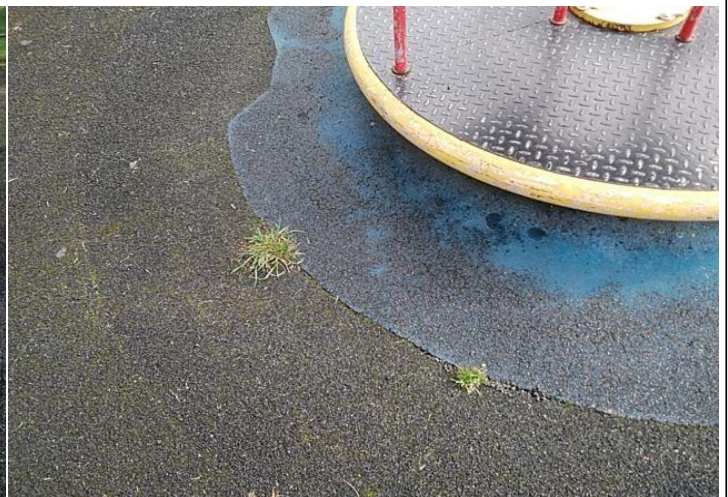
**Finding:** There are weeds/vegetation growth between or around the edges of the surfacing

**Action:** Remove weeds/vegetation growth

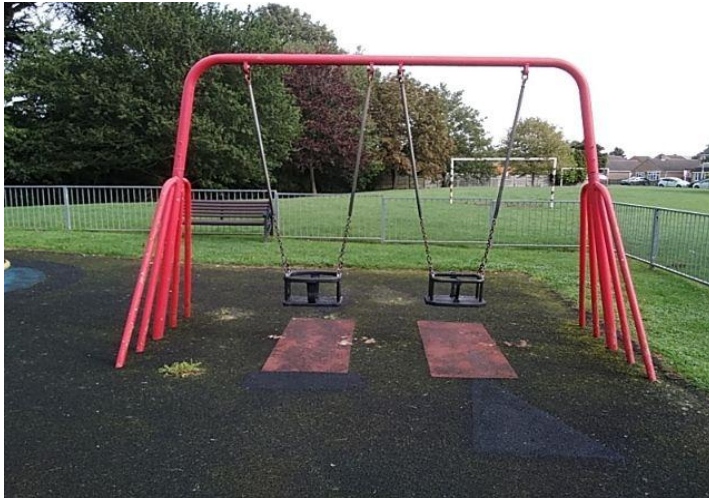
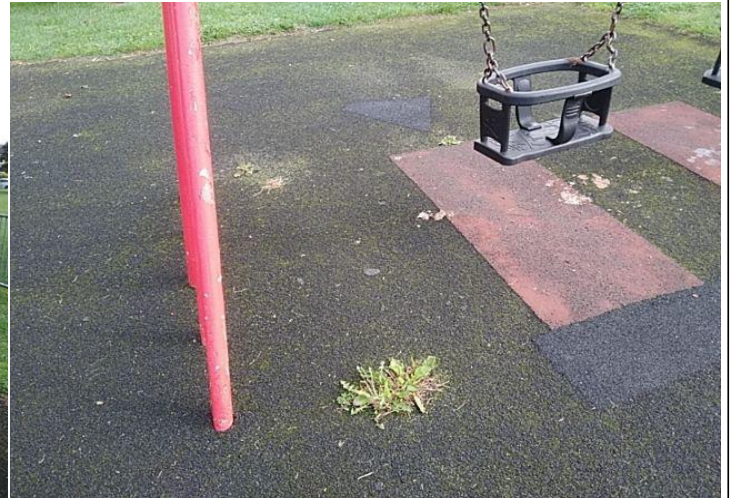
**Finding:** There are weeds/vegetation growth between or around the edges of the surfacing

**Action:** Remove weeds/vegetation growth

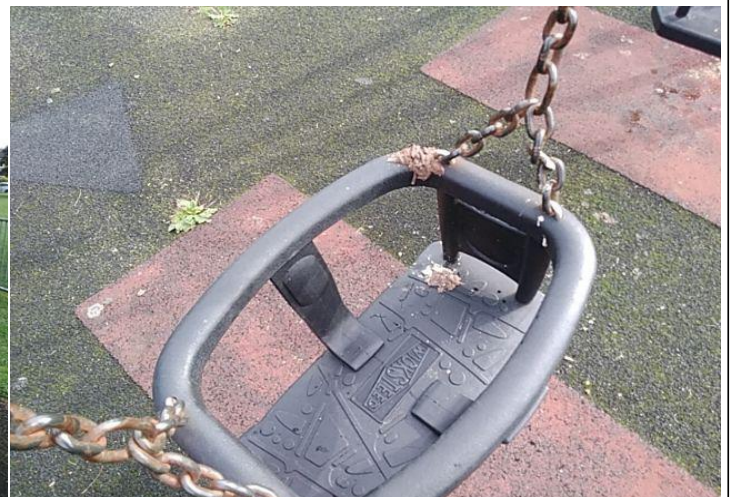
**Finding:** Bird faeces on the seat

**Action:** Clean as required

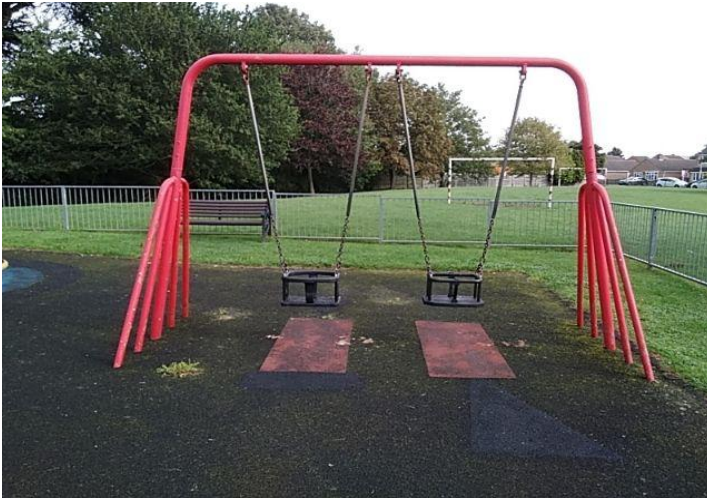
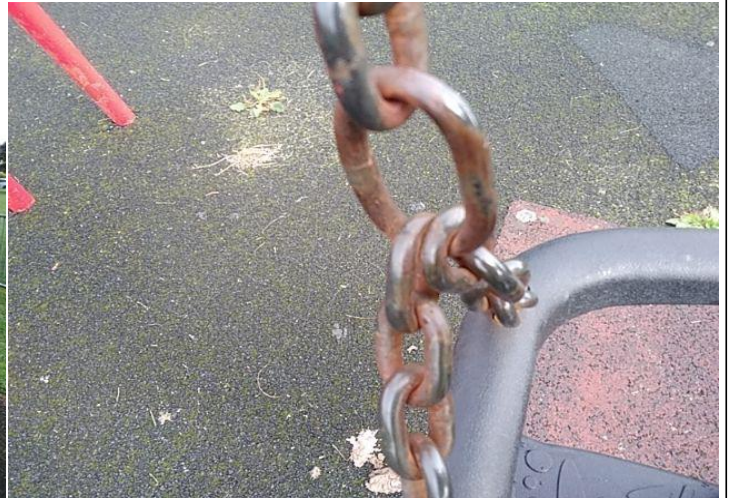
**Finding:** The chain links are worn in excess of 40% and require renewing

**Action:** Replace worn chains

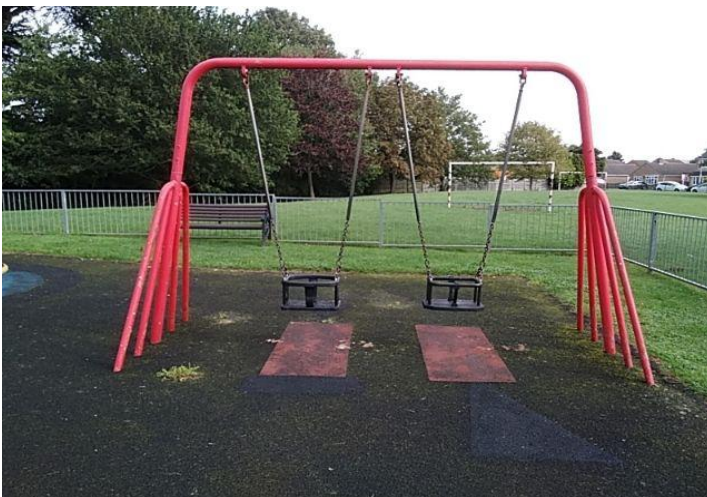
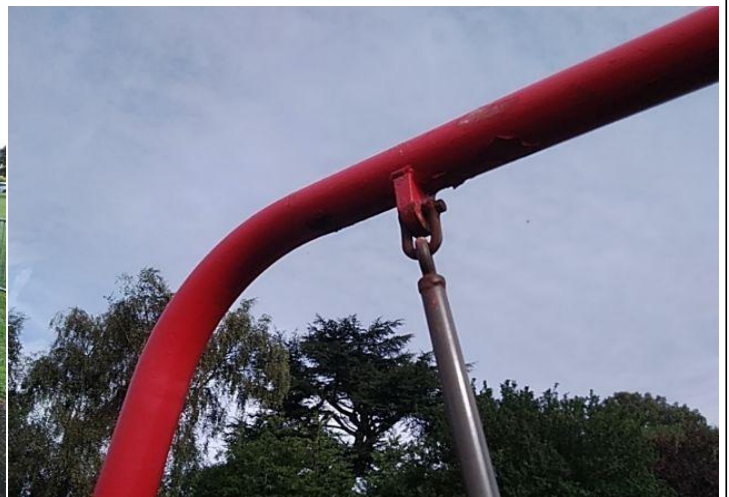
**Finding:** The bushes are showing signs of wear

**Action:** Monitor for any further deterioration and replace as required

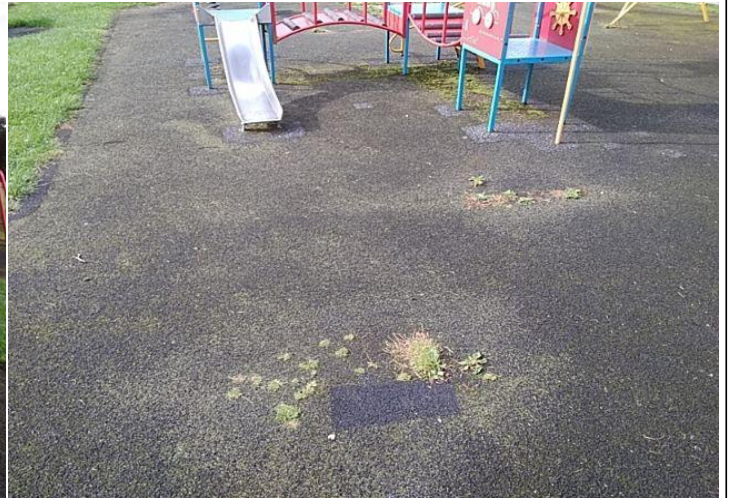
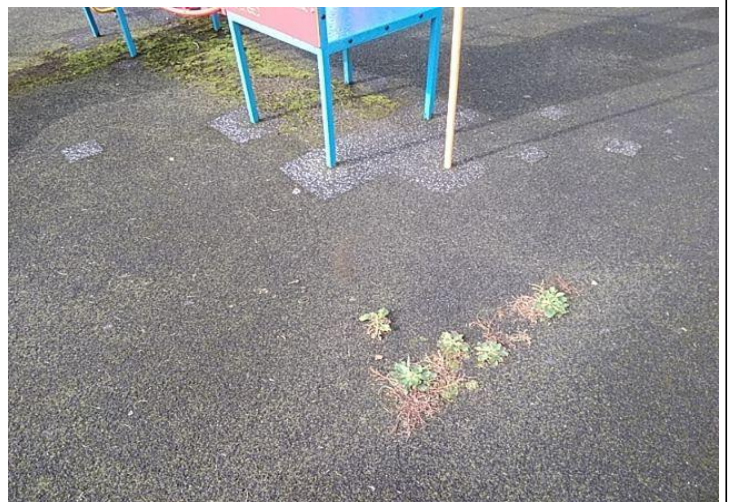
**Finding:** There are weeds/vegetation growth between or around the edges of the surfacing

**Action:** Remove weeds/vegetation growth

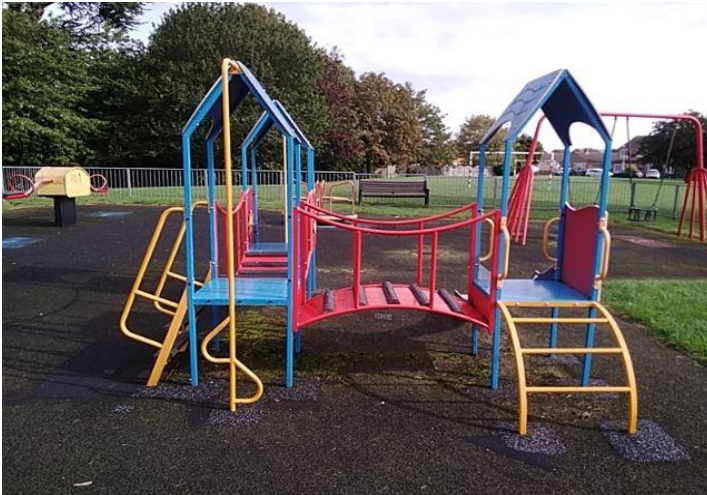
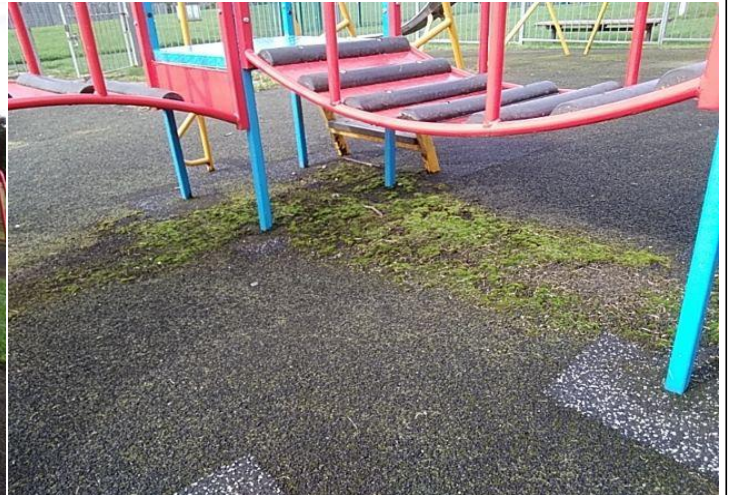
**Finding:** There is algae or moss growth on the surface resulting in slippery conditions

**Action:** Clean and treat appropriately

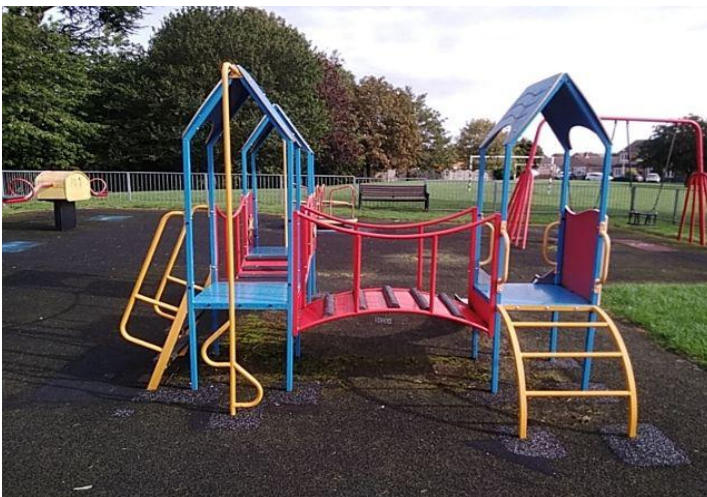
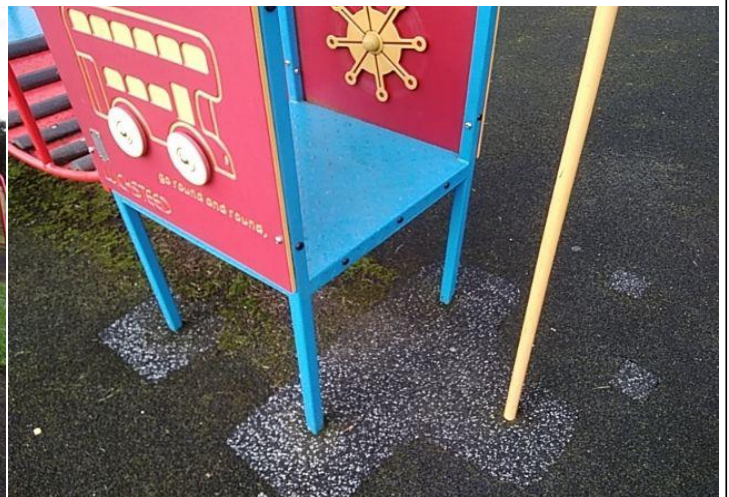
**Finding:** The free space between the fireman's pole and the platform is less than the minimum recommended dimension of 350mm in BS EN 1176 Part 1; this is however an intended design feature by the manufacturer to assist younger users in accessing the pole and is a very low risk finding - no remedial action is recommended

**Action:** Monitor - No remedial work recommended

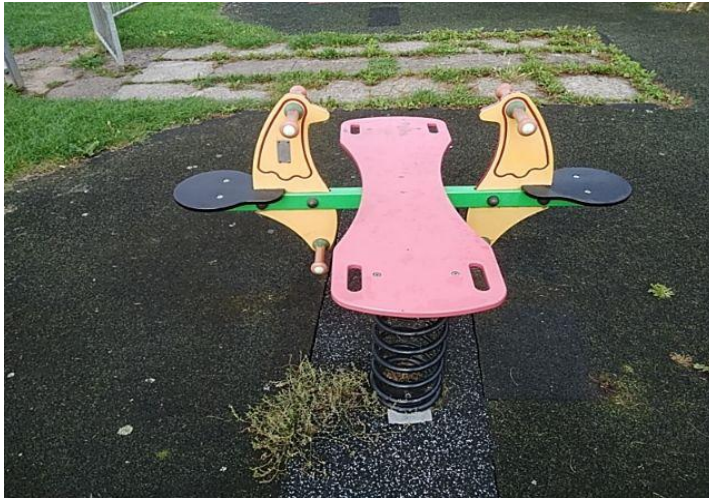
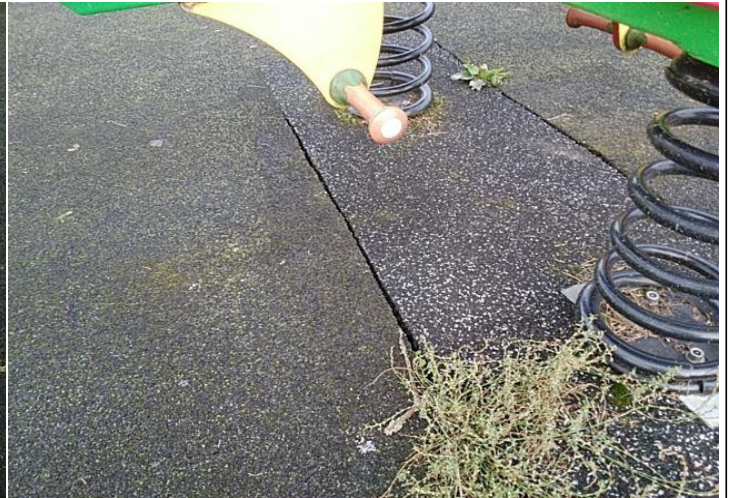
**Finding:** Splits in the wetpour playing surface.

**Action:** Monitor

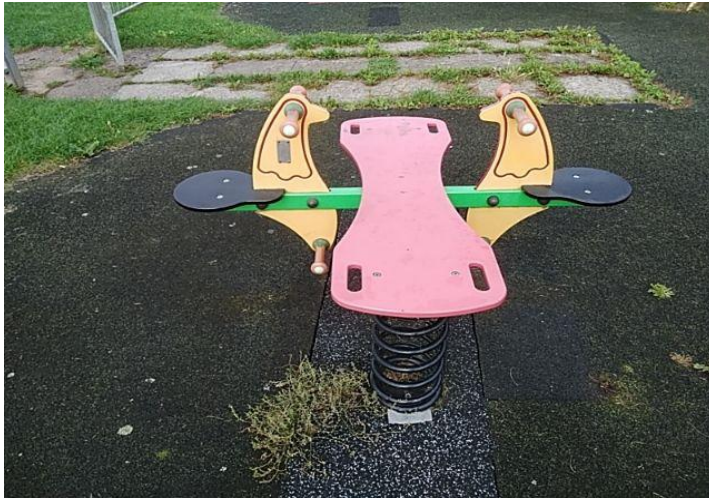
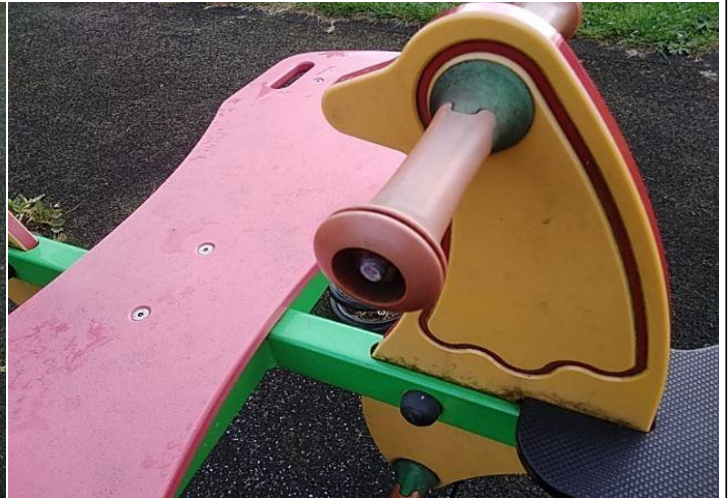
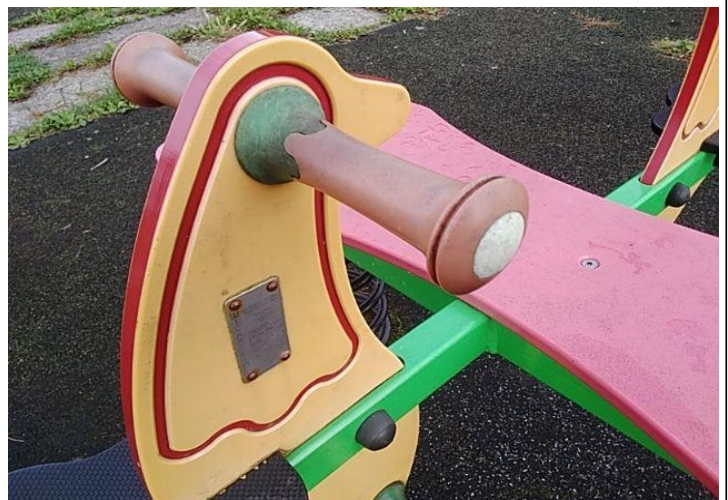
**Finding:** There are post / end caps missing from the item

**Action:** Replace missing post cap x 1

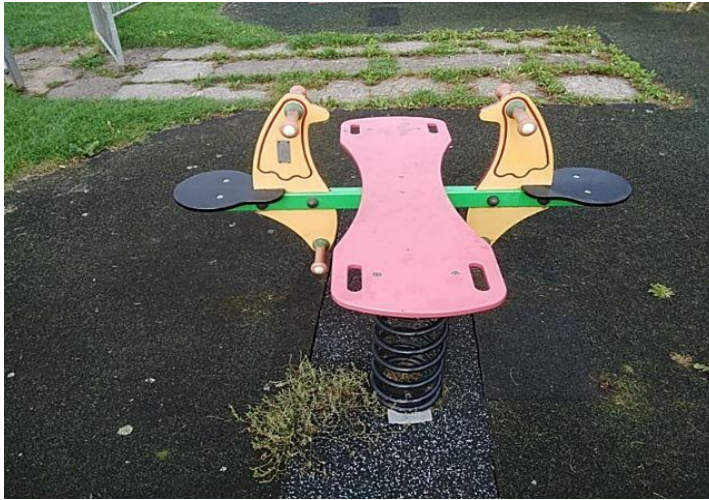
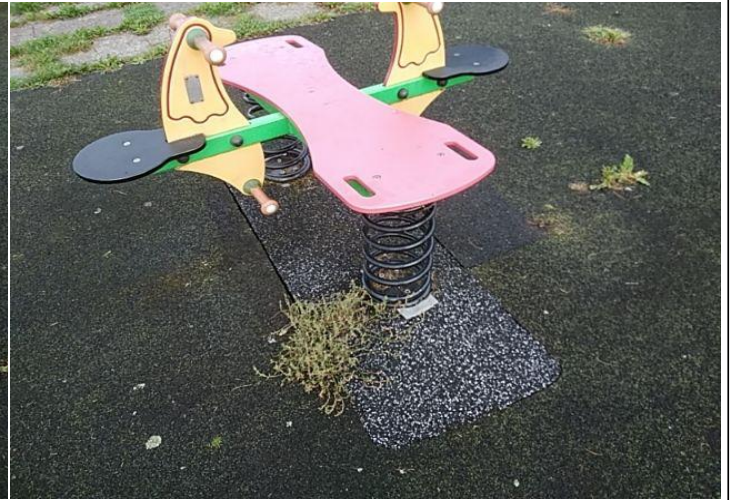
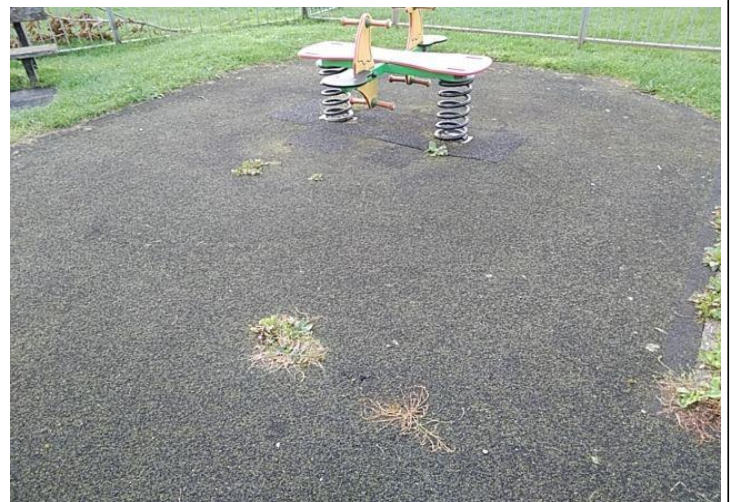
**Finding:** There are weeds/vegetation growth between or around the edges of the surfacing

**Action:** Remove weeds/vegetation growth

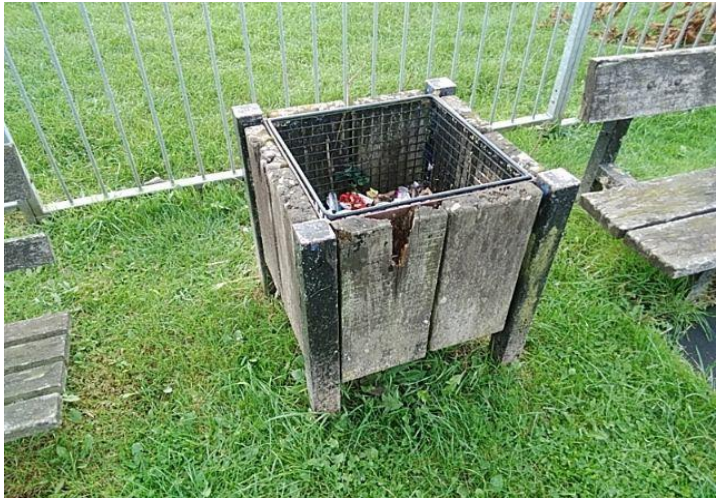
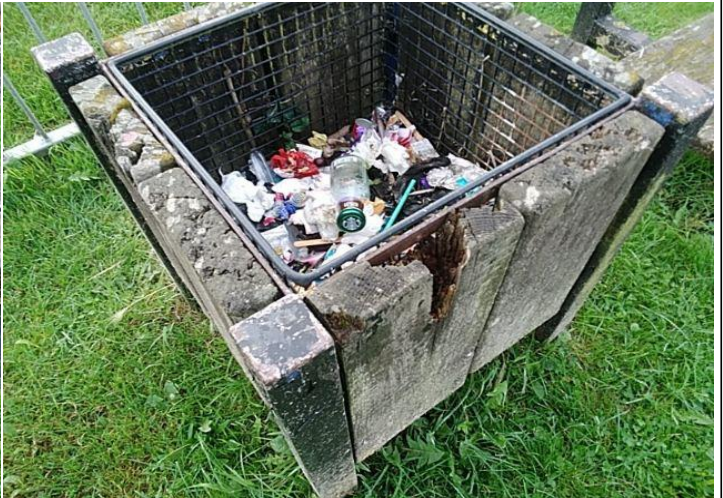
**Finding:** Wood rot at the timber slats.

**Action:** Replace as required x 8

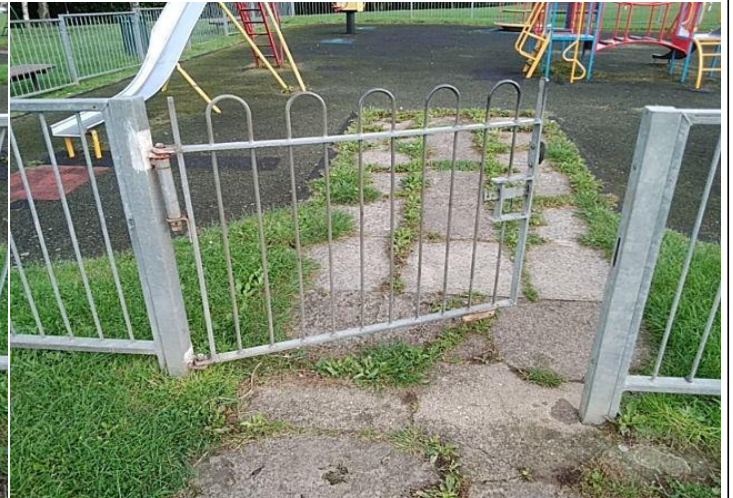
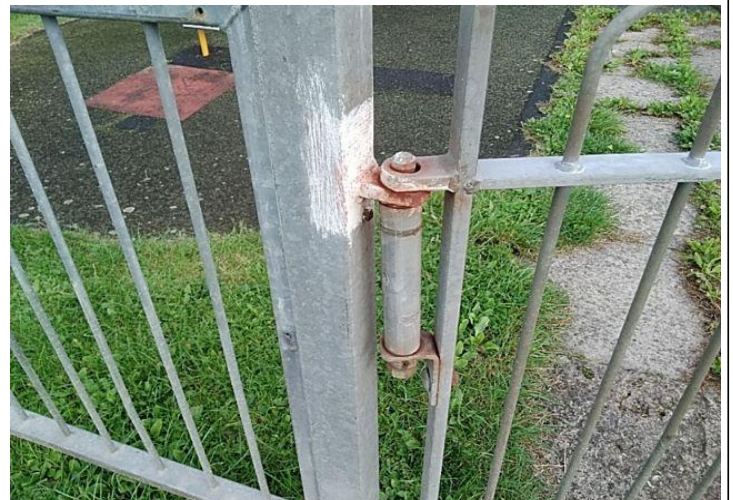
**Finding:** The gate is not operating correctly

**Action:** Take effective action to ensure the gate closes between 4 and 8 seconds

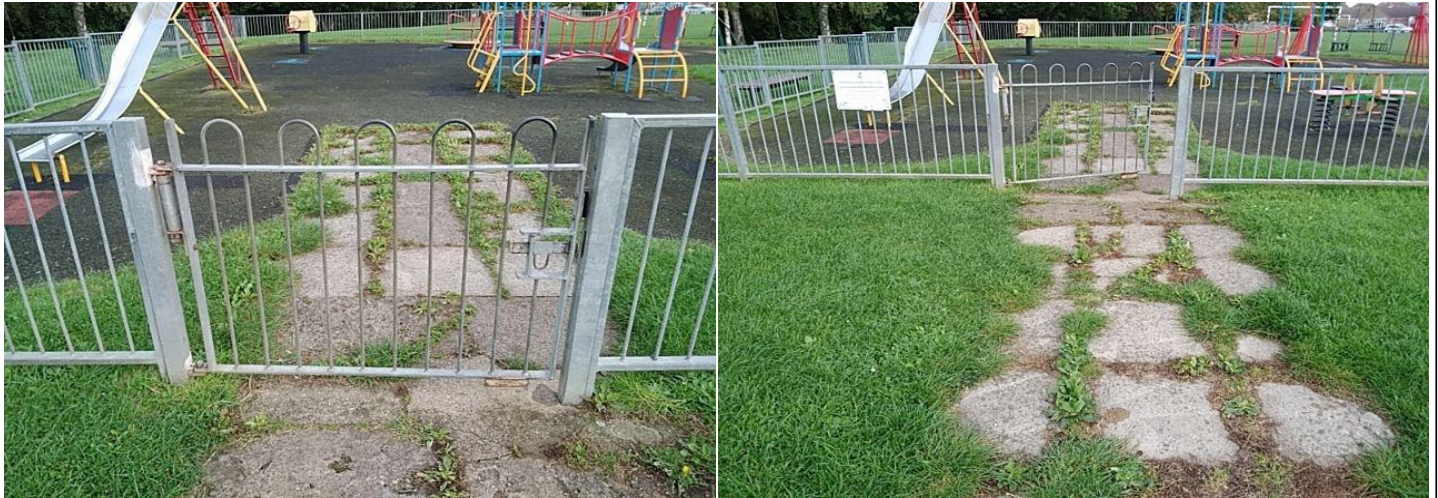
**Finding:** Uneven paving slabs may create trip hazards.

**Action:** Monitor - rework as required.

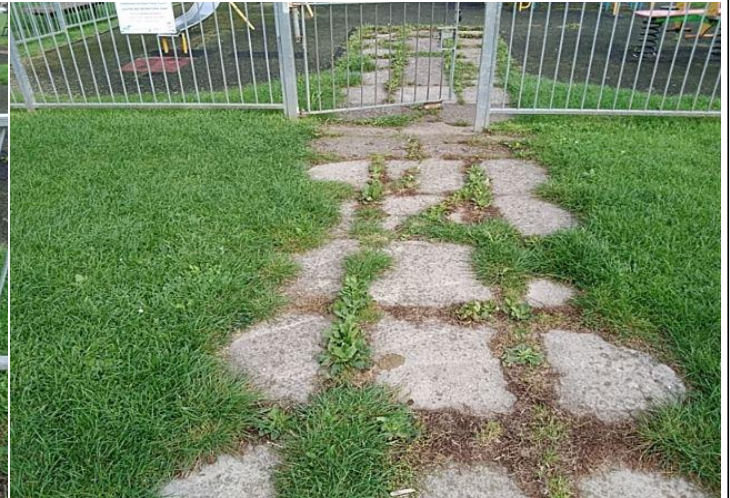
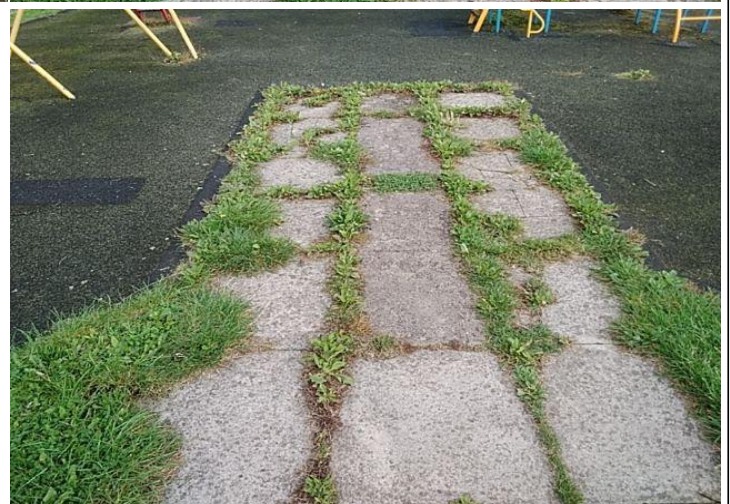
**Finding:** There are weeds/vegetation growth between or around the edges of the surfacing

**Action:** Remove weeds/vegetation growth

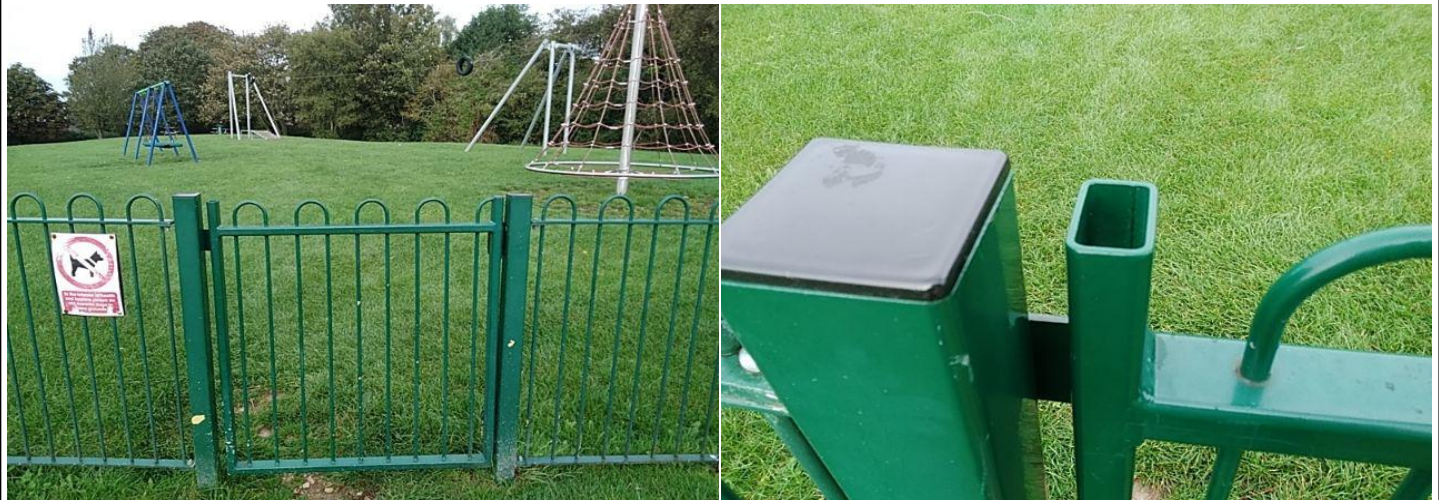
<b>Finding:</b>	1 cap is missing.	<b>Action:</b>	Replace the missing cap - refer to the manufacturers for replacement parts.
-----------------	-------------------	----------------	---

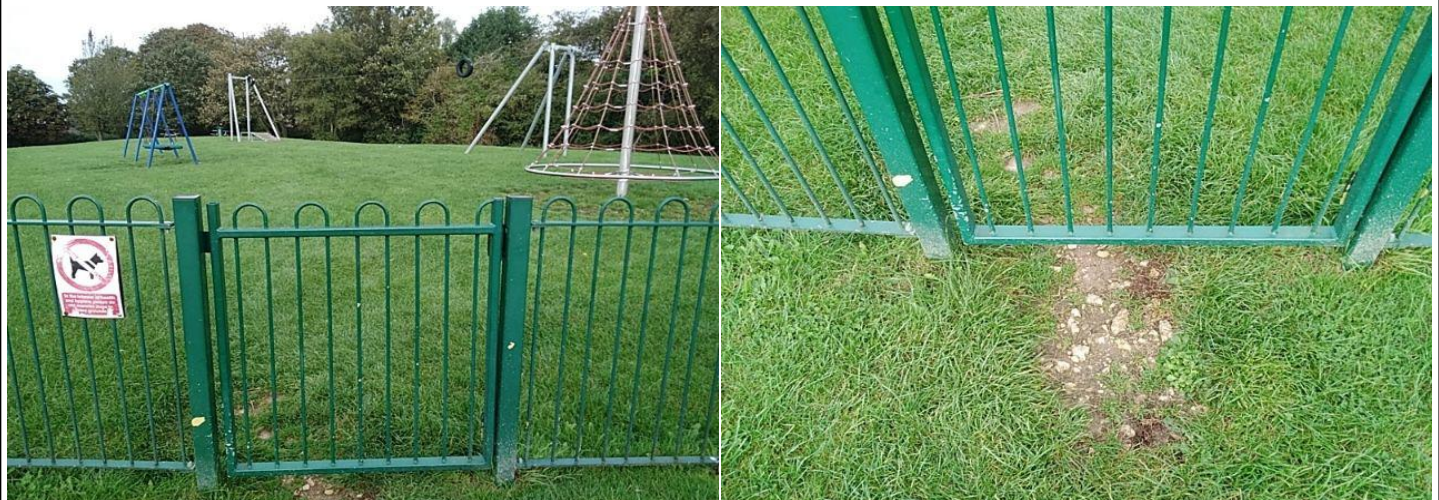
<b>Finding:</b>	Loose stones have been laid at the area of ground erosion	<b>Action:</b>	Monitor
-----------------	---	----------------	---------

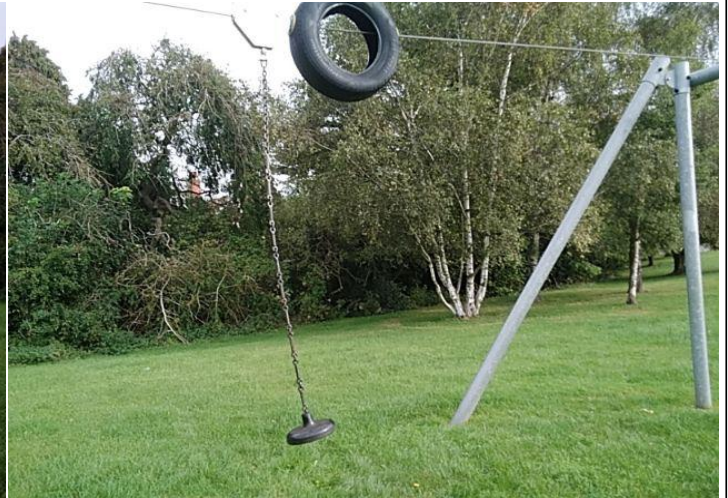
**Finding:** The seat is less than 2.0 metres from the post when extended at 45 degrees at the end of the area of travel and does not meet the requirements of BS EN 1176 Part 4  
**Action:** Adjust the cable stop position to ensure the minimum distance is maintained

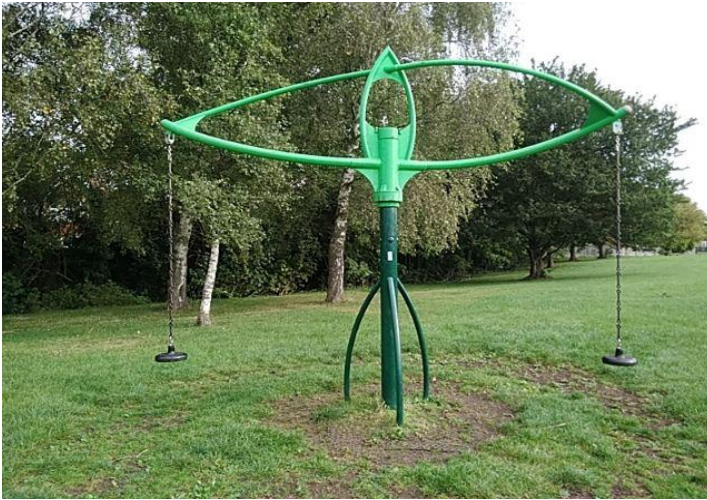
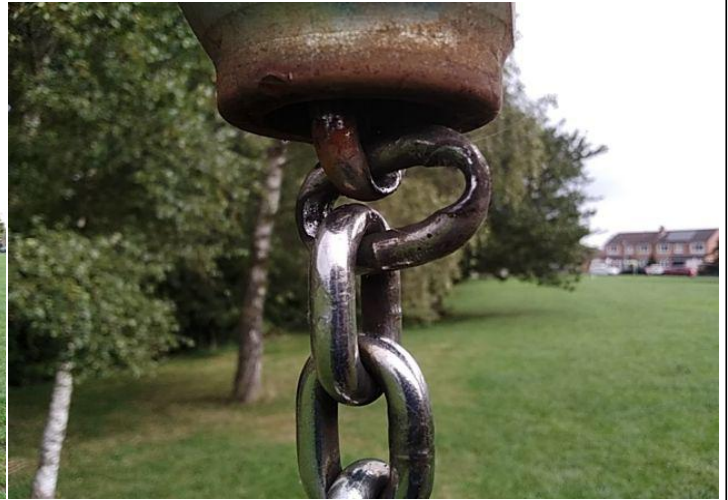
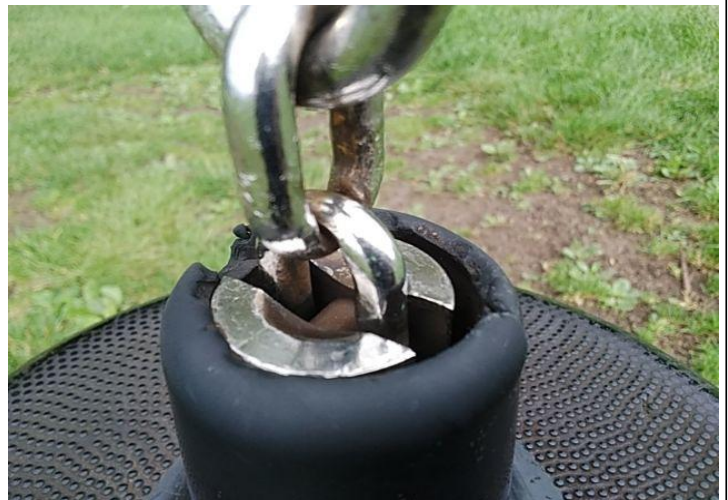
**Finding:** The chain links are worn in excess of 40% and require renewing

**Action:** Replace worn chains

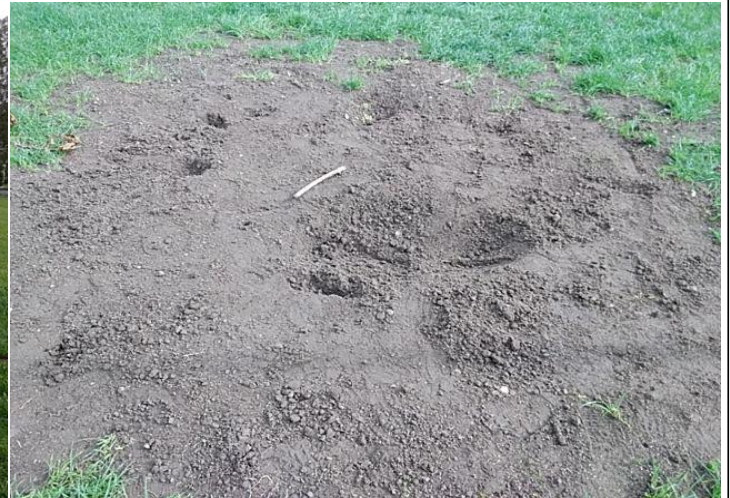
**Finding:** Ground erosion.

**Action:** Grounds maintenance as required to provide a sound and reasonably level surface.
