## Annual Inspection

Colsterworth & District Parish Council

Colster Way Play Area

Inspection Ref: 2184915

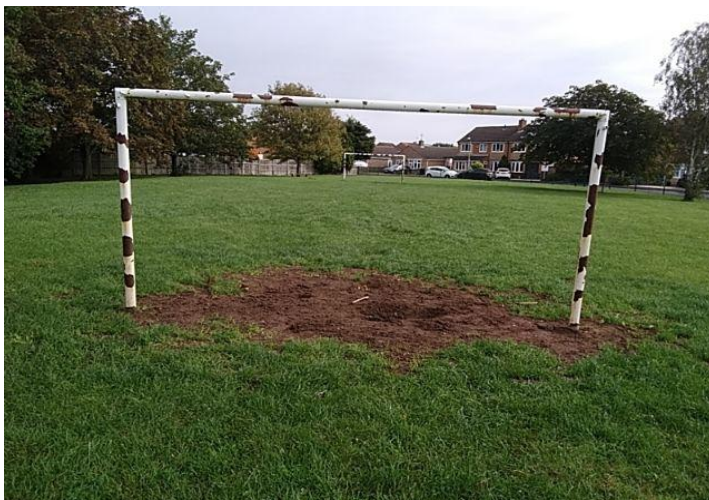
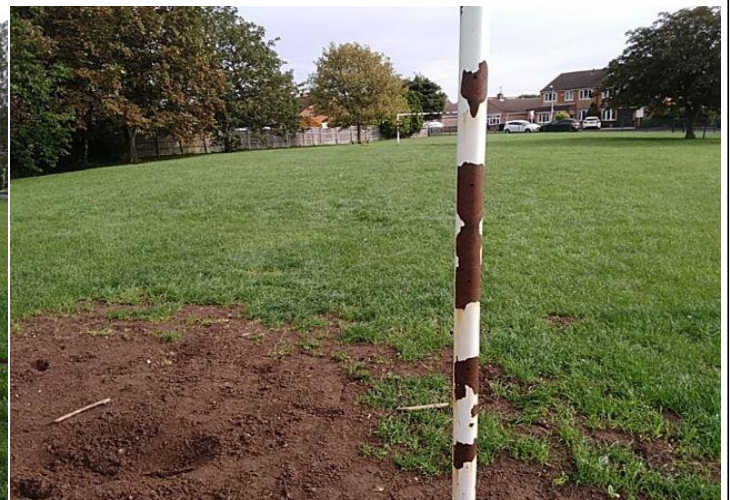
**Finding:** Corrosion

**Action:** Rub down and repaint as required

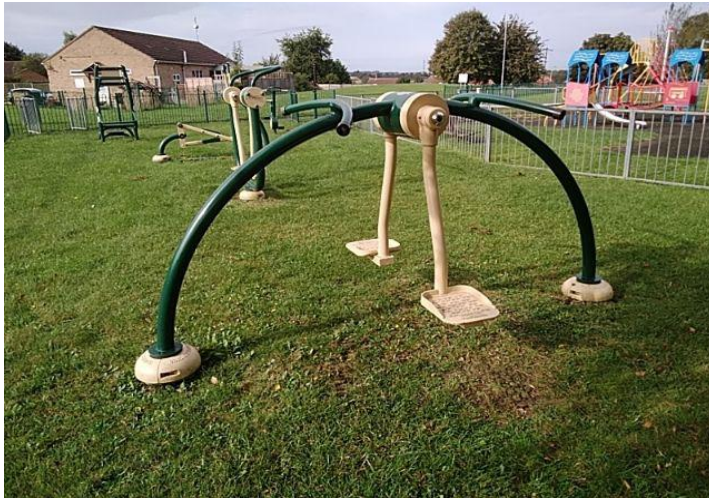
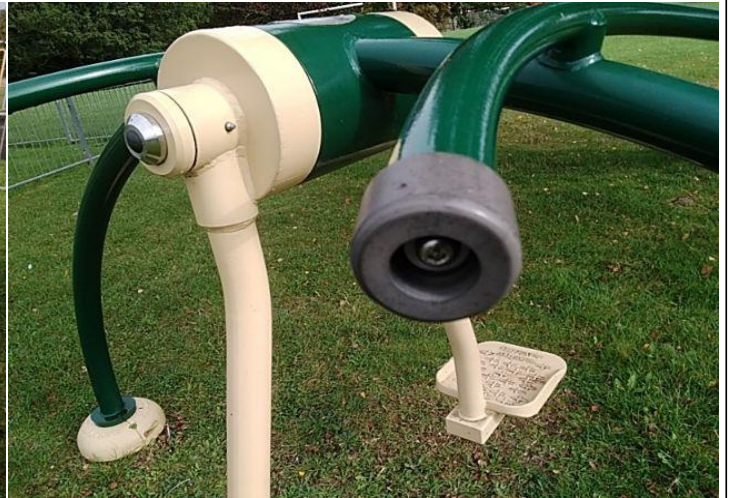
**Finding:** There is/are bolt cap covers missing or damaged on the item

**Action:** Replace missing or damaged bolt cap covers x 4

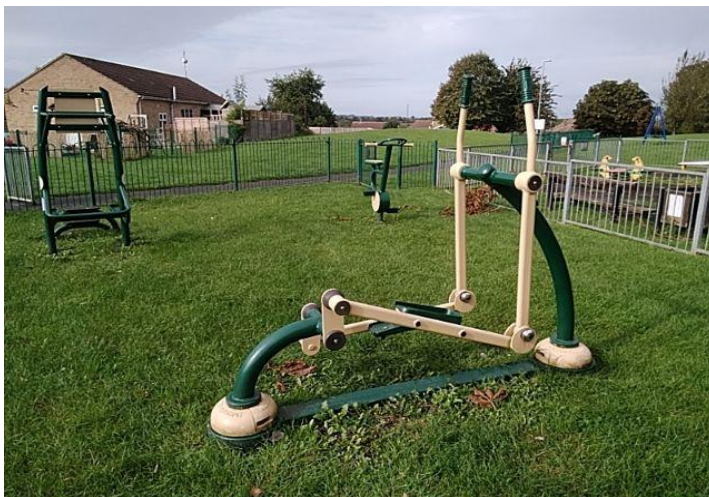
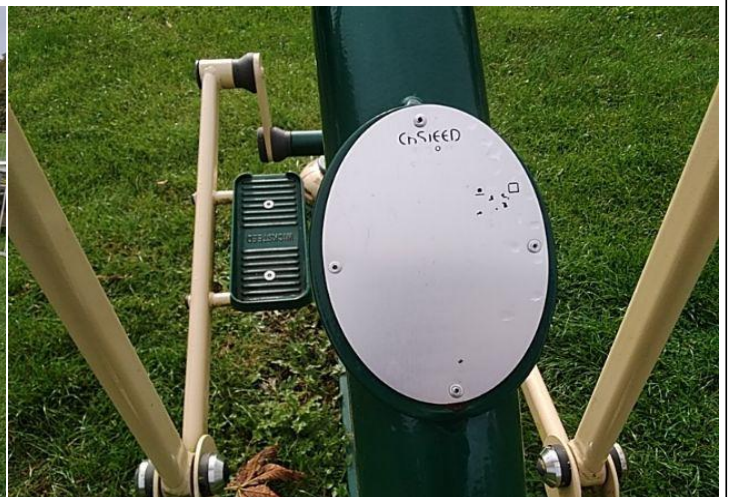
**Finding:** The instruction label has faded

**Action:** Replace the label

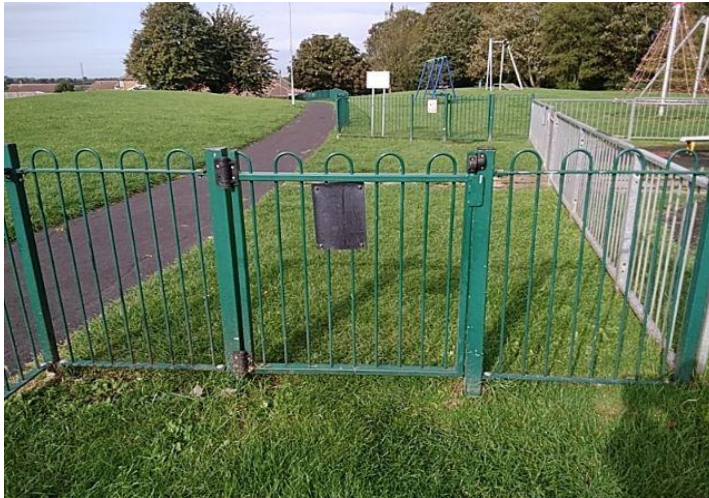
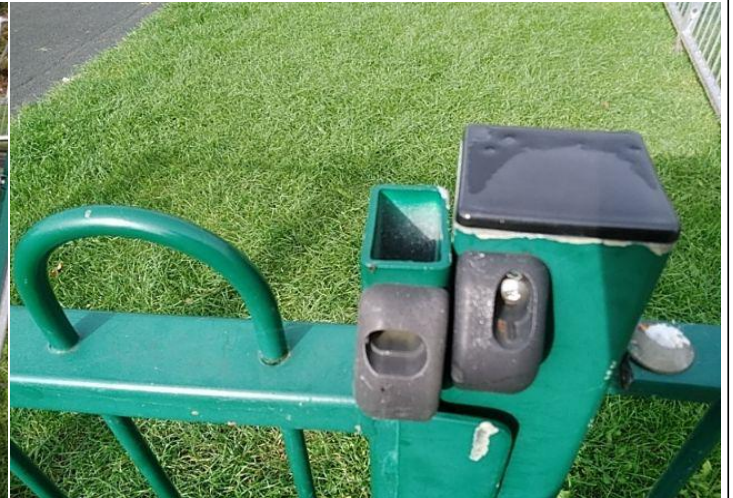
**Finding:** There are post / end caps missing from the item

**Action:** Replace missing post caps

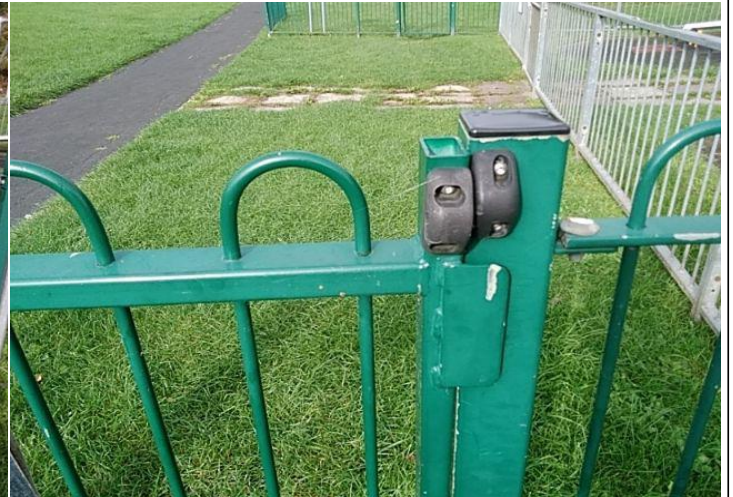
**Finding:** There are openings that are less than 12mm that could trap or crush fingers

**Action:** Where possible a 12mm gap should be maintained on both sides or between the gate leaves

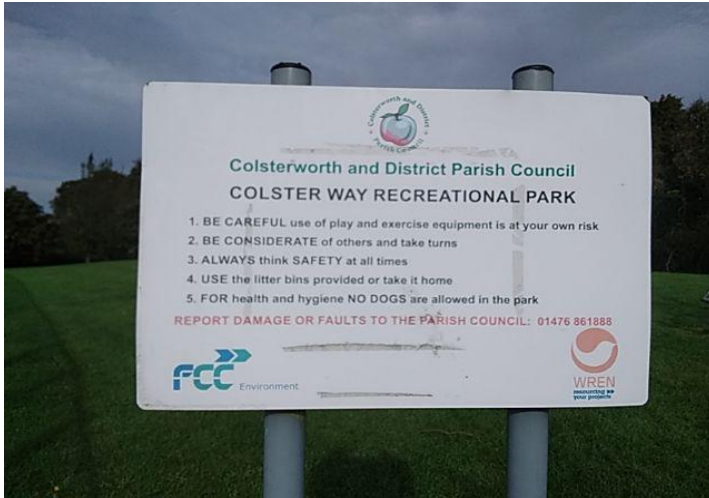
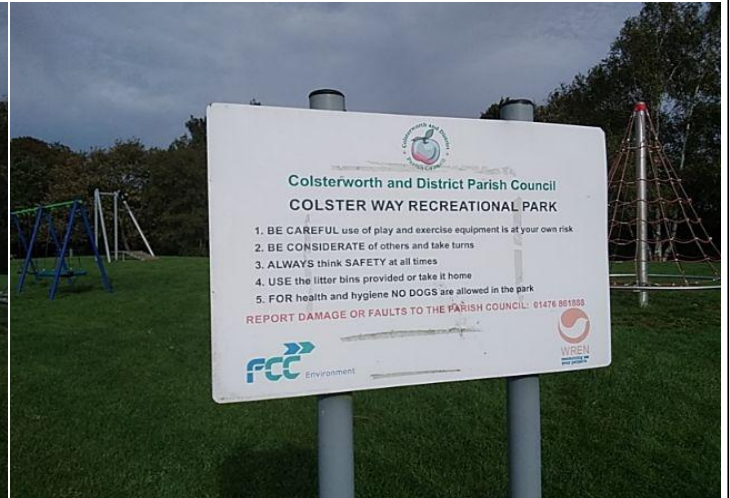
**Finding:** BS EN 1176 Part 7 recommends that signage shall include emergency contact details  
**Action:** Provide additional information
