## Annual Inspection

Colsterworth & District Parish Council

Old Post Lane Play Area

Inspection Ref: 2184916

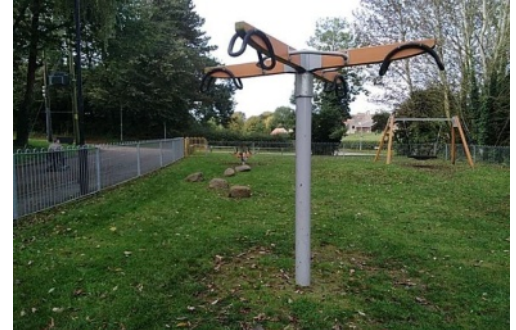
**Item:** Overhead Rotator  
**Manufacturer:** Lappset UK Ltd  
**Surface Type:** Grass Matrix Tiles  
**Item Quantity:** 1  
**Equipment Compliance:** N/A  
**Surface Area Compliance:** N/A

This item is satisfactory - no work required -

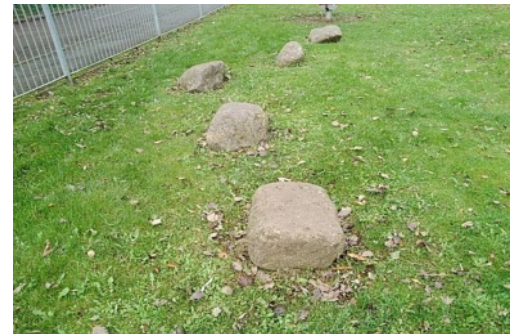
**Item:** Boulders  
**Manufacturer:** Natural Feature  
**Surface Type:** Grass  
**Item Quantity:** 5  
**Equipment Compliance:** N/A  
**Surface Area Compliance:** N/A

This item is satisfactory - no work required -

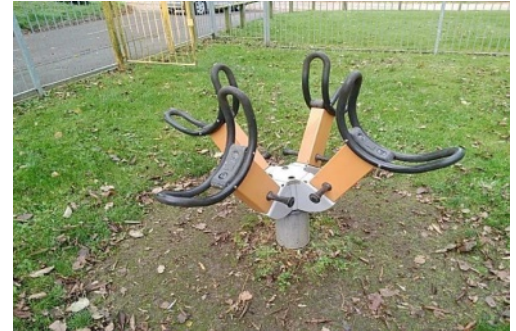
**Item:** Spinner  
**Manufacturer:** Lappset UK Ltd  
**Surface Type:** Grass Matrix Tiles  
**Item Part Number:** 010624  
**Item Quantity:** 1  
**Equipment Compliance:** N/A  
**Surface Area Compliance:** N/A  
**Total Findings:** 1

This item is satisfactory - no work required -

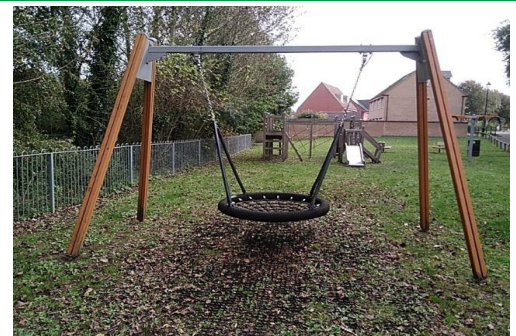
**Item:** Basket Swing - Type 1  
**Manufacturer:** Lappset UK Ltd  
**Surface Type:** Grass Matrix Tiles  
**Item Quantity:** 1  
**Equipment Compliance:** N/A  
**Surface Area Compliance:** N/A  
**Total Findings:** 1

The seat clearance from finished surface level to the underside of the seat is too low when measured in its most onerous position and does not meet the requirements of BS EN 1176 Part 2 - Install seats to a minimum height of 400mm for Group Swing Seats

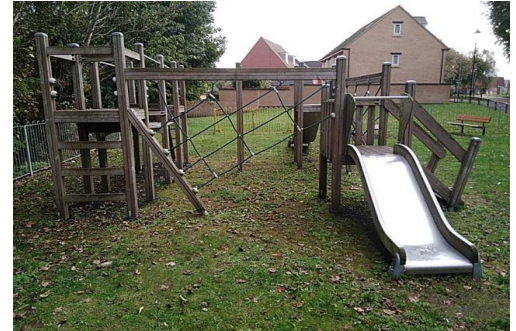
**Item:** Multi Play (Junior)  
**Manufacturer:** Lappset UK Ltd  
**Surface Type:** Grass Matrix Tiles  
**Item Quantity:** 1  
**Equipment Compliance:** N/A  
**Surface Area Compliance:** N/A

The item fails to meet the requirements of BS EN 1176 Part 1 4.2.7.2 for head and neck entrapment where the opening between the lowest balance beam and the grey platform below is less than 230mm. - Refer to the manufacturers for advice.

The adjacent foliage is overhanging - Cut back and maintain

There is or are fixings missing on the item - Replace all missing fixings

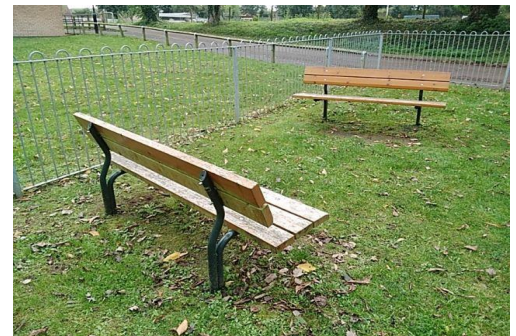
**Item:** Seat  
**Manufacturer:** Unknown  
**Surface Type:** Grass Matrix Tiles  
**Item Quantity:** 1  
**Equipment Compliance:** N/A  
**Surface Area Compliance:** N/A

The timber stain is in poor condition - Prepare all affected parts and re-stain with an appropriate preservative

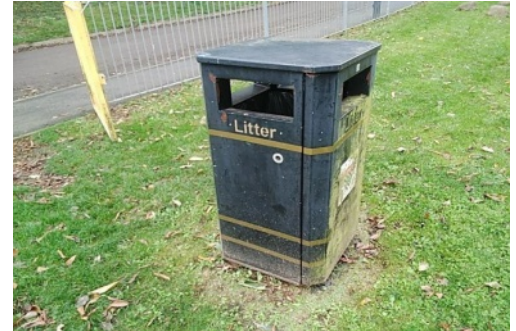
**Item:** Litter Bin  
**Manufacturer:** Broxap  
**Surface Type:** Grass  
**Item Quantity:** 1  
**Equipment Compliance:** N/A  
**Surface Area Compliance:** N/A

This item is satisfactory - no work required -

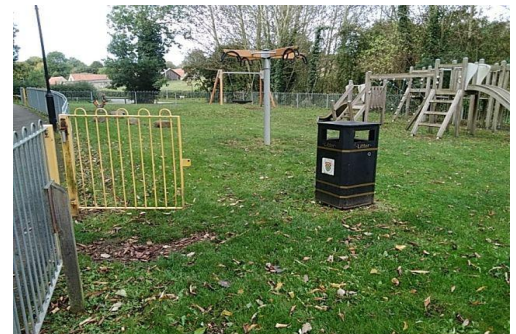
**Item:** Site General  
**Manufacturer:** Unknown  
**Surface Type:** Grass  
**Item Quantity:** 1  
**Equipment Compliance:** N/A  
**Surface Area Compliance:** N/A

It is recommended that signage, with information including the site address, contact information for maintenance issues and emergency contact details are provided for the facility - Provide in accordance with the recommendations

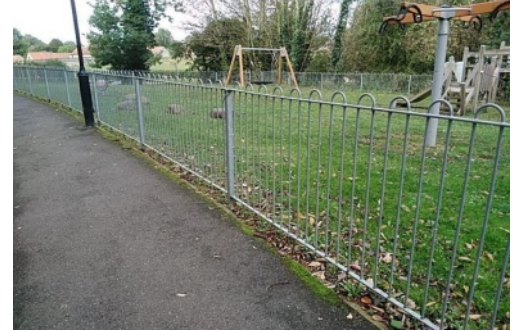
**Item:** Fence - Bow Top  
**Manufacturer:** Unknown  
**Surface Type:** Grass  
**Item Quantity:** 1  
**Equipment Compliance:** N/A  
**Surface Area Compliance:** N/A

This item is satisfactory - no work required -

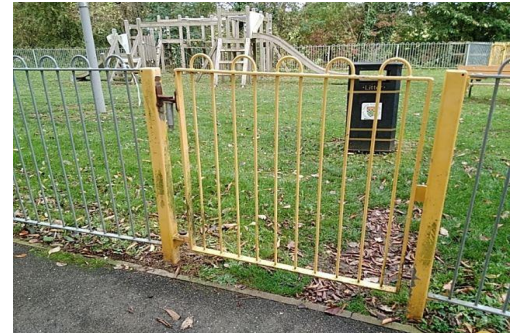
**Item:** Gate - Self Closing  
**Manufacturer:** Unknown  
**Surface Type:** Grass  
**Item Quantity:** 2  
**Equipment Compliance:** N/A  
**Surface Area Compliance:** N/A

The gate is not operating correctly - Take effective action to ensure the gate closes between 4 and 8 seconds

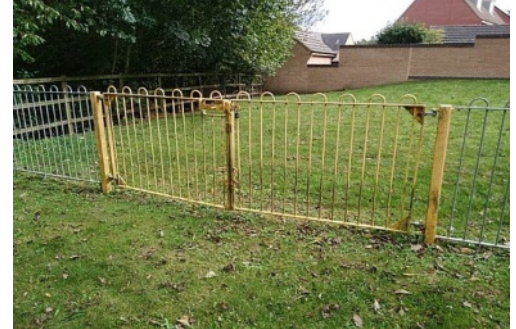
**Item:** Gate - Maintenance  
**Manufacturer:** Unknown  
**Surface Type:** Grass  
**Item Quantity:** 1  
**Equipment Compliance:** N/A  
**Surface Area Compliance:** N/A

This item is satisfactory - no work required -

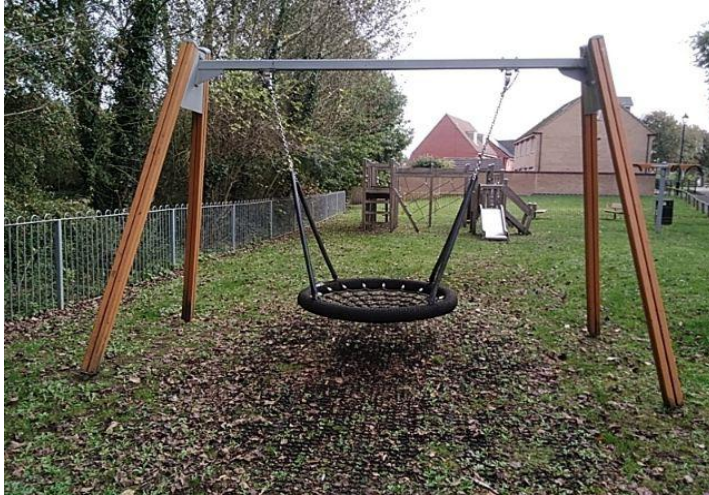
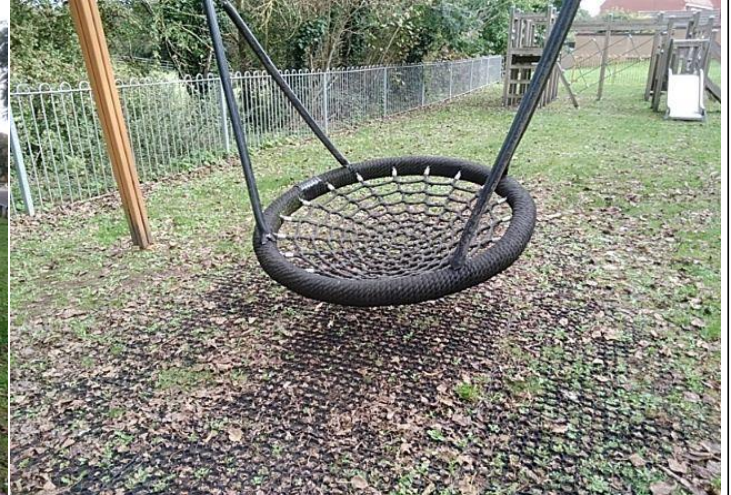
### 10 - Low Risk (Finding 1)

**Item:** Swings - Basket Swing - Type 1  
**Manufacturer:** Lappset UK Ltd

**Finding:** The seat clearance from finished surface level to the underside of the seat is too low when measured in its most onerous position and does not meet the requirements of BS EN 1176 Part 2

**Action:** Install seats to a minimum height of 400mm for Group Swing Seats

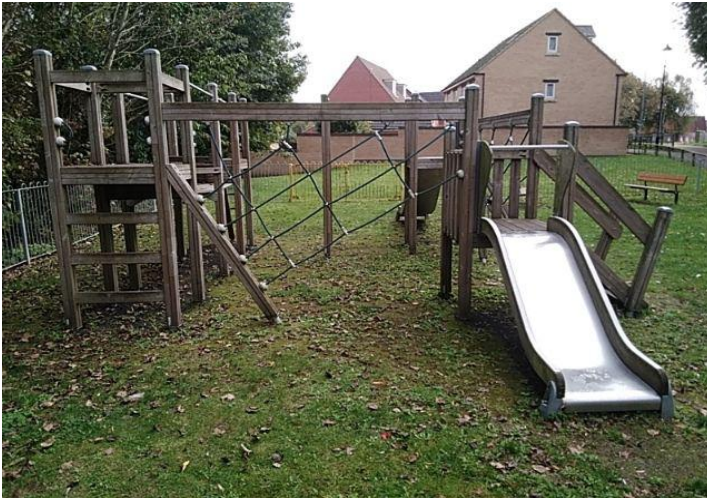
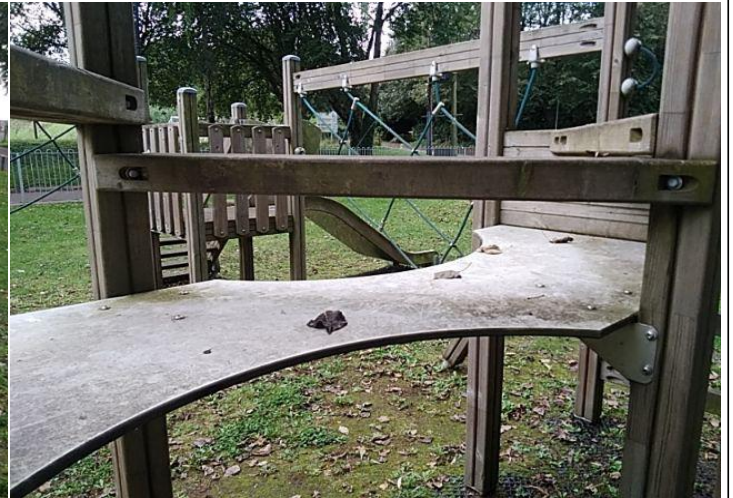
6 - Low Risk (Finding 1)

**Item:** Activity Equipment - Multi Play (Junior)  
**Manufacturer:** Lappset UK Ltd

**Finding:** The item fails to meet the requirements of BS EN 1176 Part 1 4.2.7.2 for head and neck entrapment where the opening between the lowest balance beam and the grey platform below is less than 230mm.

**Action:** Refer to the manufacturers for advice.

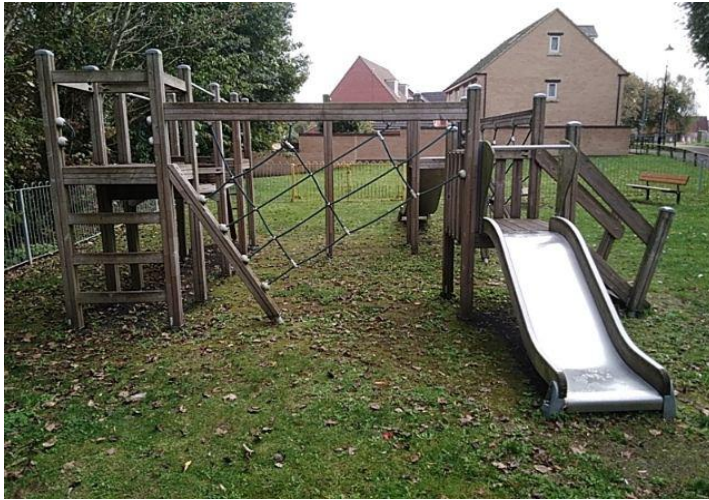
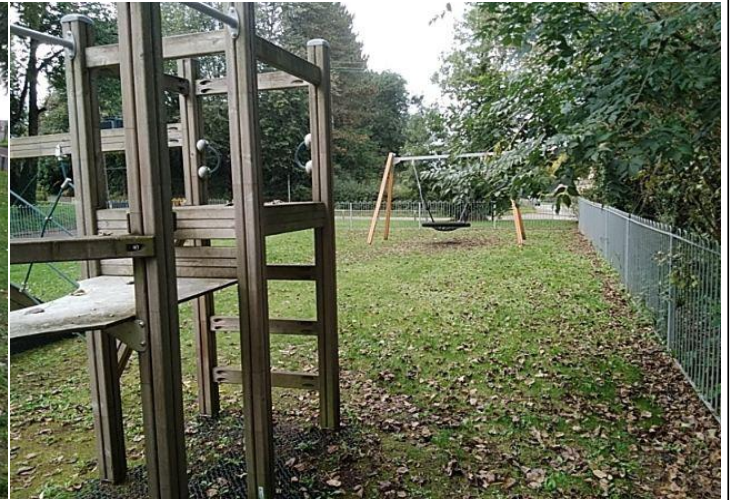
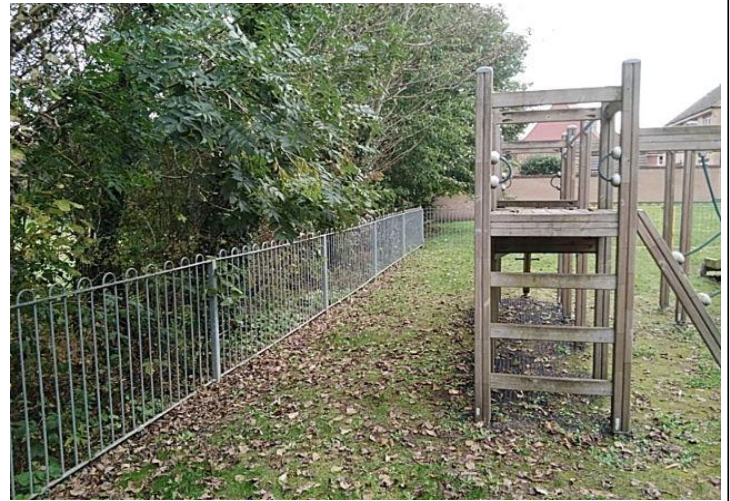
**i** 6 - Low Risk (Finding 2)

**Item:** Activity Equipment - Multi Play (Junior)  
**Manufacturer:** Lappset UK Ltd

**Finding:** The adjacent foliage is overhanging

**Action:** Cut back and maintain

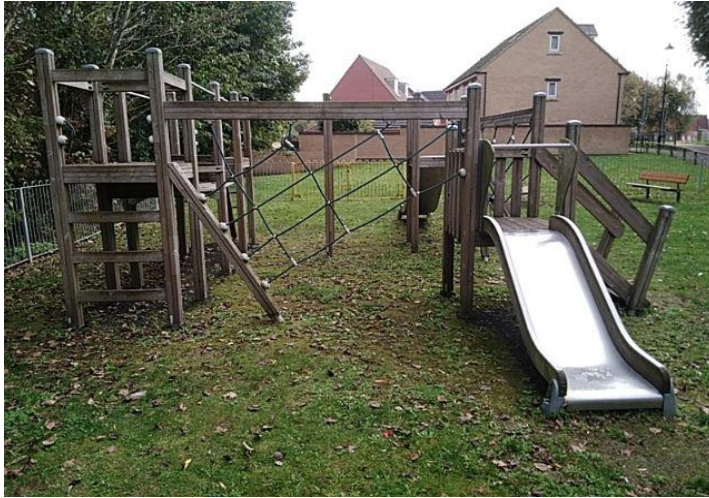
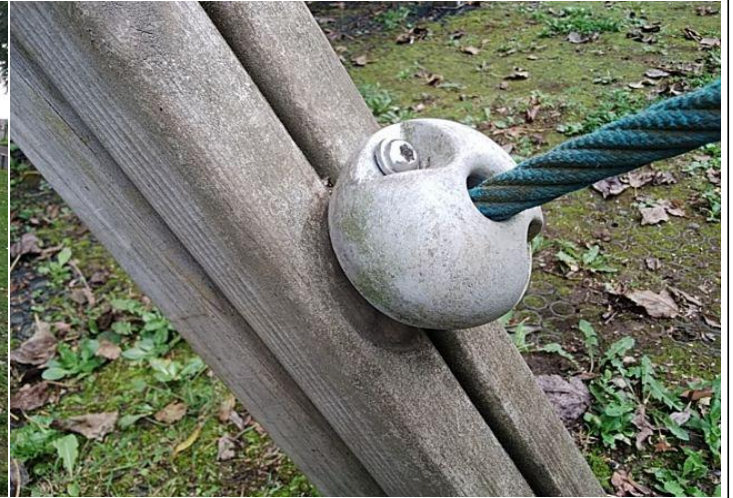
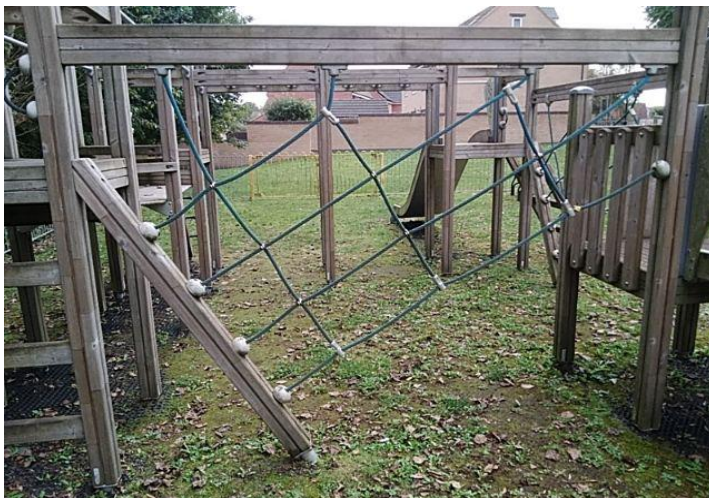
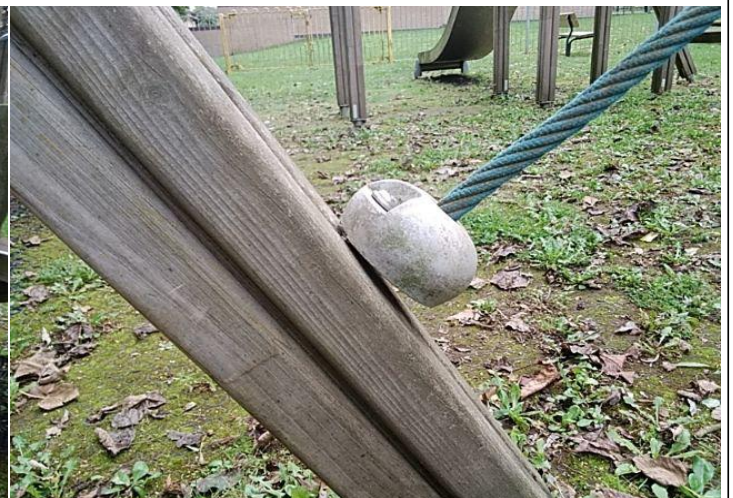
12 - Moderate Risk (Finding 3)

**Item:** Activity Equipment - Multi Play (Junior)  
**Manufacturer:** Lappset UK Ltd

**Finding:** There is or are fixings missing on the item

**Action:** Replace all missing fixings

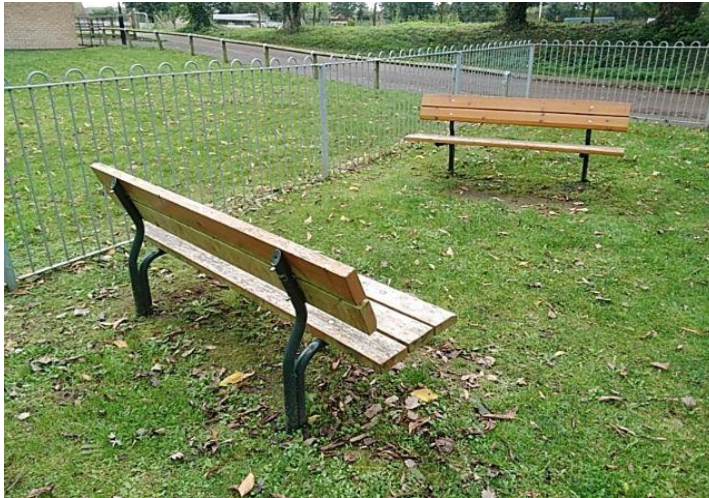
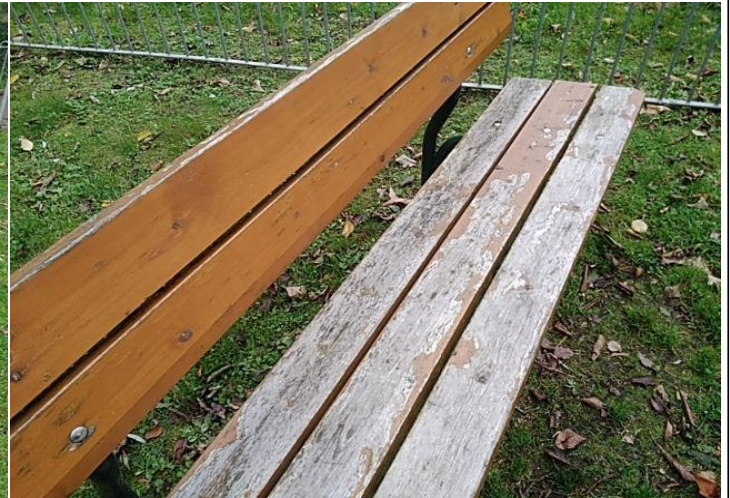
**i** 6 - Low Risk (Finding 1)

**Item:** Ancillary Items - Seat  
**Manufacturer:** Unknown

**Finding:** The timber stain is in poor condition

**Action:** Prepare all affected parts and re-stain with an appropriate preservative

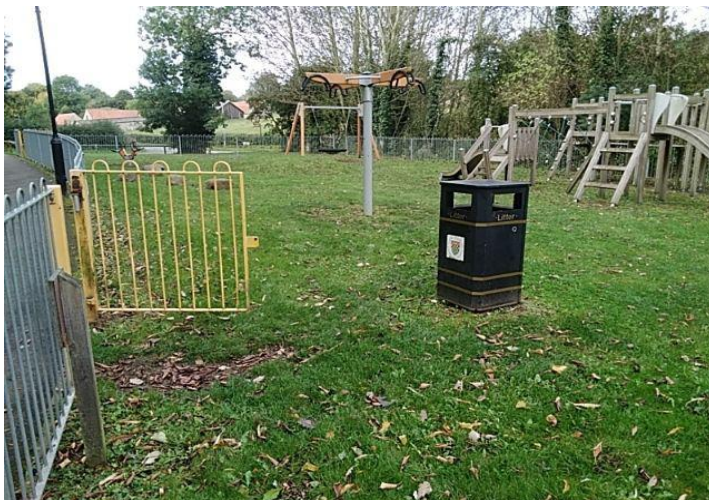
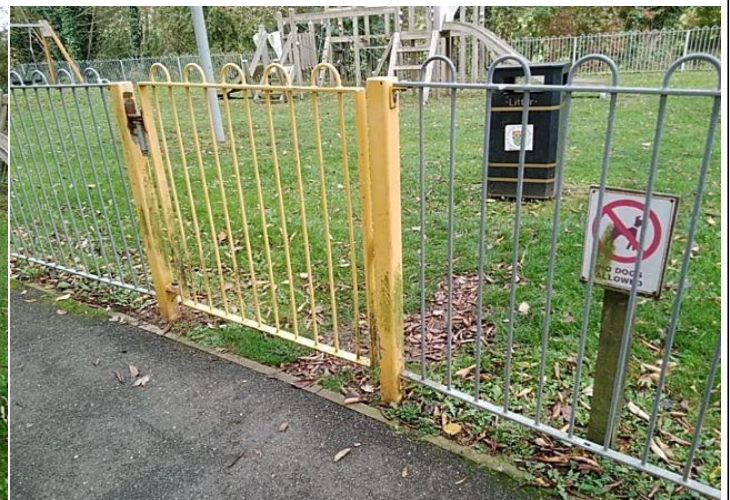
**i** 5 - Very Low Risk (Finding 1)

**Item:** Ancillary Items - Site General  
**Manufacturer:** Unknown

**Finding:** It is recommended that signage, with information including the site address, contact information for maintenance issues and emergency contact details are provided for the facility

**Action:** Provide in accordance with the recommendations

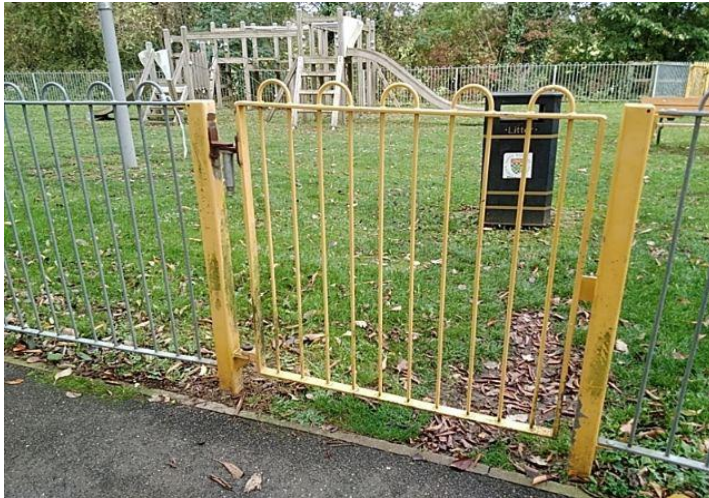
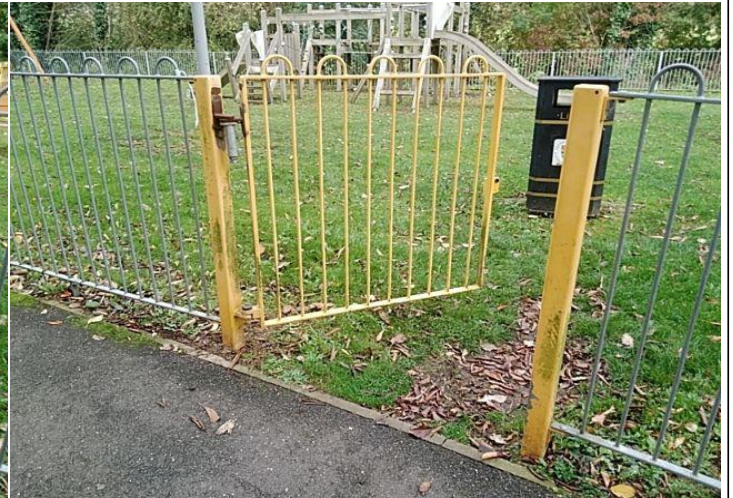
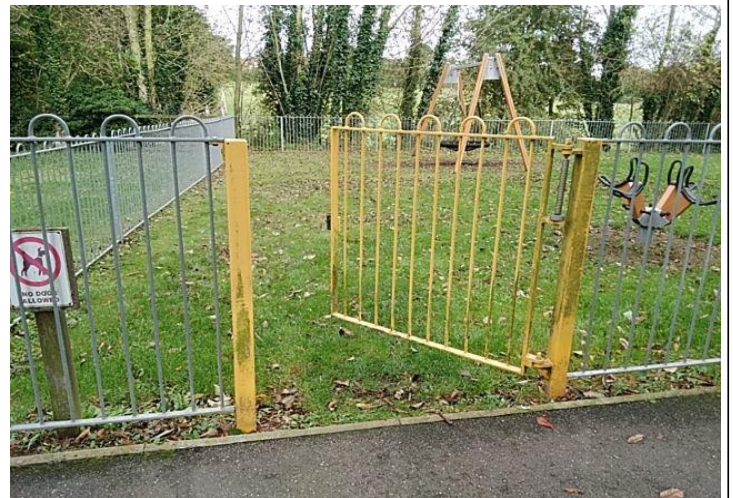
**i** 5 - Very Low Risk (Finding 1)

**Item:** Gates - Gate - Self Closing  
**Manufacturer:** Unknown

**Finding:** The gate is not operating correctly

**Action:** Take effective action to ensure the gate closes between 4 and 8 seconds
