River Witham, North Witham

Flooding 6th January 2025 – Evidence Based Review

Date: 9th May 2025

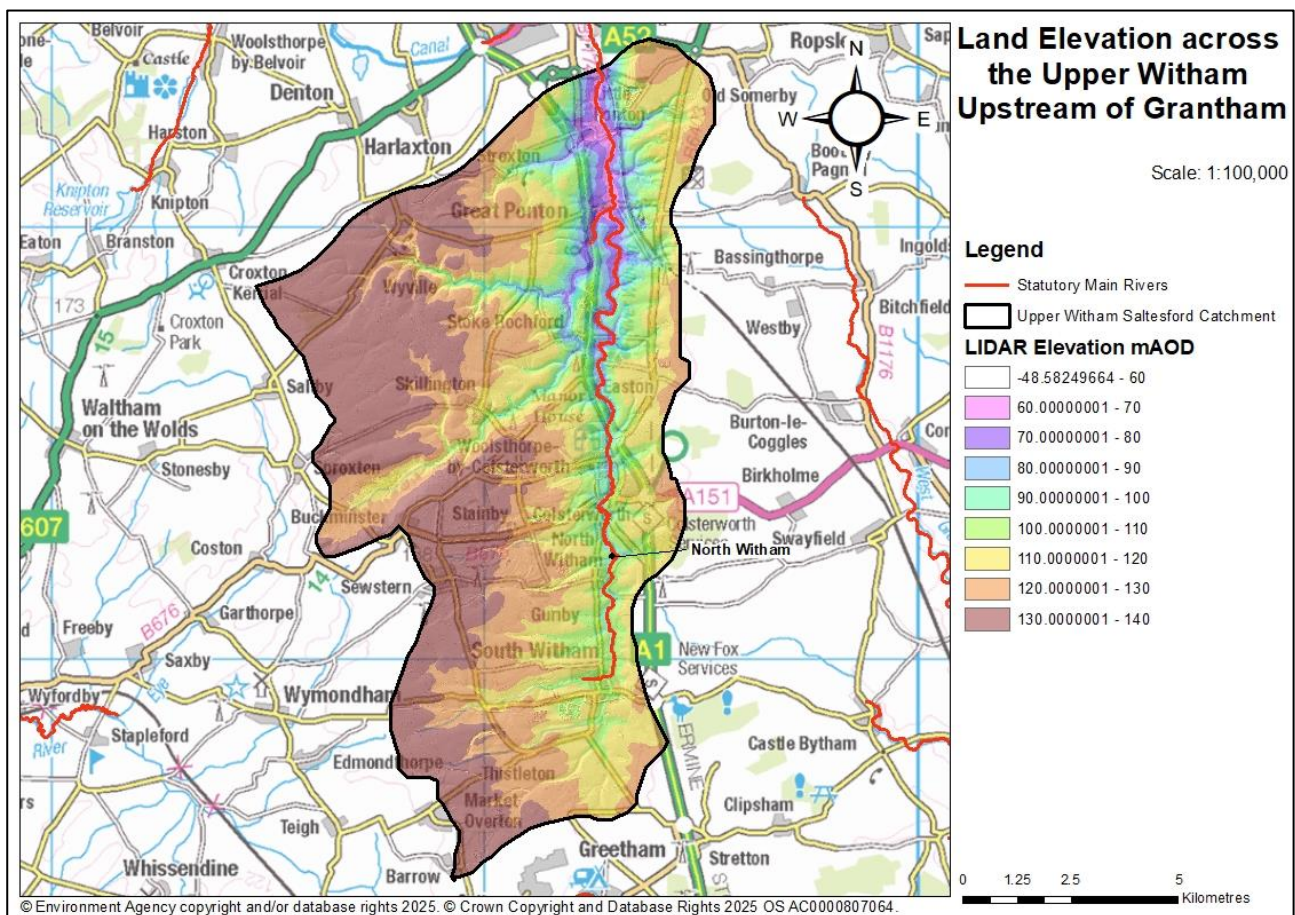
Figure 1: Topography of the Upper Witham Upstream of Grantham.

North Witham is a small village located within the South Kesteven District of Lincolnshire. The village is located along the upper course of the River Witham, approximately 9 miles (14 km) south from the nearest major town of Grantham. Its approximate central National Grid Reference is SK 92667 21867. It has an estimated population of 143 in around 72 households. North Witham sits at a relatively high elevation at around 100m above sea level, being in the higher ground of the River Witham catchment. Land levels around the Witham valley at this point peak at around 140-150m above sea level.

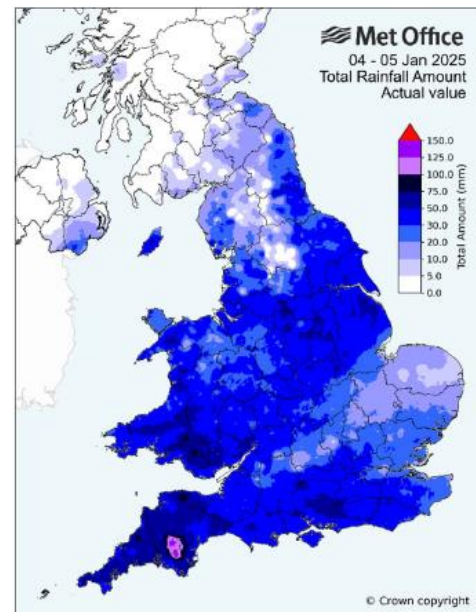
**Figure 02: National Rainfall
4th to 5th January 2025**

The period from late December 2024 to early January 2025 brought some very wet and windy weather, with significant cold spells and snowfalls across upland areas in the north. Several long-running rainfall gauging stations in eastern England recorded their wettest January day on record on the 5th January. The very wet weather was accompanied by some strong winds and near freezing temperatures and rain fell on extremely saturated and frozen ground. The heavy rain between the 4th to 6th January led to significant flooding problems. Worst hit areas included parts of Leicestershire and Lincolnshire with major incidents being declared by the Lincolnshire Resilience Forum. Map (Source: Met Office. Crown copyright, 2025).

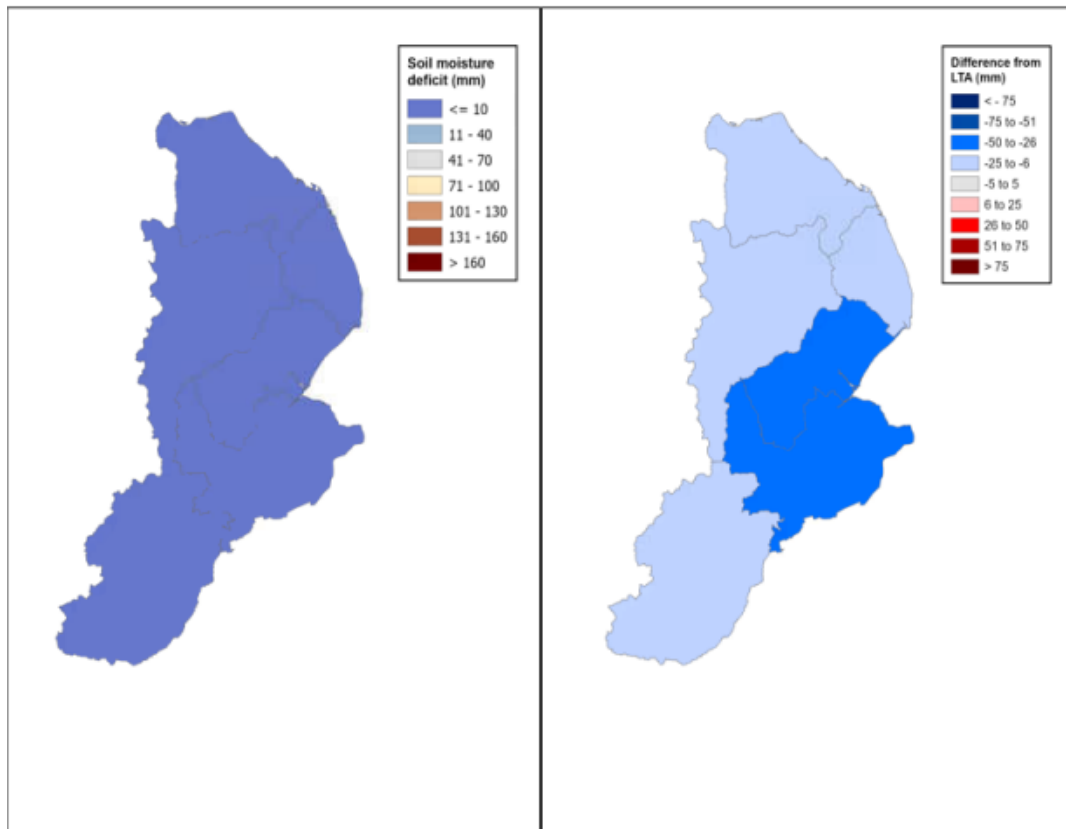
Figure 3: Lincolnshire Soil Moisture Deficit during December 2024

The ground conditions across the catchment were already saturated. The soil had the capacity to absorb less than 5mm of rainfall (known as the soil moisture deficit). The actual amount of water the soil can absorb is also dependant on other factors such as soil type, evaporation rates and rainfall intensity. Temperatures overnight on the 5th and 6th January were around 0°C and snow had fallen on the higher ground, meaning the surface of the ground was frozen and, in some places, covered with a layer of snow. Vegetation cover in January is significantly reduced, with no leaves on trees. These factors resulted in rainfall running overland and straight into watercourses rather than infiltrating into the ground and reaching watercourses at a slower rate. This caused rapidly rising river levels and flooding.

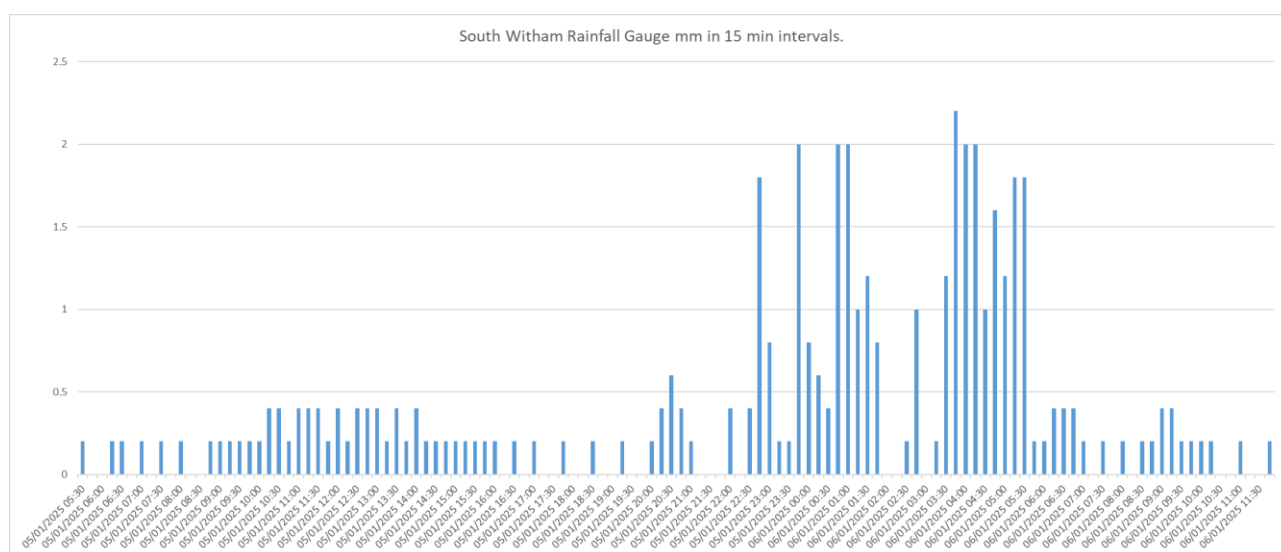
Figure 4: Rainfall at South Witham Rainfall Gauge in 15 minute intervals from 05:30 on 05/01/2025 to 11:45 on 06/01/2025

The South Witham rainfall gauge received 47.6mm between 05:30hrs on 05/01/2025 and 11:45hrs on 06/01/2025 totalling 30.25 hours. Peak rainfall was between 22:45hrs on the 05/01/2025 and 05:30hrs on 06/01/2025 inclusive (Figure 4).

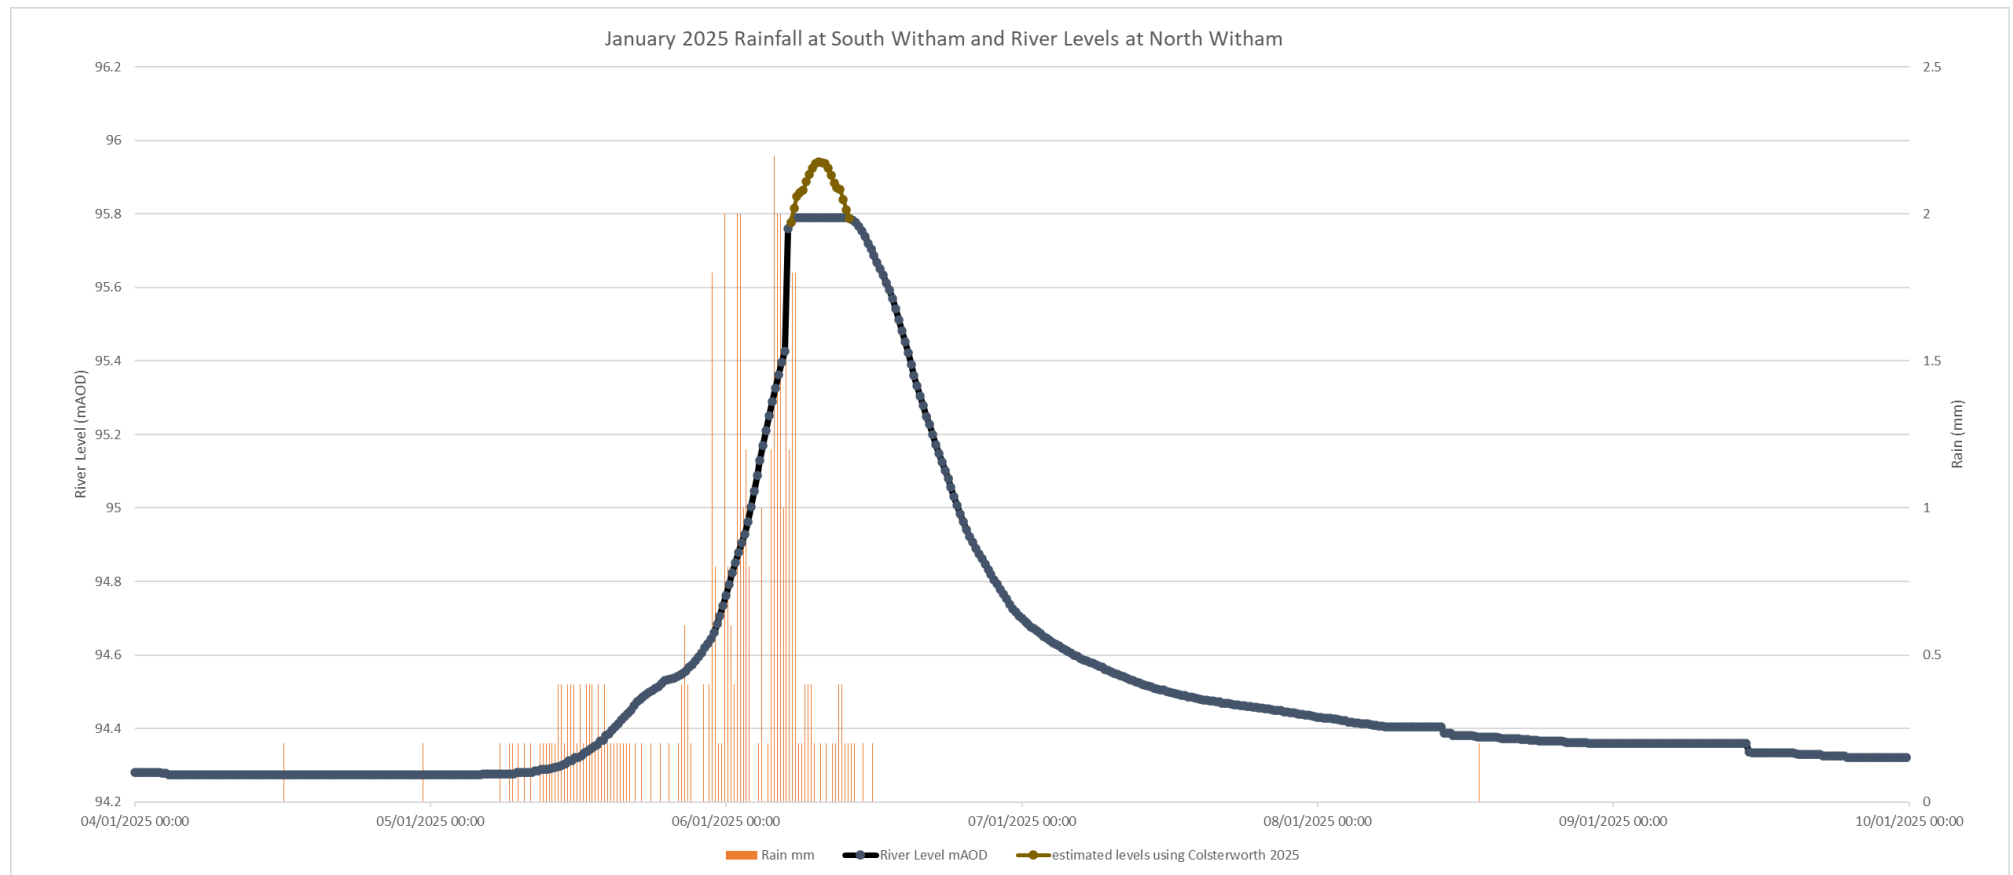
Figure 5: River Levels and rainfall at North Witham Gauging Station from 04/01/2025 to 10/01/2025. The brown line is the estimated level extrapolated using the change in levels at the next gauging station downstream, Colsterworth, for the same rainfall event.

The River Witham responded to Rainfall between 05:30hrs on the 05/01 and 11:45hrs on the 06/01 resulting in the highest river level recorded since 2000, peaking at 95.79m above sea level between 05:30hrs and 09:45hrs inclusive on the 6th January. It is believed

that river levels were higher than this as the gauging station appears to have drowned out (Figure 5). On 06/01/25 the river level increased sharply from 95.427m above sea level at 04:45hrs to 95.76m above sea level at 05:00hrs, an increase of 0.333m. This was shortly before the apparent drowning out of the gauge at 05:30hrs.

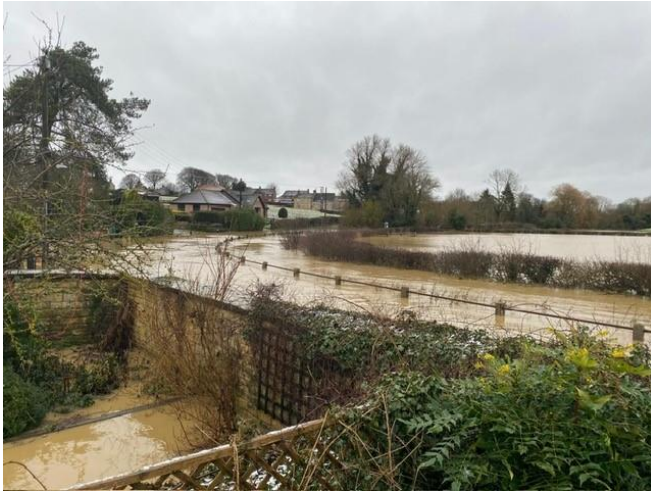
Fields on the right and left of the river; close to the houses, flooded (figures 6 and 8). Fields upstream before the river passes under Water Lane flooded (figure 8). Fields further upstream before a bend in the river flooded (figure 9).

Figure 6: Flooding of Water Lane on the left of the river and a field on the right of the river. Provided by the public.

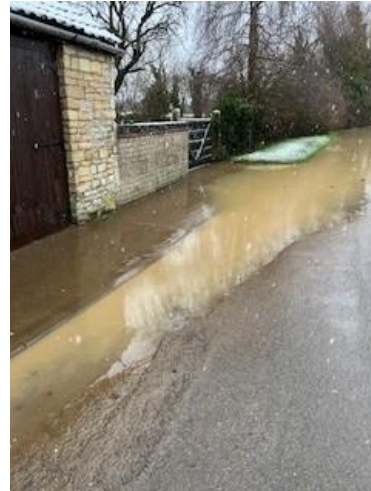
The road flooded up to approximately the outside of the property called Riverside Forge downstream (figure 7) and to where the road crosses the Witham upstream. The flood level on the road was to the height of the fence running between the road and the river. Photo evidence from the public shows this, however photos were likely taken after peak water levels.

Figure 7: Flooding on Water Lane, downstream extent. Provided by Public.

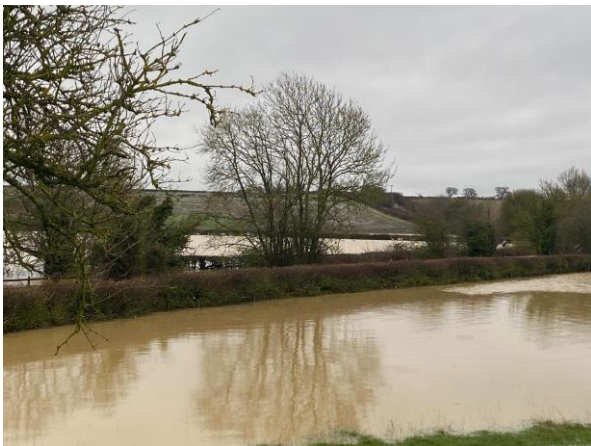
Figure 8: Flooding of fields on right side of the Witham (background) and left side of the Witham (foreground). Provided by the public.

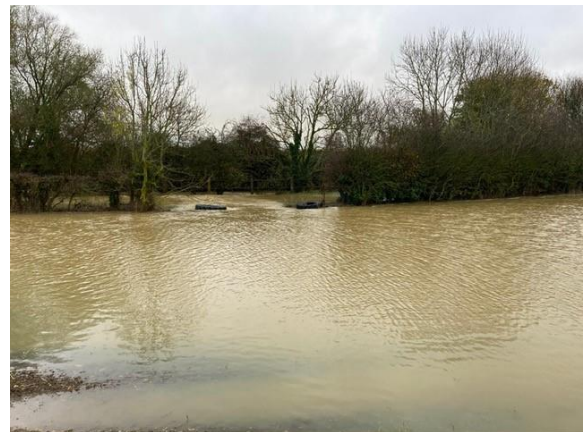
Figure 9: Field off Water Lane where the river passes under the road. Provided by the public.

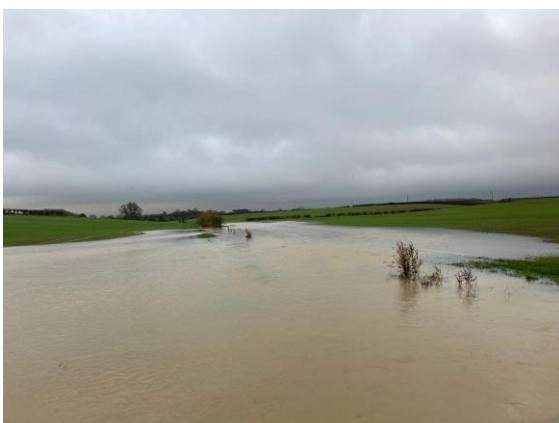
Figure 10: Field upstream of Water Lane. Provided by the public.

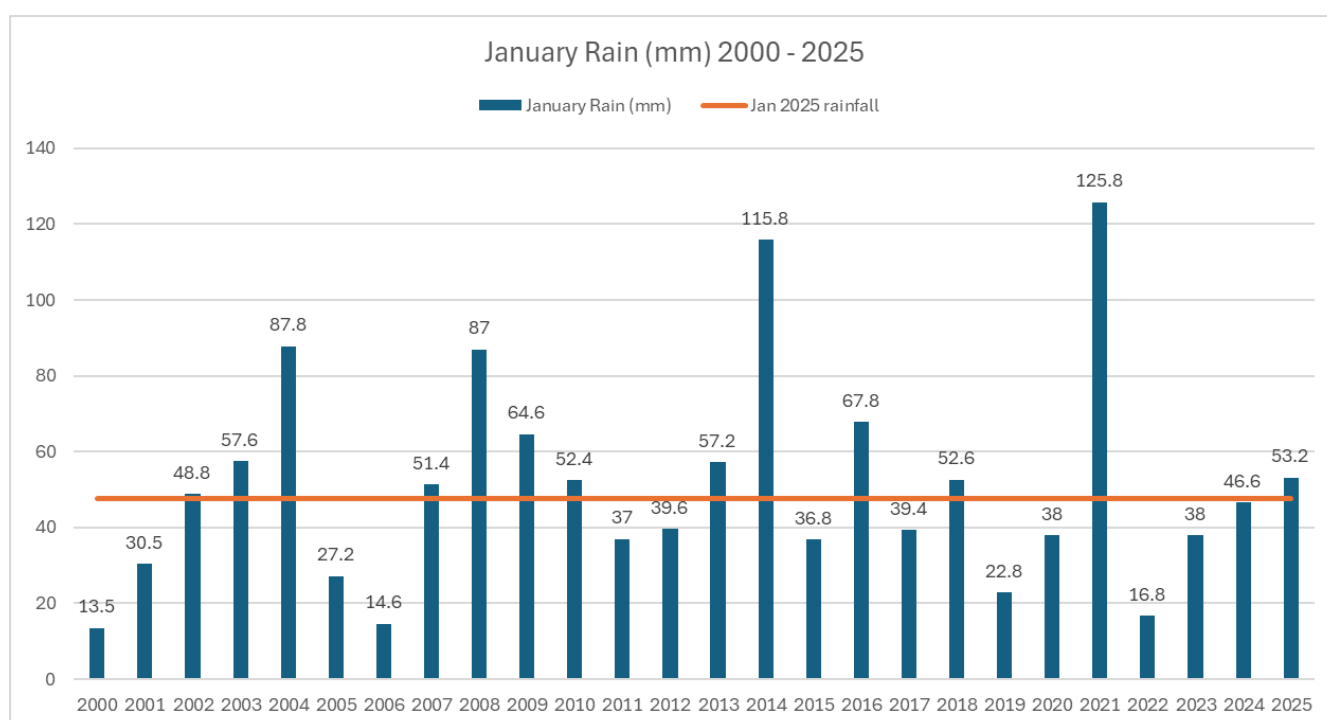
Figure 12: South Witham Rainfall Gauge January monthly rainfall totals 2000 to 2025. The orange line indicates the rainfall for the Jan 2025 event. The rainfall total for Jan 2025 is only up until 21/01/2025 rather than the full month.

noted that total rainfall for this event (47.6mm) is close to the monthly average for January for this area (52mm) and was received in 30.25h. The rainfall in this event was greater than the total January rainfall for some previous years. The rainfall for January 2025 was above average at 53.2mm as of the 21/01/2025, however as with other measures was not the highest on record, see Figure 12

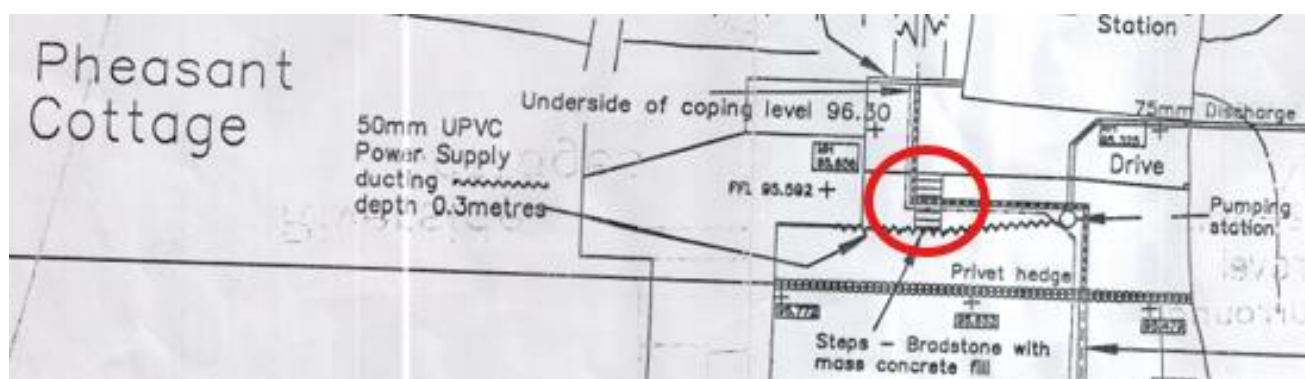
The defences installed as part of the North Witham Flood Alleviation Scheme in 2003 included walls and embankments to a level of 96.3m above sea level. These works were constructed on behalf of the Environment Agency but became the responsibility of the householders following completion of construction. These defences prevented the internal flooding of properties River Cottage and Riverside Cottages. Pheasant Cottage flooded internally however the defences for Pheasant Cottage appear to have been altered, with the removal of the “as built” access steps in the wall (as indicated in drawing number NJD 31128/02D- see appendix 1). The steps have been replaced by a demountable defence, which has a lower crest height than the flood wall. Considering no other properties flooded internally, it is reasonable to assert that a possible failure in this demountable defence, the possibility that it was overtopped or the possibility that the defence was not in place at the time of flooding is the cause of the internal flooding of Pheasant Cottage.

Figure 13: Excerpt from as built drawings showing steps detail at Pheasant Cottage

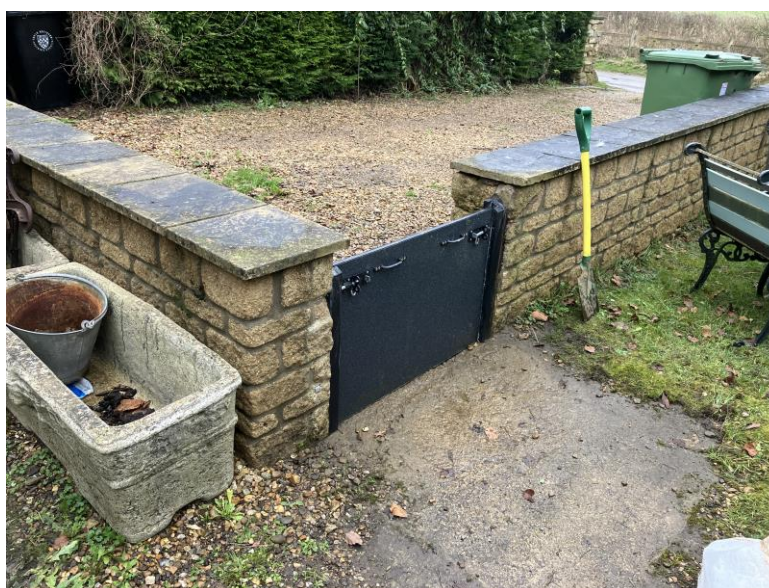
Figure 14: The demountable defence outside Pheasant Cottage that has replaced the steps as built in the original design. Provided by Environment Agency.

Internal flooding of the property called Pheasant Cottage was caused by the removal of the steps that were part of the “as built” defences. The steps were replaced with a demountable defence. The demountable defence is lower than the wall and it is unknown if it is watertight. It is unknown if the defence was in place at the time of flooding.

- Attempt to contact the homeowner of Pheasant Cottage regarding restoring the flood defences to as built condition.

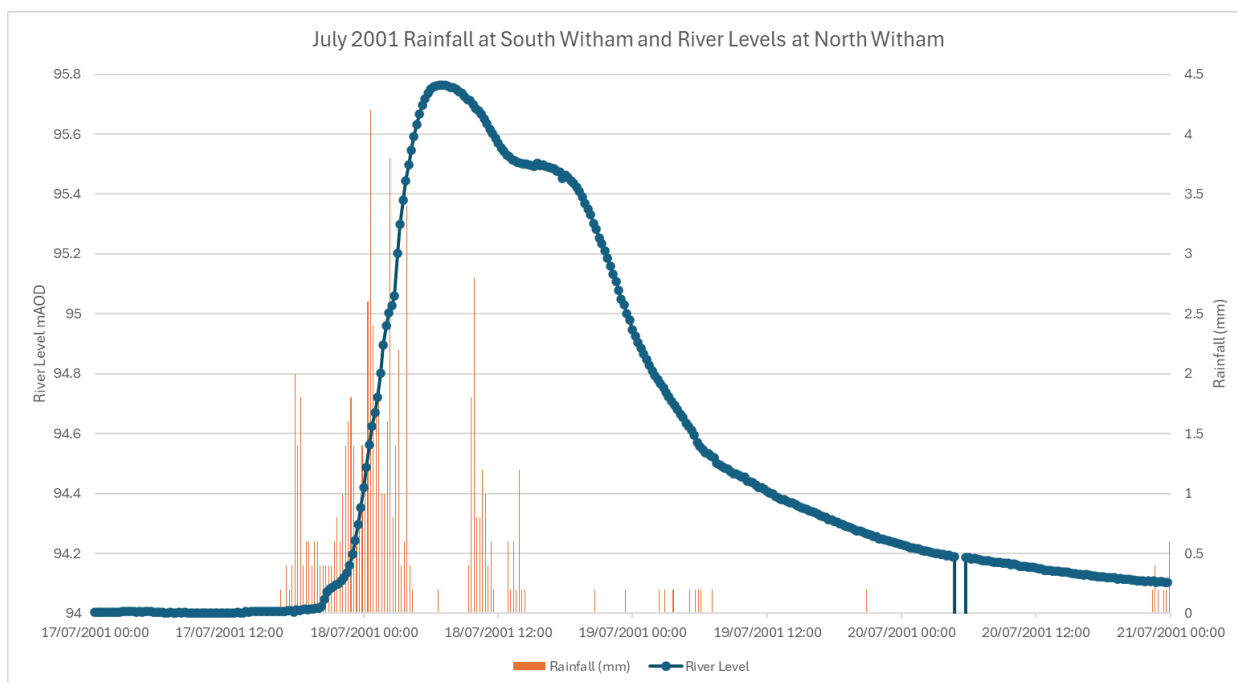
Figure 15: River Levels at North Witham and Rainfall at South Witham Gauges between 17/07/2001 and 21/07/2001.

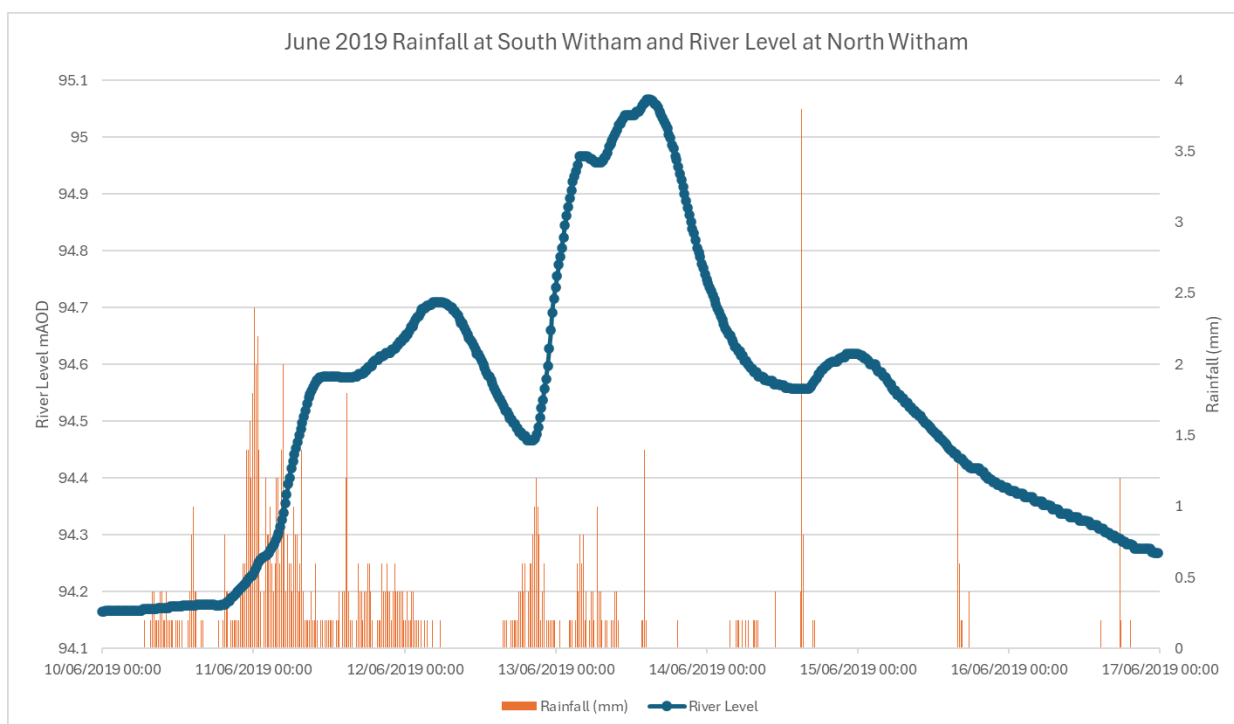
Figure 16: River Levels at North Witham and Rainfall at South Witham Gauges between 10/06/2019 and 17/06/2019.

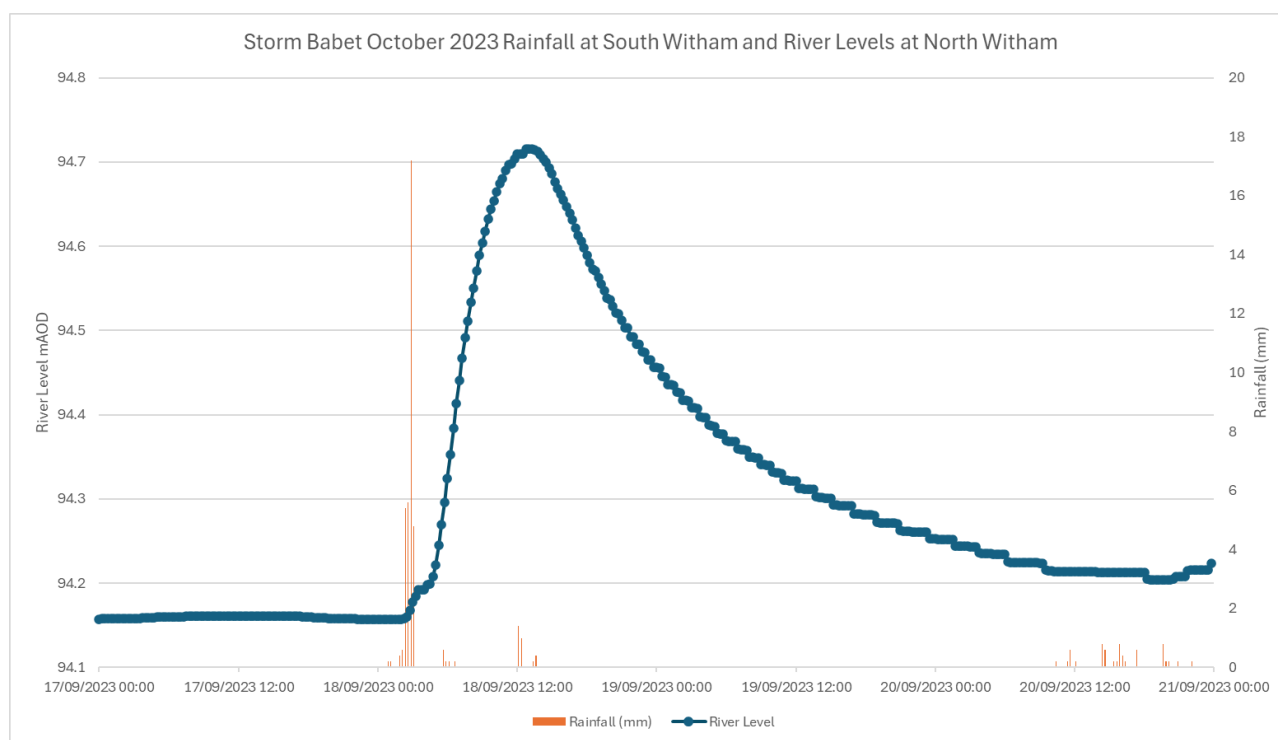
Figure 17: River Levels at North Witham and Rainfall at South Witham Gauges between 17/09/2023 and 21/09/2023.

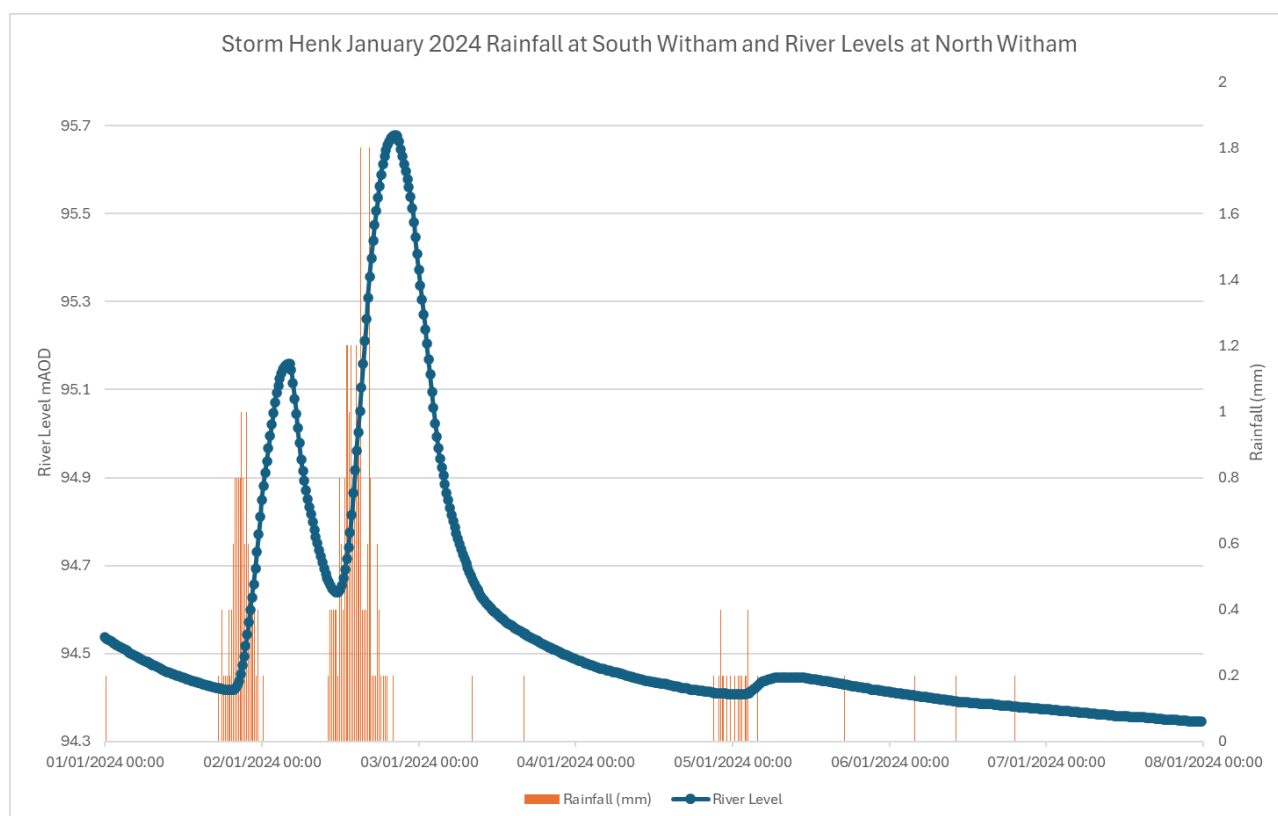
Figure 18: River Levels at North Witham and Rainfall at South Witham Gauges between 01/01/2024 and 08/01/2024.
