## Annual Inspection

Colsterworth & District Parish Council

North Witham Village Hall

Inspection Ref: 2184917

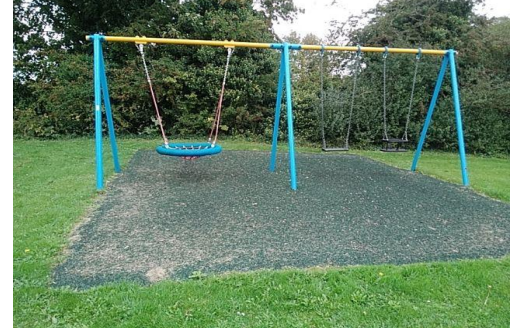
**Item:** 2 Bay Swing  
**Manufacturer:** Wicksteed Playgrounds  
**Surface Type:** EcoScape Softbond  
**Item Quantity:** 1  
**Equipment Compliance:** Yes  
**Surface Area Compliance:** Yes

Soft spots in the surfacing around the centre posts - Monitor

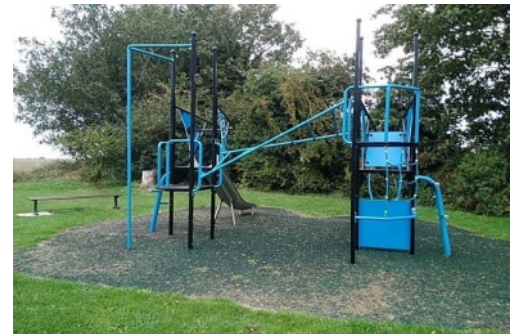
**Item:** Multi Play (Senior)  
**Manufacturer:** Wicksteed Playgrounds  
**Surface Type:** EcoScape Softbond  
**Item Quantity:** 1  
**Equipment Compliance:** Yes  
**Surface Area Compliance:** Yes

This item is satisfactory - no work required -

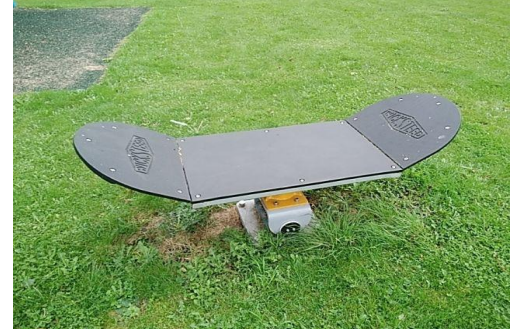
**Item:** See Saw  
**Manufacturer:** Wicksteed Playgrounds  
**Surface Type:** Grass  
**Item Quantity:** 1  
**Equipment Compliance:** No  
**Surface Area Compliance:** Yes

There is no identification label affixed to the equipment - Provide an identification label

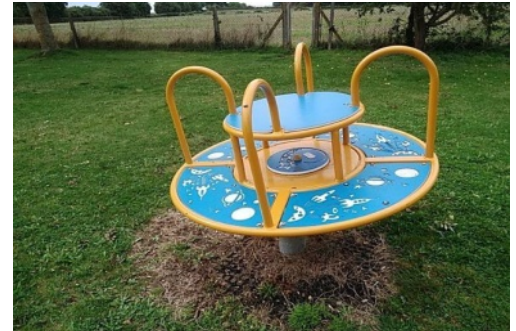
**Item:** Roundabout  
**Manufacturer:** Wicksteed Playgrounds  
**Surface Type:** Grass Matrix Tiles  
**Item Quantity:** 1  
**Equipment Compliance:** Yes  
**Surface Area Compliance:** Yes

This item is satisfactory - no work required -

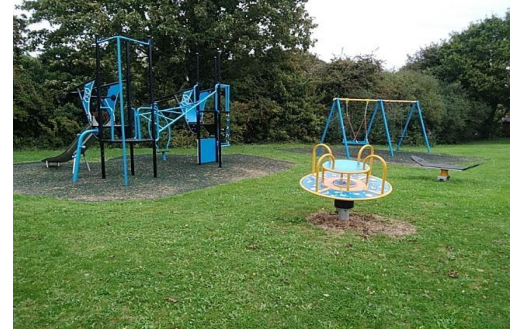
**Item:** Site General  
**Manufacturer:** Unknown  
**Surface Type:** Grass  
**Item Quantity:** 1  
**Equipment Compliance:** N/A  
**Surface Area Compliance:** N/A

It is recommended that signage, with information including the site address, contact information for maintenance issues and emergency contact details are provided for the facility - Provide in accordance with the recommendations

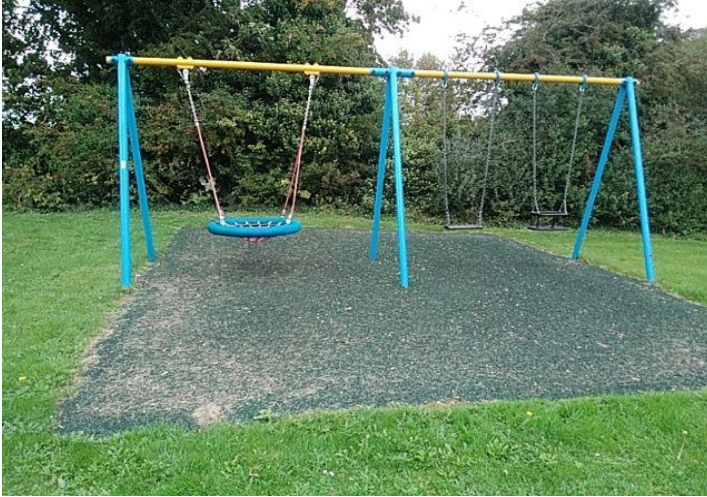
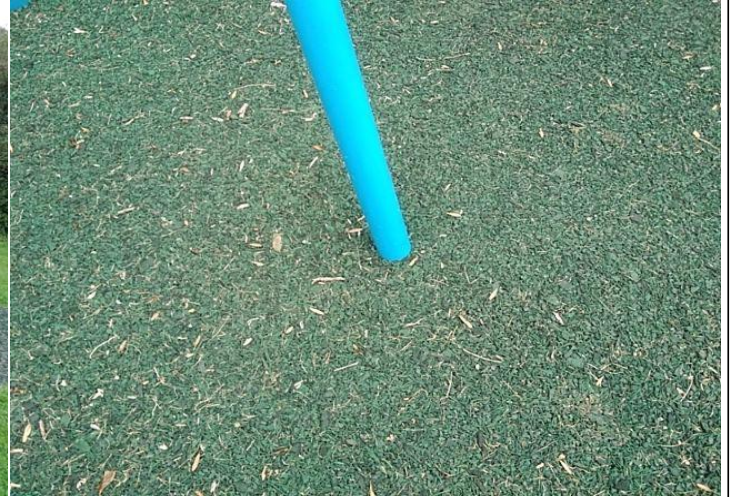
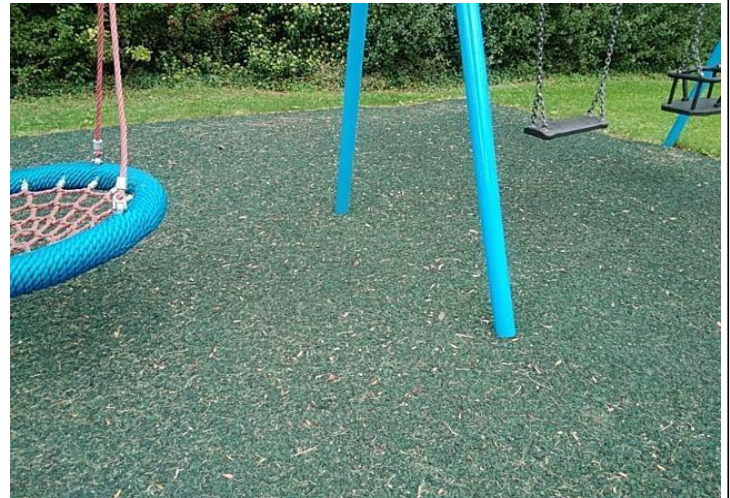
**Item:** Swings - 2 Bay Swing  
**Manufacturer:** Wicksteed Playgrounds

**Finding:** Soft spots in the surfacing around the centre posts **Action:** Monitor

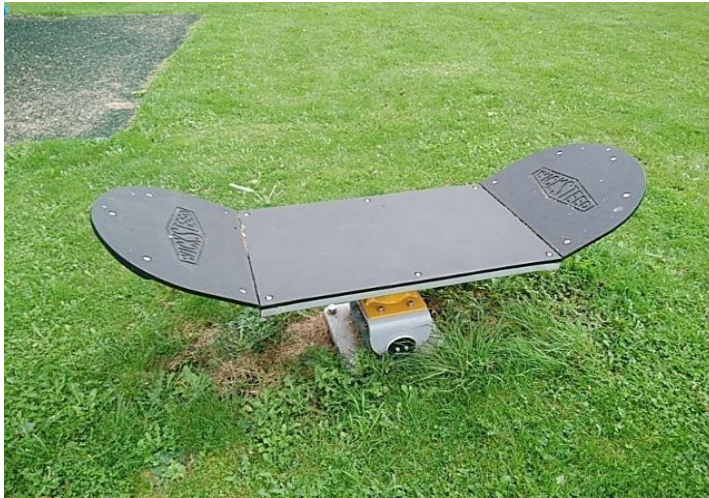
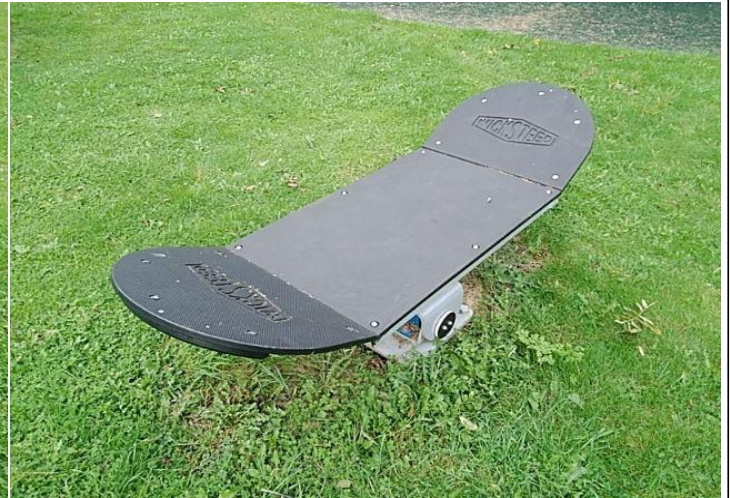
**Item:** Rocking Equipment - See Saw  
**Manufacturer:** Wicksteed Playgrounds

**Finding:** There is no identification label affixed to the equipment

**Action:** Provide an identification label

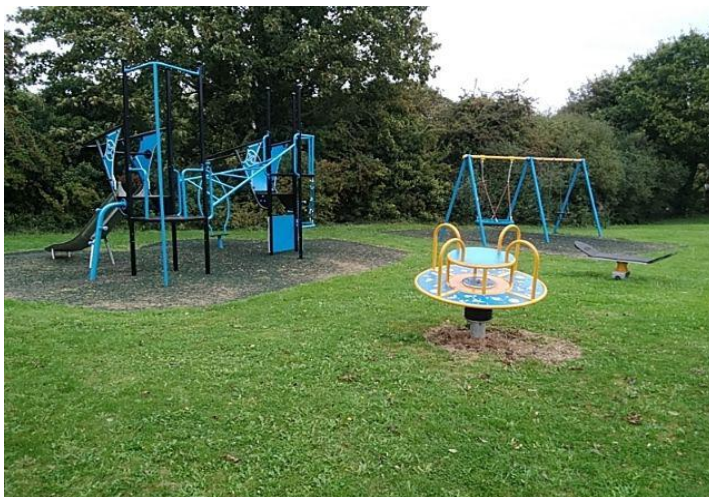
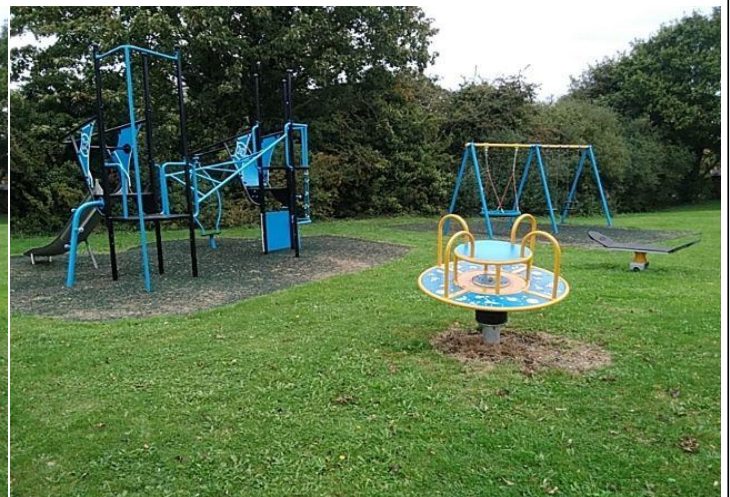
**Item:** Ancillary Items - Site General  
**Manufacturer:** Unknown

**Finding:** It is recommended that signage, with information including the site address, contact information for maintenance issues and emergency contact details are provided for the facility

**Action:** Provide in accordance with the recommendations
