Annual Inspection

Colsterworth & District Parish Council

Woolsthorpe By Colsterworth Play Area

Woolsthorpe Road, Woolsthorpe By Colsterworth, NG33
5NU

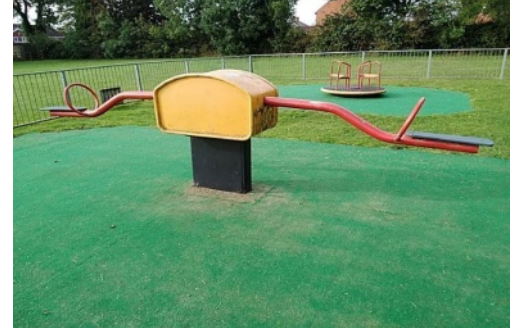
Item: See Saw
Manufacturer: Wicksteed Playgrounds
Surface Type: Notts Sports
Item Part Number: Jolly Gerald
Item Quantity: 1
Equipment Compliance: N/A
Surface Area Compliance: N/A
Total Findings: 1

This item is satisfactory - no work required -

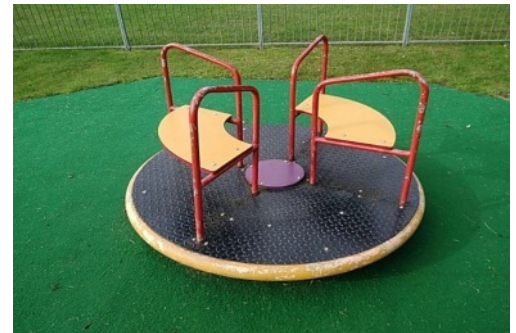
Item: Roundabout
Manufacturer: Wicksteed Playgrounds
Surface Type: Notts Sports
Item Quantity: 1
Equipment Compliance: N/A
Surface Area Compliance: N/A
Total Findings: 1

This item is satisfactory - no work required -

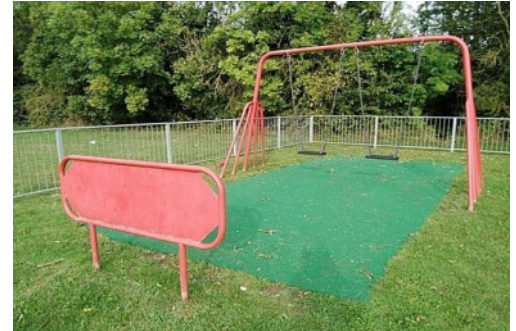
Item: 1 Bay 2 Seat (Flat)
Manufacturer: Wicksteed Playgrounds
Surface Type: Notts Sports
Item Part Number: 2.3m Arch Swing
Item Quantity: 1
Equipment Compliance: N/A
Surface Area Compliance: N/A
Total Findings: 1

This item is satisfactory - no work required -

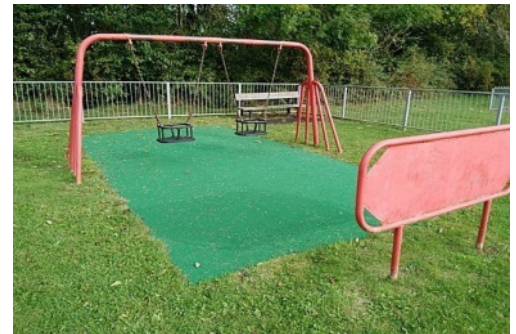
Item: 1 Bay 2 Seat (Cradle)
Manufacturer: Wicksteed Playgrounds
Surface Type: Notts Sports
Item Part Number: 1.7m Arch Swing
Item Quantity: 1
Equipment Compliance: N/A
Surface Area Compliance: N/A
Total Findings: 1

This item is satisfactory - no work required -

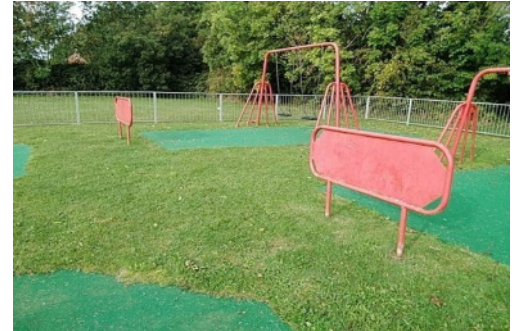
Item: Swing Barrier
Manufacturer: Wicksteed Playgrounds
Surface Type: Grass
Item Part Number: Swing barriers
Item Quantity: 2
Equipment Compliance: N/A
Surface Area Compliance: N/A
Total Findings: 1

This item is satisfactory - no work required -

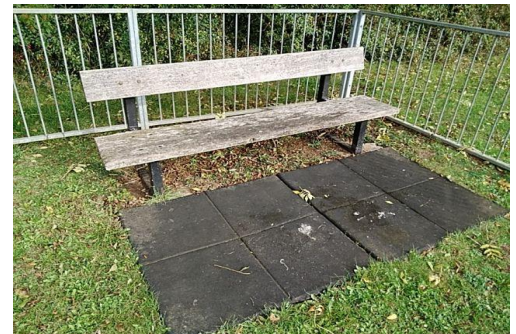
Item: Seat
Manufacturer: Wicksteed Playgrounds
Surface Type: Rubber Tiles
Item Quantity: 1
Equipment Compliance: N/A
Surface Area Compliance: N/A
Total Findings: 2

Minor damage to 1 timber seat slat. - Monitor - replace as required.

Raised edges of the rubber tiles may create trip hazards. - Grounds maintenance as required to provide a sound and reasonably level surface.

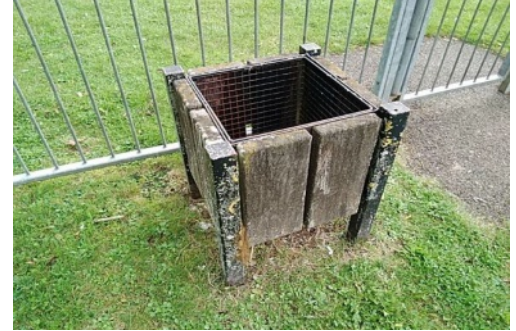
Item: Litter Bin
Manufacturer: Wicksteed Playgrounds
Surface Type: Grass
Item Quantity: 1
Equipment Compliance: N/A
Surface Area Compliance: N/A

This item is satisfactory - no work required -

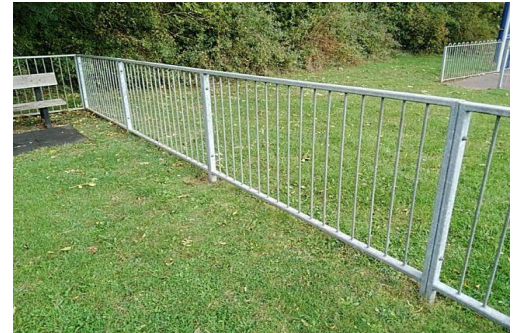
Item: Fencing - Flat Top
Manufacturer: Unknown
Surface Type: Grass
Item Quantity: 1
Equipment Compliance: N/A
Surface Area Compliance: N/A

1 upright is slightly bent - Monitor

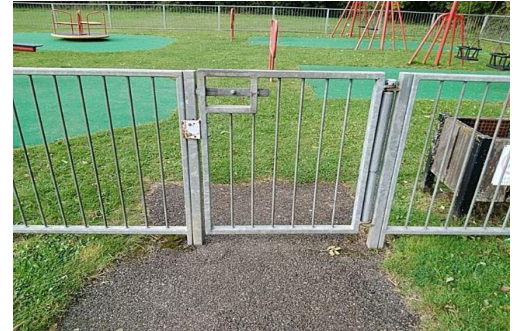
Item: Gate - Self Closing
Manufacturer: Unknown
Surface Type: Tarmac
Item Quantity: 1
Equipment Compliance: N/A
Surface Area Compliance: N/A

The sliding bolt does line up with the slot in the post due to the thickness of the rubber bump stop. - Monitor - rework as required.

The gate is closing too quickly (less than 4 seconds) - Take corrective action to ensure that the gate closes in 4-8 seconds

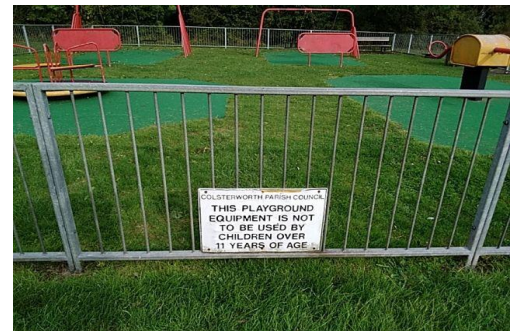
Item: Playground Sign
Manufacturer: Unknown
Surface Type: N/A
Item Quantity: 1
Equipment Compliance: N/A
Surface Area Compliance: N/A

It is recommended that signage, with information including the site address, contact information for maintenance issues and emergency contact details are provided for the facility - Provide in accordance with the recommendations

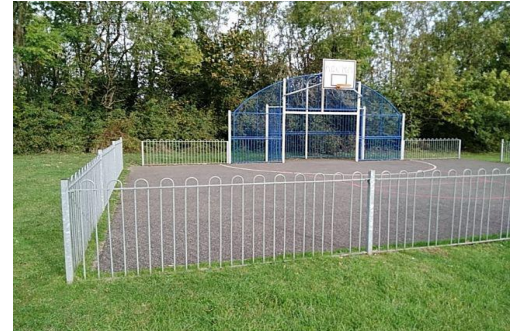
Item: Multi Use Games Area (MUGA)
Manufacturer: Unknown
Surface Type: Tarmac
Item Quantity: 1
Equipment Compliance: N/A
Surface Area Compliance: N/A

4 fence panels have missing uprights - Replace the damaged fence panels.

There are post / end caps missing from the item - Replace missing post caps

A clearly visible facility sign should be provided in a prominent position with the wording as detailed BS EN 15312- the equipment is not intended for children less than 3 years old- the warning - Do not climb on the framework or nets- the warning - Do not hang on the ring (if provided)- the warning - Do not wear rings or other jewellery- name and telephone number of the administrator- number to call in case of accident - Provide signage to BS EN 15312

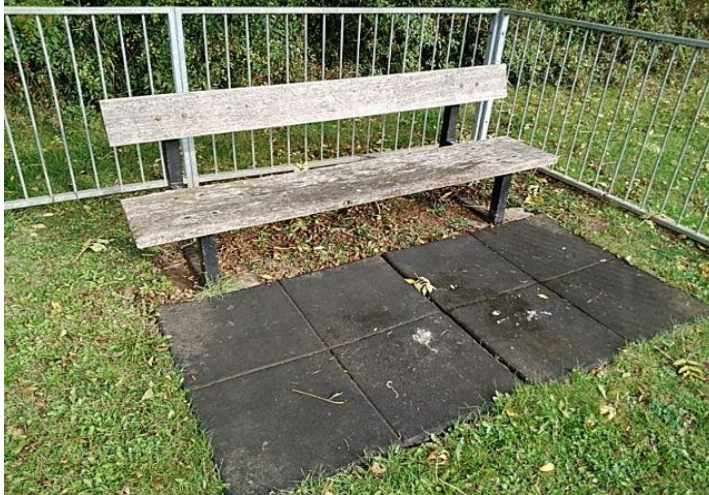
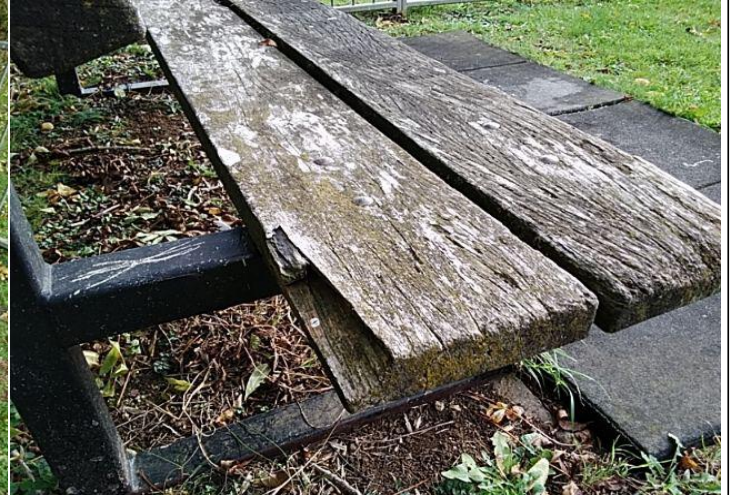
Item: Ancillary Items - Seat
Manufacturer: Wicksteed Playgrounds

Finding: Minor damage to 1 timber seat slat.

Action: Monitor - replace as required.

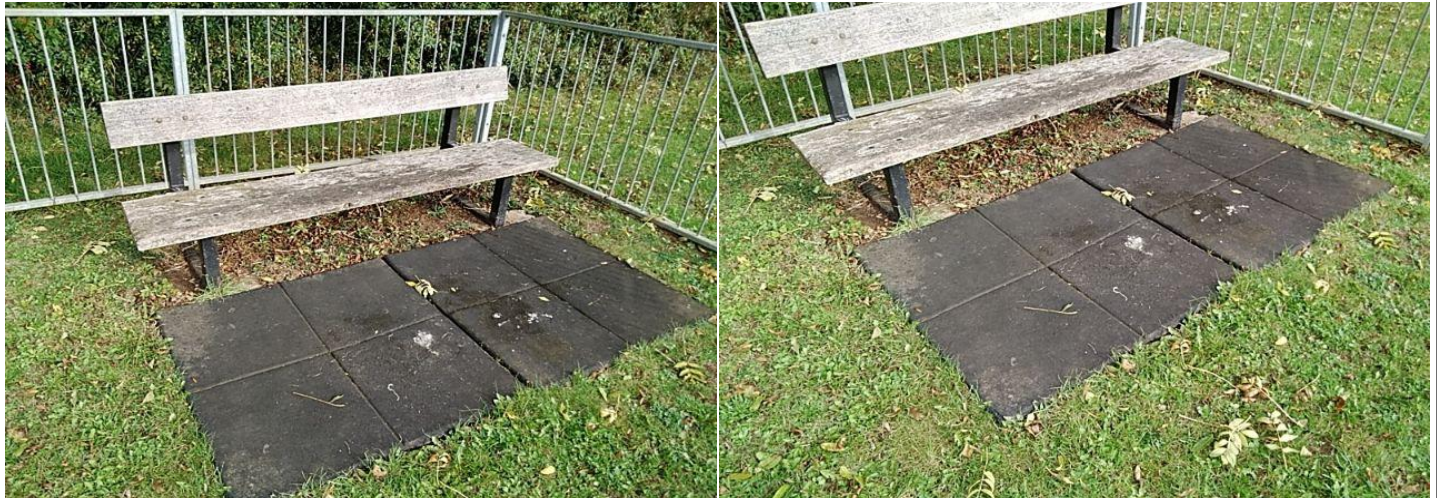
Item: Ancillary Items - Seat
Manufacturer: Wicksteed Playgrounds
Risk Level: L - Low Risk
Surface: Rubber Tiles

Finding: Raised edges of the rubber tiles may create trip hazards.
Action: Grounds maintenance as required to provide a sound and reasonably level surface.

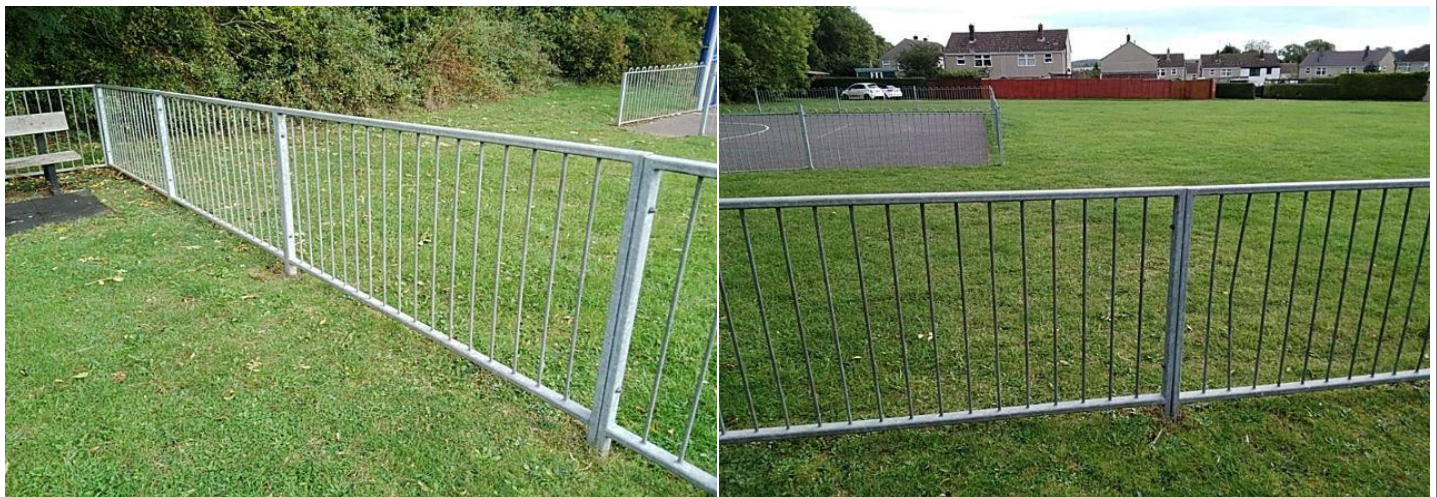
Item: Fences - Fencing - Flat Top
Manufacturer: Unknown
Risk Level: V - Very Low Risk
Surface: Grass

Finding: 1 upright is slightly bent
Action: Monitor

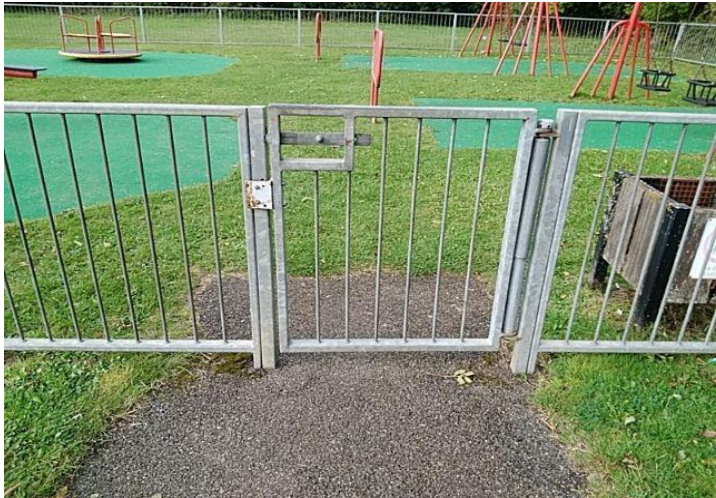
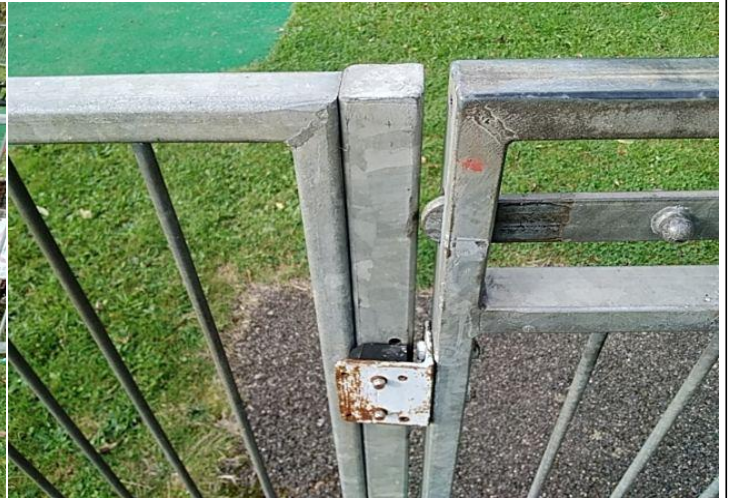
Item: Gates - Gate - Self Closing
Manufacturer: Unknown

Finding: The sliding bolt does not line up with the slot in the post due to the thickness of the rubber bump stop.

Action: Monitor - rework as required.

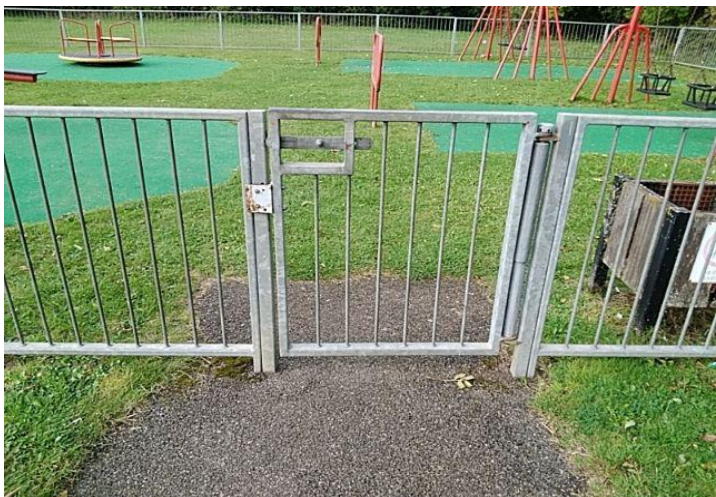
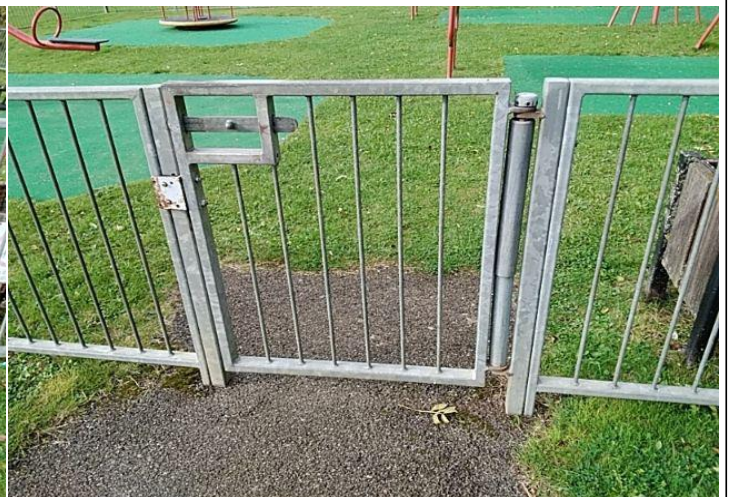
Item: Gates - Gate - Self Closing
Manufacturer: Unknown

Finding: The gate is closing too quickly (less than 4 seconds)

Action: Take corrective action to ensure that the gate closes in 4-8 seconds

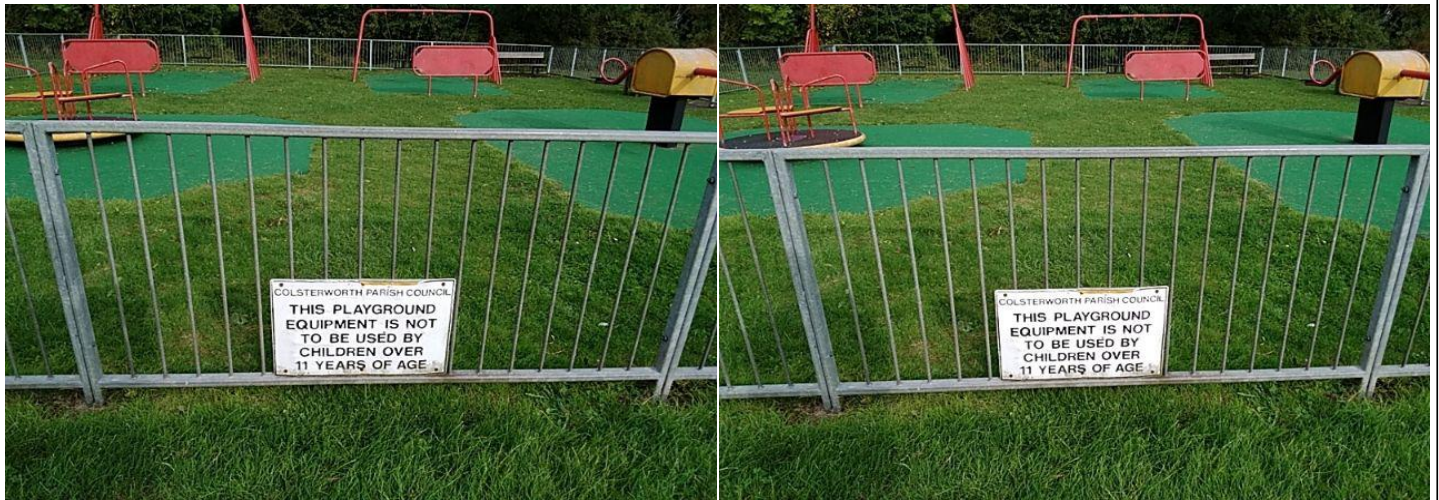
Item: Signs - Playground Sign
Manufacturer: Unknown

Finding: It is recommended that signage, with information including the site address, contact information for maintenance issues and emergency contact details are provided for the facility

Action: Provide in accordance with the recommendations

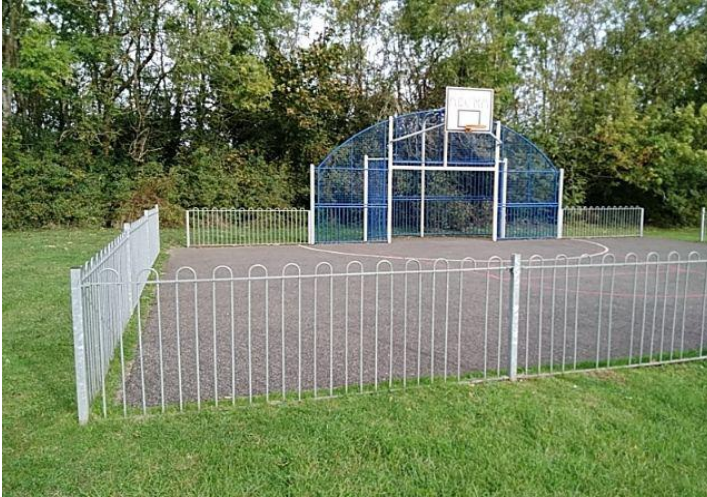
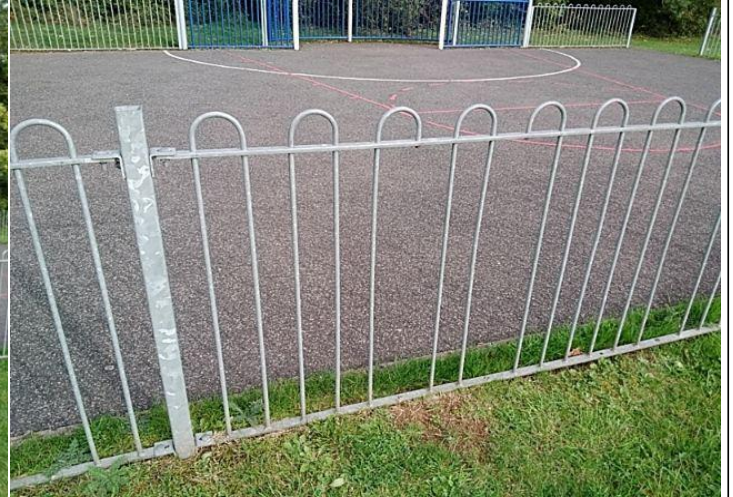
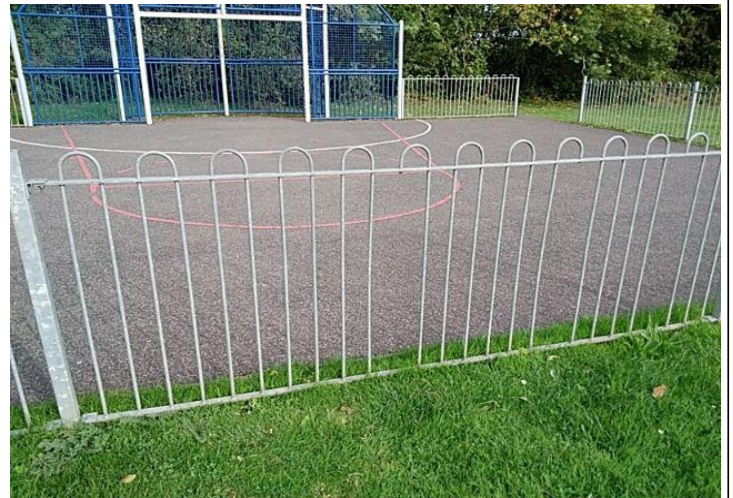
Item: Multi Use Games Area - Multi Use Games Area (MUGA)

Finding: 4 fence panels have missing uprights

Action: Replace the damaged fence panels.

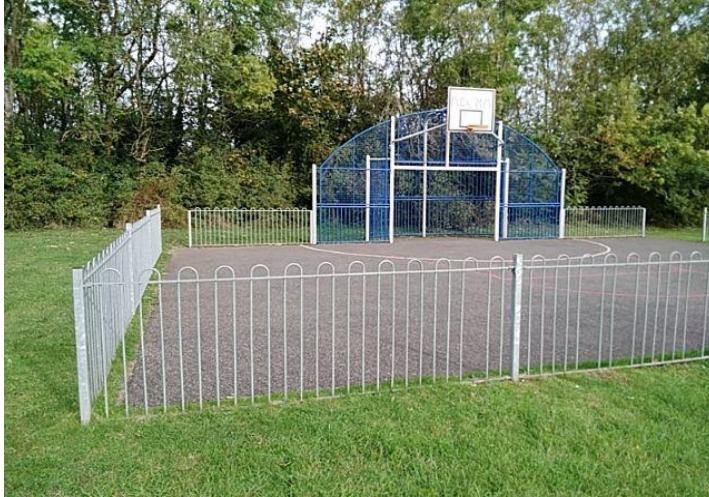
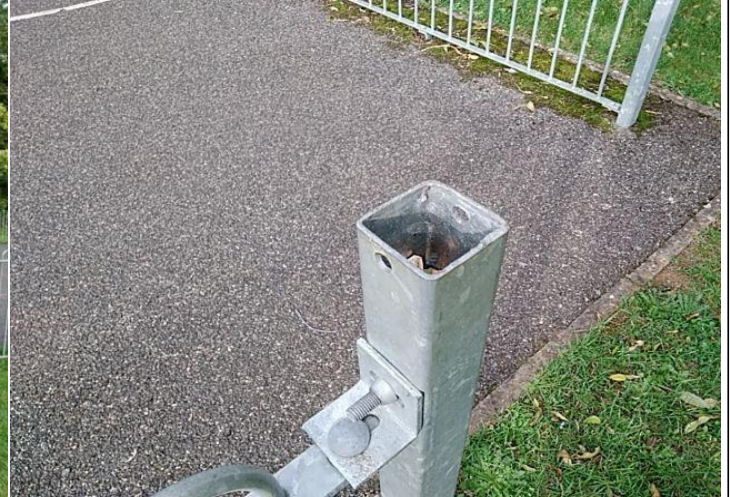
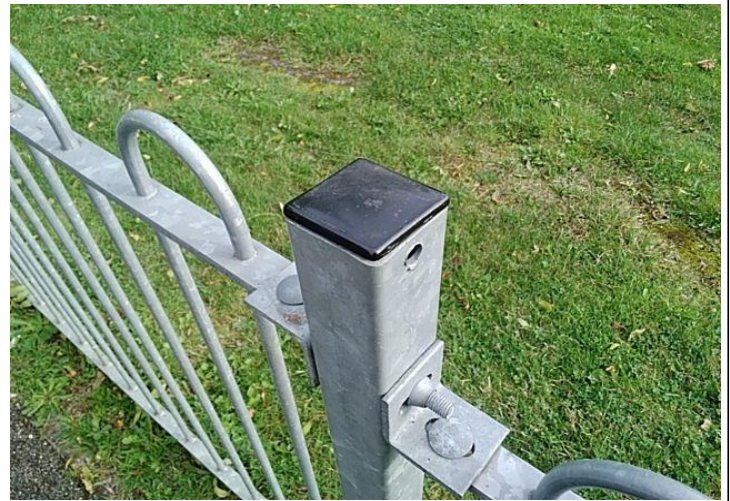
Item: Multi Use Games Area - Multi Use Games Area (MUGA)

Finding: There are post / end caps missing from the item

Action: Replace missing post caps

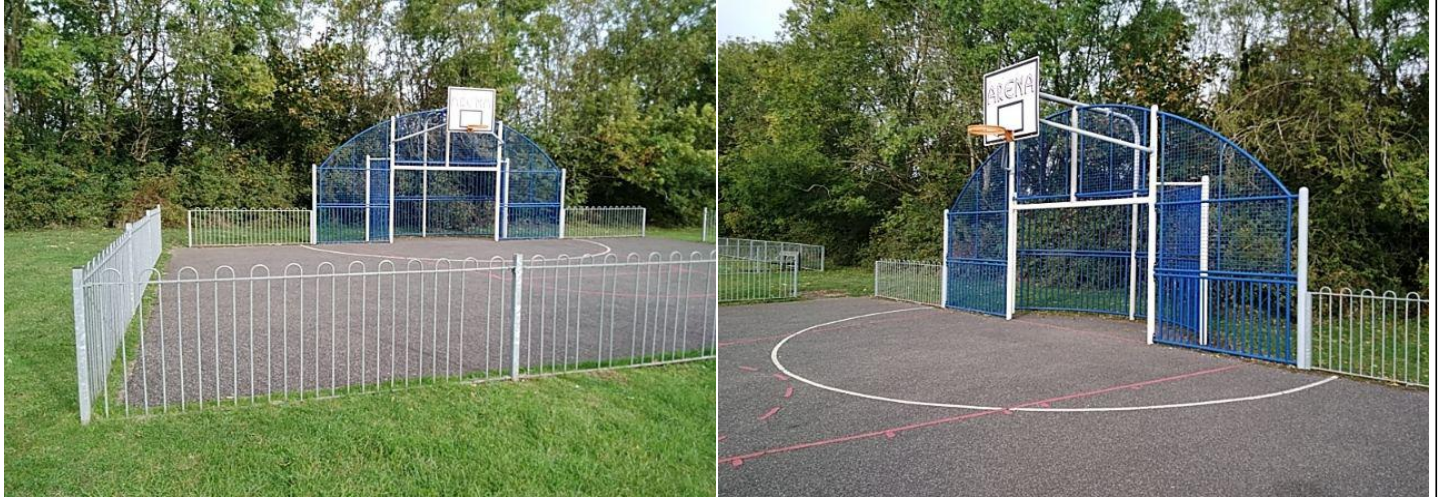
Item: Multi Use Games Area - Multi Use Games Area (MUGA) **Risk Level:** V - Very Low Risk
Manufacturer: Unknown **Surface:** Tarmac

Finding: A clearly visible facility sign should be provided in a prominent position with the wording as detailed BS EN 15312- the equipment is not intended for children less than 3 years old- the warning - Do not climb on the framework or nets- the warning - Do not hang on the ring (if provided)- the warning - Do not wear rings or other jewellery- name and telephone number of the administrator- number to call in case of accident

Action: Provide signage to BS EN 15312
