## COLSTERWORTH WAR MEMORIAL RESTORATION EXHIBITION

THE RESTORATION WAS COMPLETED IN SEPTEMBER 2024. the Parish Council and Colsterworth Festival of Remembrance wish to thank all those who donated and supported the restoration project

**STARTED WEEK COMMENCING 10<sup>TH</sup> JUNE 2024**

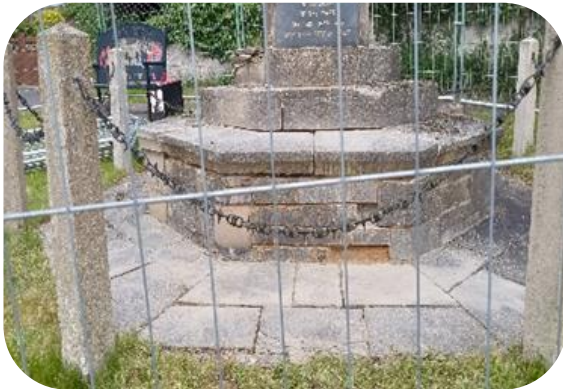
**14/06/2024 - Work starts on scraping out the old mortar.**

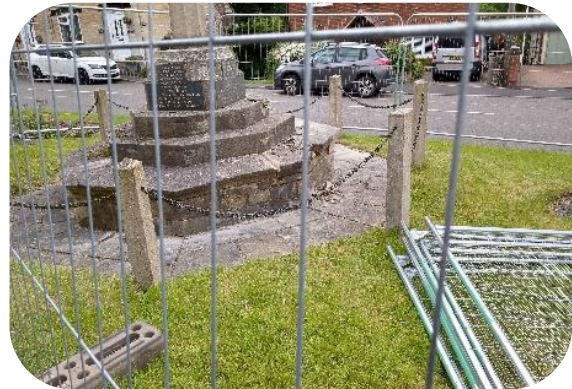
**14/06/2024 - The work has to be done by hand tools only.**

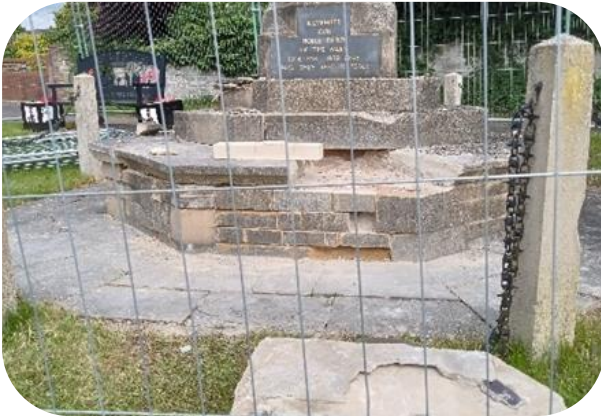
**18/06/2024 - The interior of the base is very wet internally which affects the stones. The Architect has agreed that all the slabs to Step 1 will be removed together to allow the structure to dry out.**

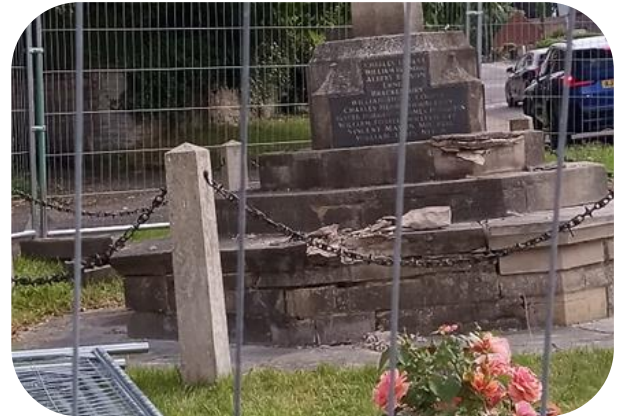
**18/06/2024  
Deterioration of the slabs can be clearly seen.**

**Email received from the Architect PPIY advising that additional works had been identified by Pinnacle Conservation Ltd of £3,266.35.**

**The base of the memorial has deteriorated further since the works were specified which has led to this additional work becoming necessary. The architect recommended acceptance of the additional work as it was within the contingency amount which has been allowed in the contract.**

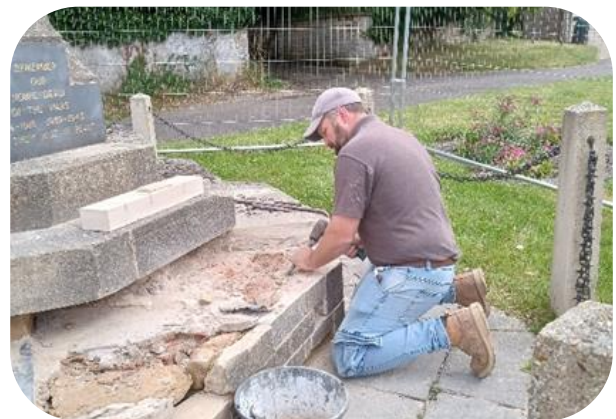
**02/07/2024 - A contractor using hand tools to carefully remove stones and concrete from the interior of the base of the War Memorial.**

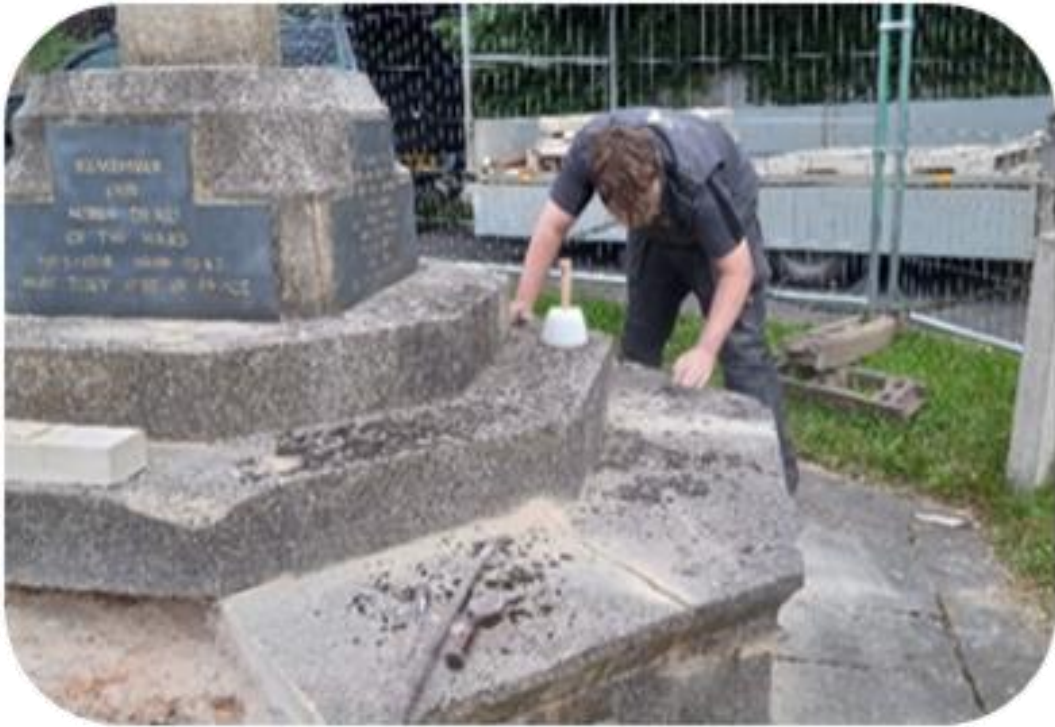
**02/07/2024 - A contractor carefully removing old pointing and rubble.**

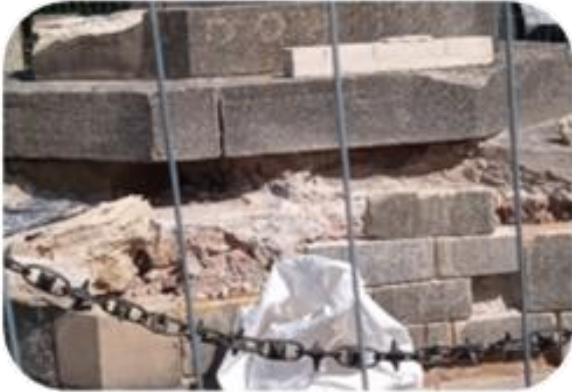
**18/07/2024 - Work continues on removing the old pointing and concrete.**

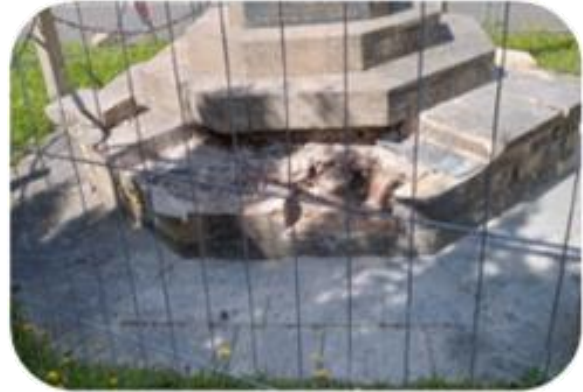
**18/07/2024 - The inside of the structure is drying out.**

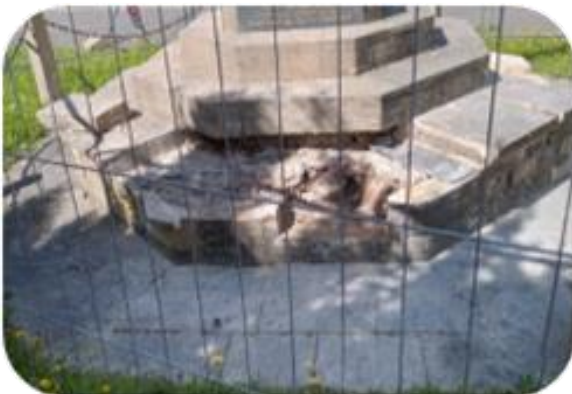
**23/07/2024 - The old stones have been cleaned in readiness for the new stones to be put in place.**

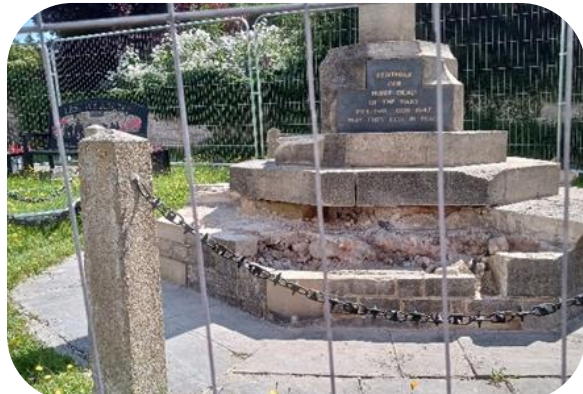
**23/07/2024 - The inside of the structure can be clearly seen having dried out.**

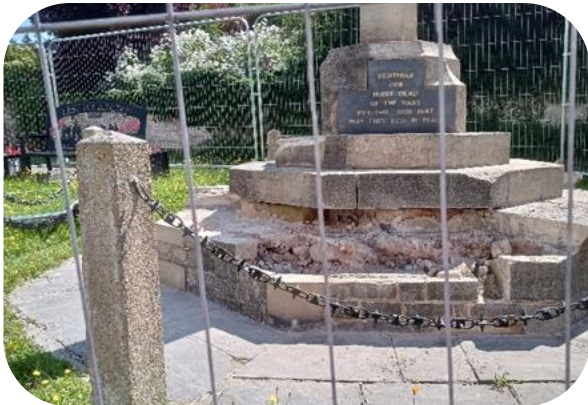
**23/07/2024 - The loose mortar and old stones have been removed.**

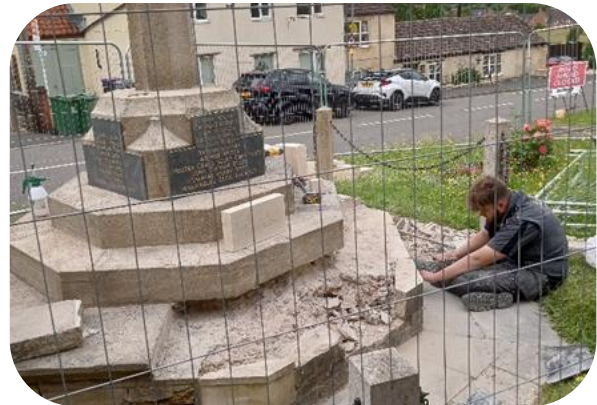
**25/07/2024 - A contractor continuing to carefully scraping out old pointing.**

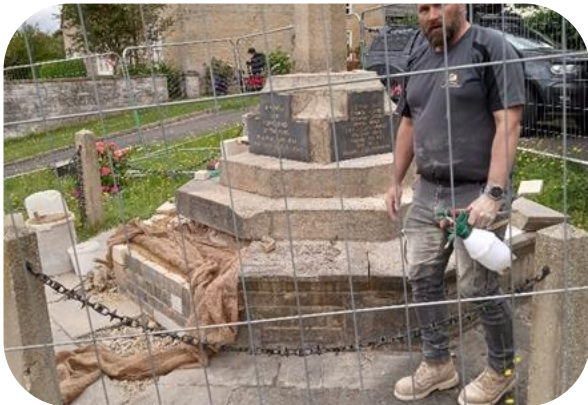
**25/07/2024 - Specialist cleaning of the existing stones before the new stones are laid.**

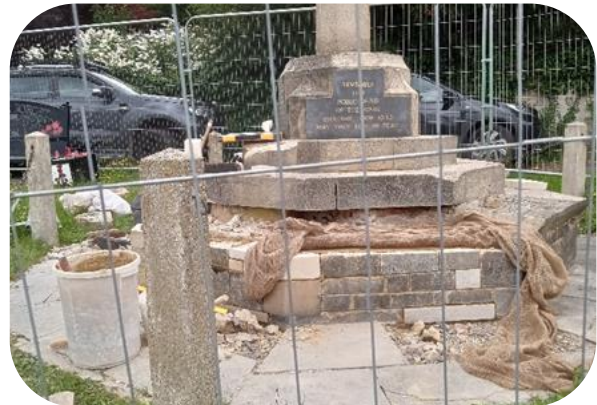
**25/07/2024 - Specialist cleaning of the War Memorial from another angle.**

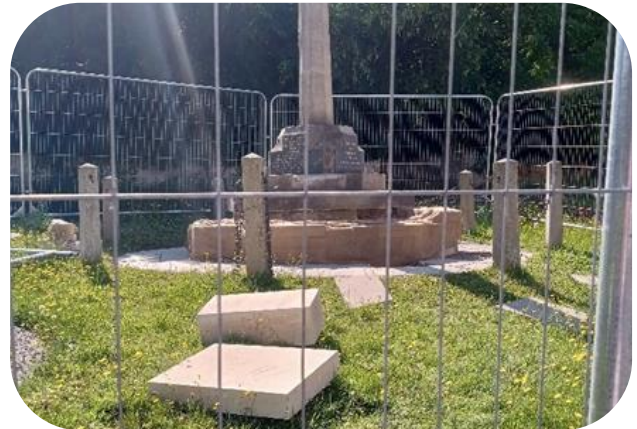
**29/07/2024 - New stones are laid on the grass ready for carefully being placed onto the War Memorial.**

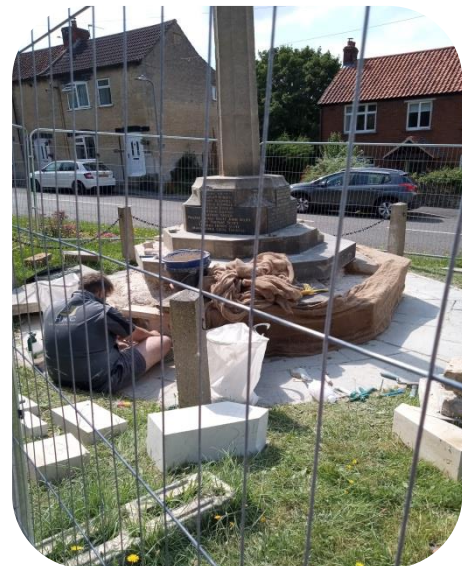
**31/07/2024 - Contractor carefully replacing some pointing.**

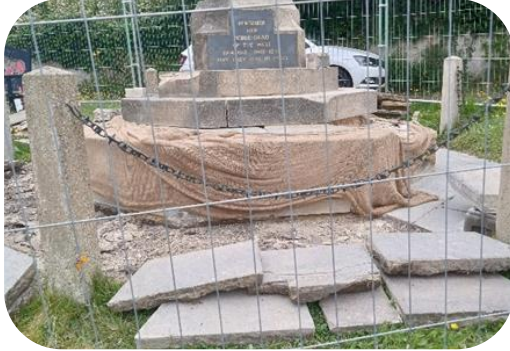
**05/08/2024 - The bottom slabs have been removed so the ground can be levelled before they are replaced.**

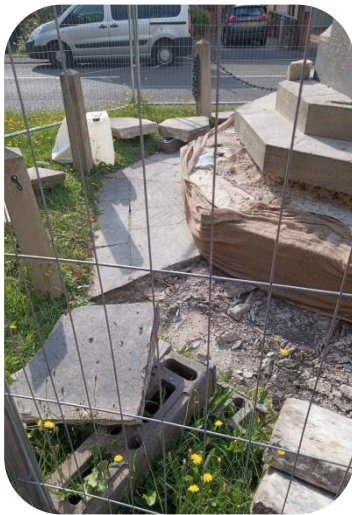
**06/08/2024 - Levelling of the ground before replacing the bottom slabs.**

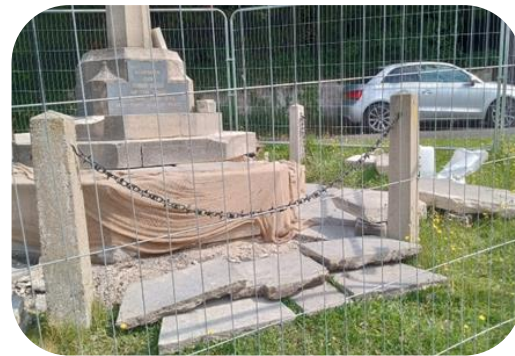
**12/08/2024 - All the bottom slabs have carefully been removed for the ground to be levelled.**

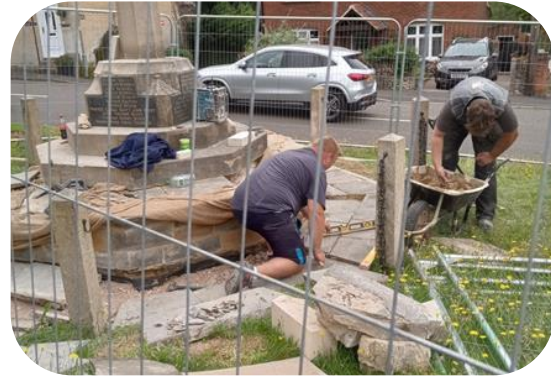
**14/08/2024 - Contractors levelling the ground using a spirit level.**

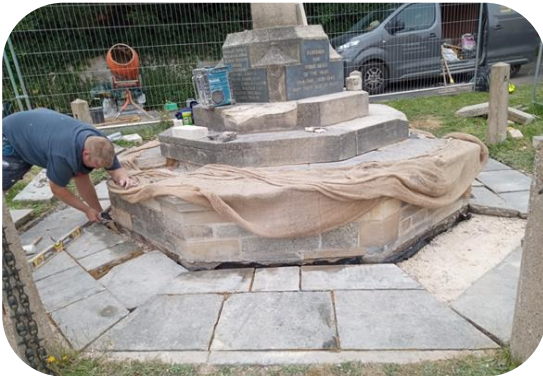
**14/08/2024 - Levelling of the ground using a spirit level whilst work continues in the contractors work shop to cut the replacement stones to size.**

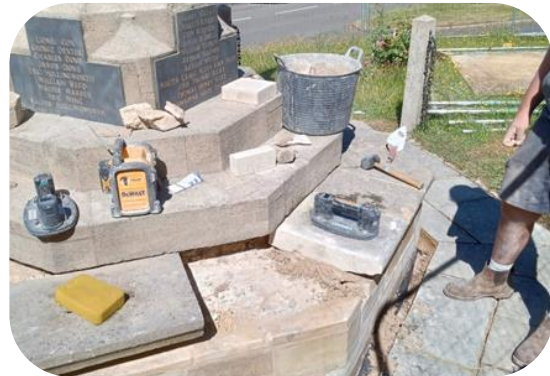
**16/08/2024 - Coping stones being carefully replaced using a suction tool to accurately place the coping stone in the correct position.**

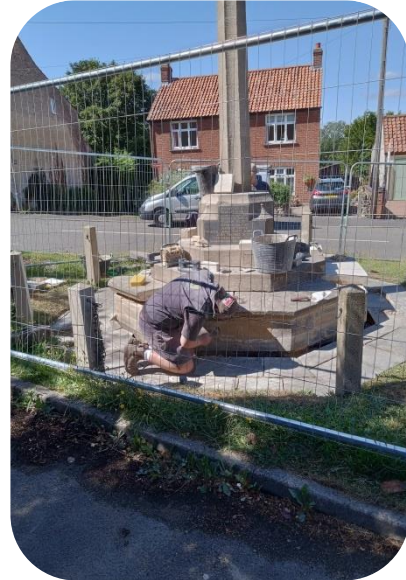
**16/08/2024 - New bricks and old bricks being set and pointed**

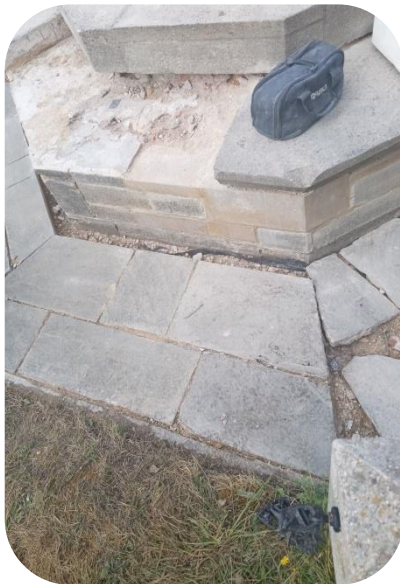
**20/08/2024 - The old damaged coping stone has been removed and awaiting the new coping stone to be fitted.**

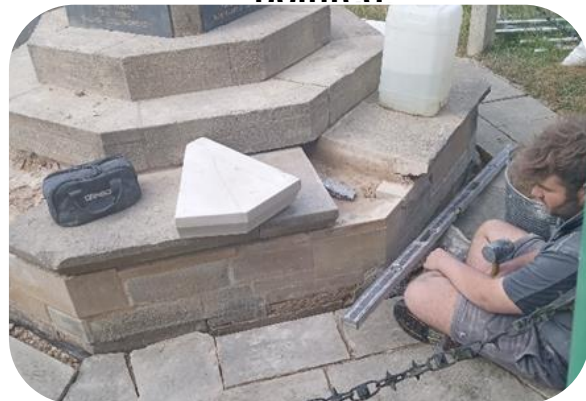
**20/08/2024 - A new coping stone is cut and ready to be carefully placed by the contractor. The grabber suction tool can be seen to assist placing the stone.**

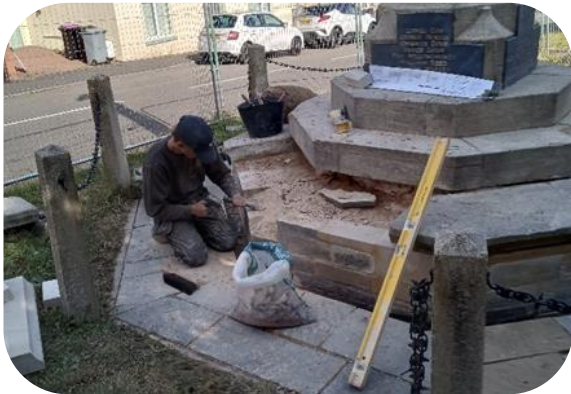
**23/08/2024 - Work continues to replace the coping stones. The restoration work is intricate using geometric principles.**

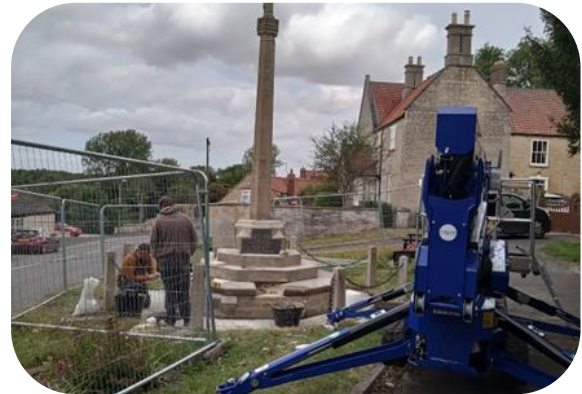
**29/08/2024 - A cherry picker is ready to enable the contractors to apply the shelter coating to the top cross.**

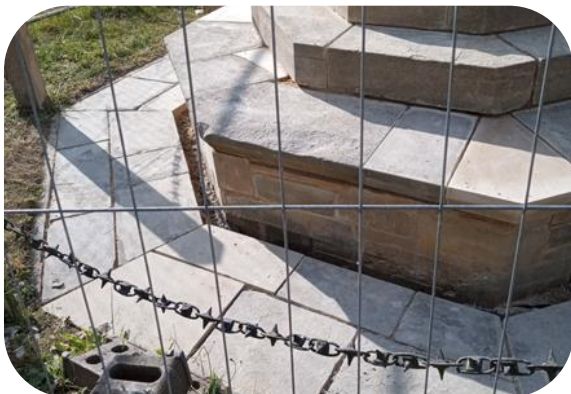
**30/08/2024 - The slabs at the base of the War Memorial have been re-set. A small channel has been left between the bottom slabs and the War Memorial for natural drainage.**

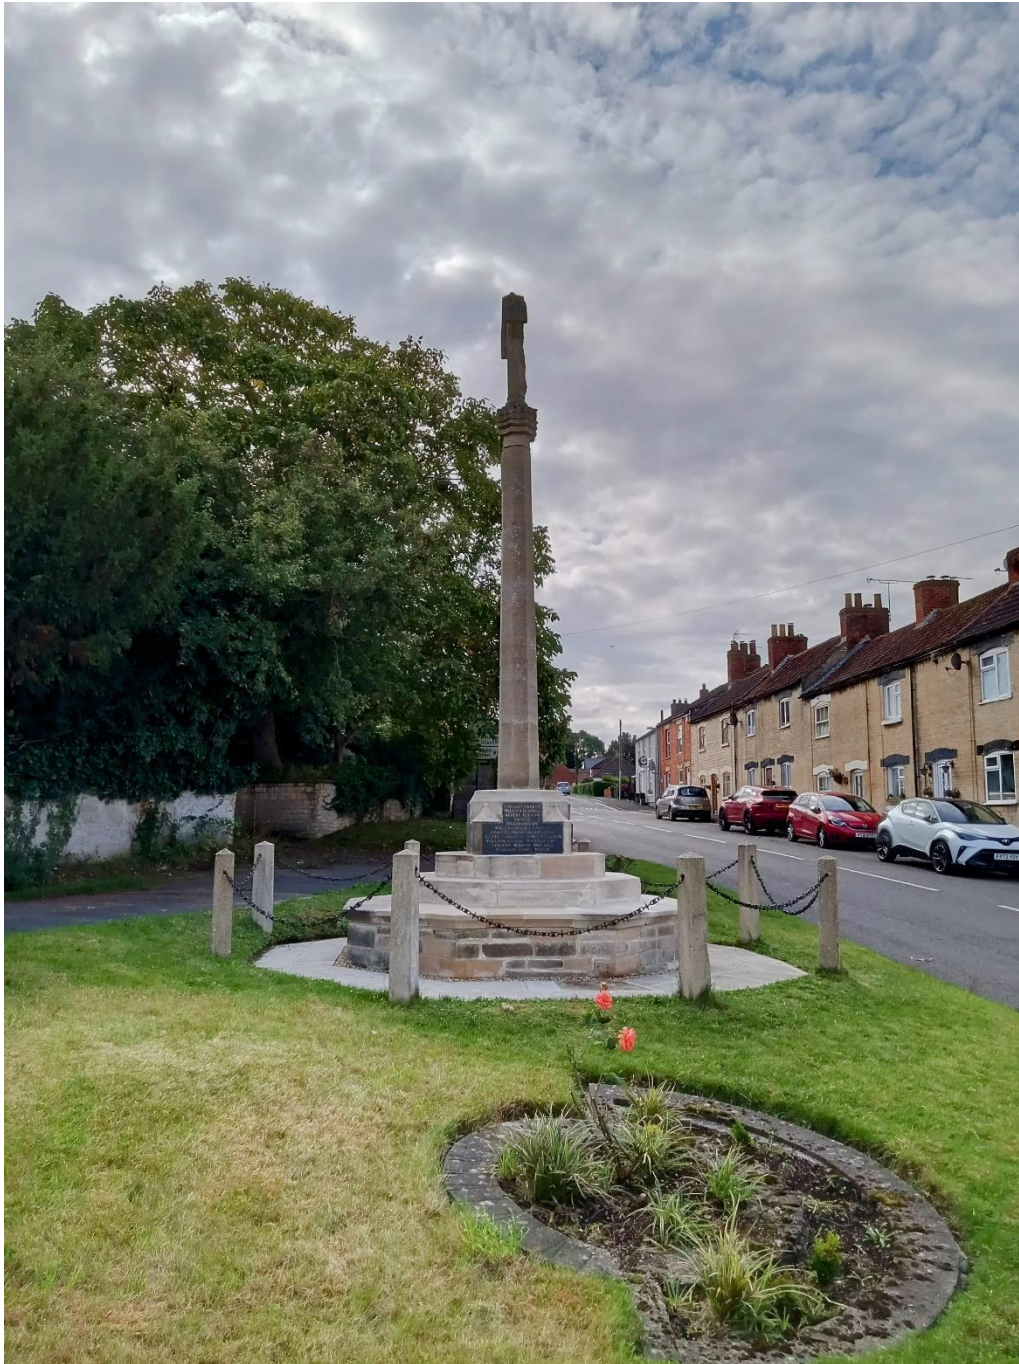
**Completion of Colsterworth War Memorial Restoration 12/09/2024.**
