# **COLSTERWORTH WAR MEMORIAL 13/6/24**

Thursday 13 June 2024

14 Issues Identified

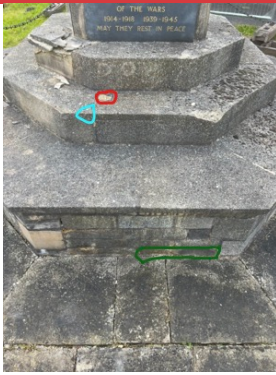
### **SIDE A (WEST)**

Everything matches the drawing except the two listed items

- Circled in red is a weathered section in the top of the stone
- circled in blue is a crack that runs through the corner of the stone
- Stone a3 circled in green is being repair to the length of 434 mm instead of 260 due to damage

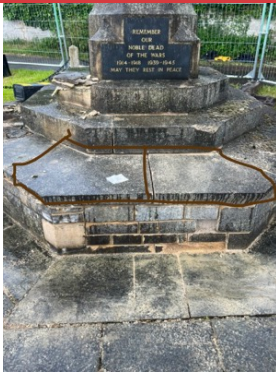
### **COPPING ON SIDE A**

All copings on side a have had the mortar in the joints broken out so they are loose to remove from the momentum when needed

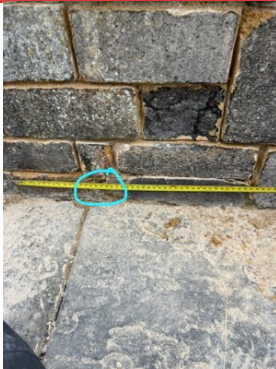
### **SIDE A CHANGES**

Stone a3 circled in green is being repair to the length of 434 mm instead of 260 mm due to damage on the left hand side

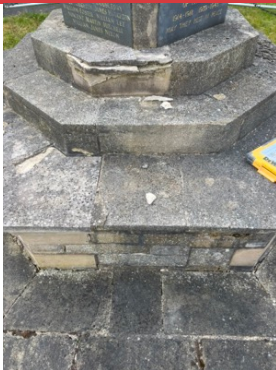
### **SIDE B (NORTHWEST)**

Everything matches the drawings

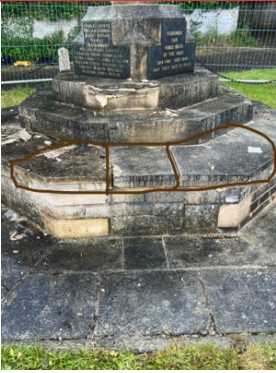
### **COPPINGS ON SIDE B**

All 3 coping on side b have had the mortar broken out of the joints to be removed from the monument when needed to be.

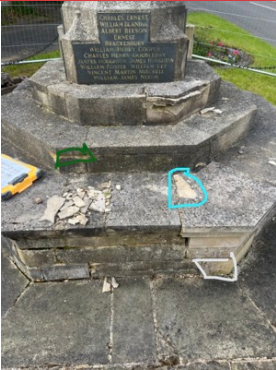
### **SIDE C (NORTH)**

Everything matches drawings except 3 listed below

- circled in green weatherd front face to stone
- circled in blue top of the stone has been weatherd
- Circled in grey the crack from side b is returning through the stone on side c

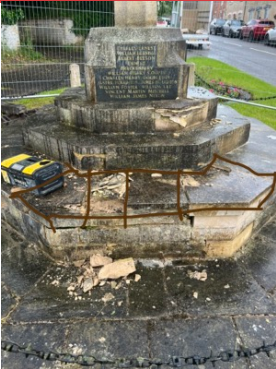
### **COPPING STONES ON SIDE C**

All the coping stones on side c have had the mortar broken out of the joints so they can be removed from the monument when removing the damp proof layering in the bed joint

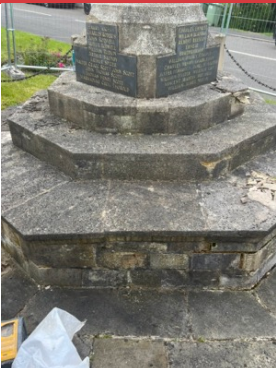
### **SIDE D (NORTH EAST)**

Everything matches with the drawing

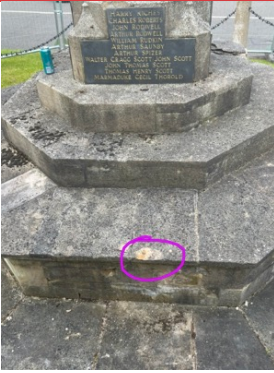
### **SIDE E (EAST)**

Everything matches with drawing except listed

- circled in purple stone top has weathers away

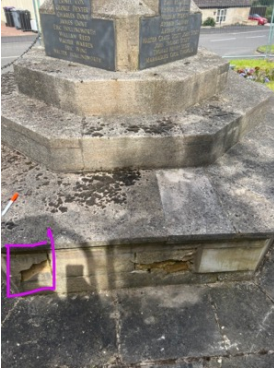
### **SIDE F (SOUTH EAST)**

Everything matches the drawing except listed below

- circled purple have face falling of and cracks through

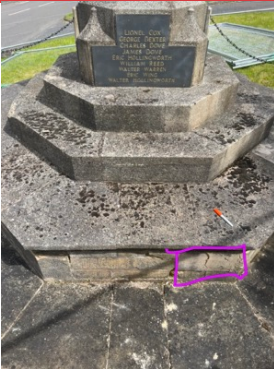
### **SIDE G (SOUTH)**

Everything matches drawings except the circled purple the face is falling off the stone and cracks running through

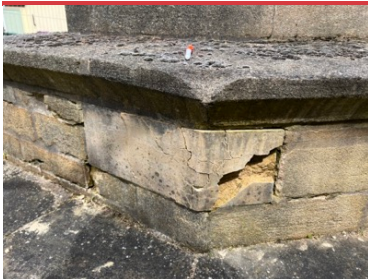
### **SIDE G STONE REPLACEMENT (NOT ON DRAWINGS)**

This stone isn't down to be replaced on the drawing but should be

The dims as follows-

Length-500 mm

Width-200mm

Height 210 mm

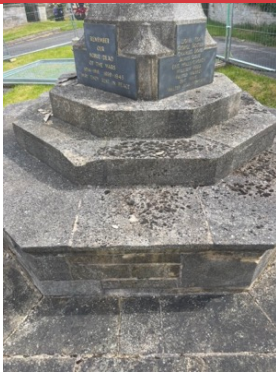
## **SIDE H (SOUTHWEST)**

Everything matches with drawings
