# the **play inspection** company

## Annual Inspection

Colsterworth & District Parish Council

Colster Way Play Area

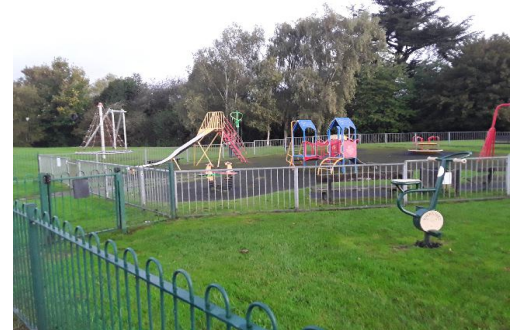
**Item:** Site General  
**Manufacturer:** Not Applicable  
**Surface Type:** N/A  
**Item Quantity:** 1  
**Equipment Compliance:** N/A  
**Surface Area Compliance:** N/A

The grass mats are silted up, the soil is compacted and the area will become very slippery when the soil is wet. - Reinstate as required

There is algae, silt or moss growth on the safety surface resulting in slippery conditions - Clean and treat appropriately

The fitness equipment I'D labels have faded and become illegible - Replace the labels as required

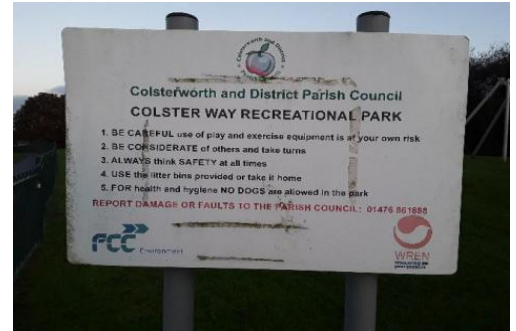
**Item:** Sign  
**Manufacturer:** Unknown  
**Surface Type:** N/A  
**Item Quantity:** 2  
**Equipment Compliance:** N/A  
**Surface Area Compliance:** N/A

BS EN 1176 Part 7 recommends that signage shall include emergency contact details - Provide additional information

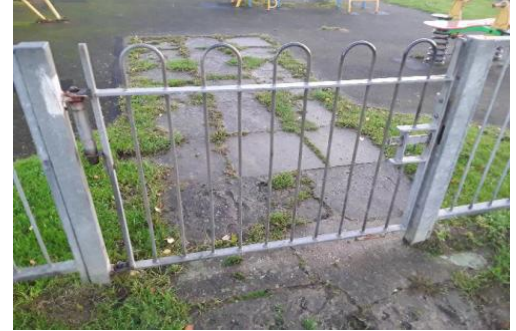
**Item:** Gate - Self Closing  
**Manufacturer:** Unknown  
**Surface Type:** Paving Slabs  
**Item Quantity:** 1  
**Equipment Compliance:** N/A  
**Surface Area Compliance:** N/A

The concrete base under the gate is uneven creating trip hazards - Repair the damaged areas of concrete to provide a uniform surface

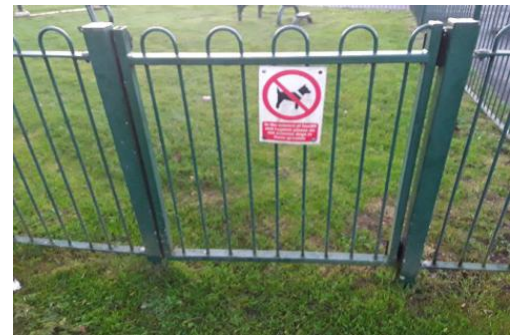
**Item:** Gate - Self Closing  
**Manufacturer:** Unknown  
**Surface Type:** Grass  
**Item Quantity:** 2  
**Equipment Compliance:** N/A  
**Surface Area Compliance:** N/A

There is / are post or end caps missing / damaged on the item - Replace missing / damaged post or end caps

The rubber buffer is missing from the latch plate - Replace rubber buffer

The gate latch is damaged - Repair or replace the latch

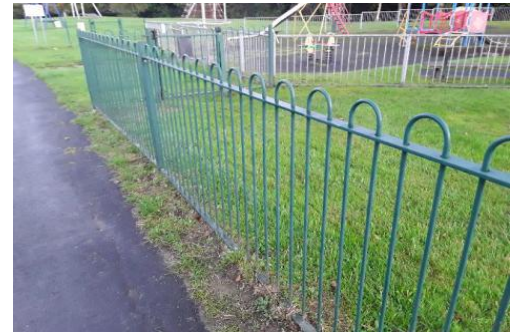
**Item:** Fence - Bow Top  
**Manufacturer:** Unknown  
**Surface Type:** Grass  
**Item Quantity:** 1  
**Equipment Compliance:** N/A  
**Surface Area Compliance:** N/A

A number of fixings have worked loose around the fencing - Secure all loose fixings

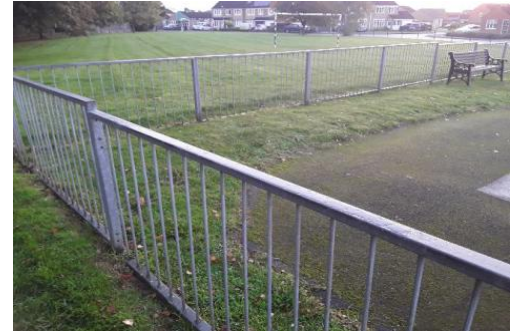
**Item:** Fencing - Flat Top  
**Manufacturer:** Unknown  
**Surface Type:** Grass  
**Item Quantity:** 1  
**Equipment Compliance:** N/A  
**Surface Area Compliance:** N/A

There is minor damage to the fence sections - Monitor for any further deterioration and repair as required

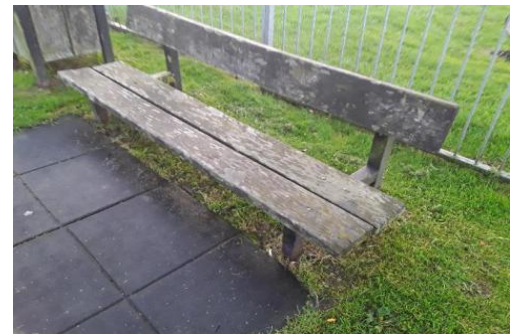
**Item:** Bench  
**Manufacturer:** Wicksteed Playgrounds  
**Surface Type:** Rubber Tiles  
**Item Quantity:** 2  
**Equipment Compliance:** N/A  
**Surface Area Compliance:** N/A

There are gaps opening in between the tiles in front of the bench - Monitor for any further deterioration and repair as required

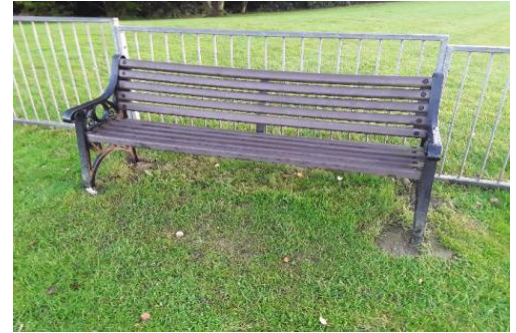
**Item:** Bench  
**Manufacturer:** Unknown  
**Surface Type:** Grass  
**Item Quantity:** 1  
**Equipment Compliance:** N/A  
**Surface Area Compliance:** N/A

There is/are bolt cap covers missing or damaged on the item - Replace missing or damaged bolt cap covers

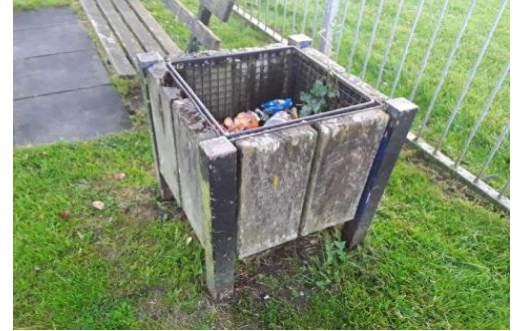
**Item:** Litter Bin  
**Manufacturer:** Wicksteed Playgrounds  
**Surface Type:** Grass  
**Item Quantity:** 1  
**Equipment Compliance:** N/A  
**Surface Area Compliance:** N/A

There are parts of the timber on the structure that have rotted - Replace all affected timbers

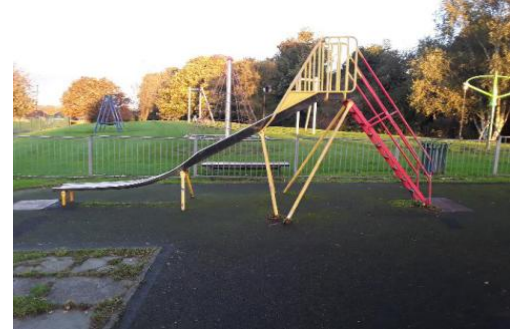
**Item:** Free Standing Slide  
**Manufacturer:** Wicksteed Playgrounds  
**Surface Type:** Wet Pour  
**Item Quantity:** 1  
**Equipment Compliance:** No  
**Surface Area Compliance:** Yes

The slide is predominately south facing and will catch the majority of the sun's heat during the day. Slide surfaces can become very warm during periods of sustained sunny weather - Monitor - No remedial work recommended

The paintwork on this item has been damaged or worn exposing the metal underneath which is rusting / corroding - Treat affected areas and repaint

There is/are finger entrapment/s in the structure and the item fails to meet the requirements of BS EN 1176 Part 1 4.2.7.6 Entrapment of fingers - Monitor - No remedial work recommended

The item fails to meet the requirements of BS EN 1176 Part 1 4.2.7.2 head and neck entrapment in the barriers and/or steps - Monitor - No remedial work recommended

There is / are toggle entrapment/s present in contravention of the recommendations set out in BS EN 1176 Part 1 - Monitor - no remedial work recommended

There are a number of dents in the slide surface - Monitor for any further deterioration and repair as required

The side of the slide is damaged - Monitor for any further deterioration and repair as required

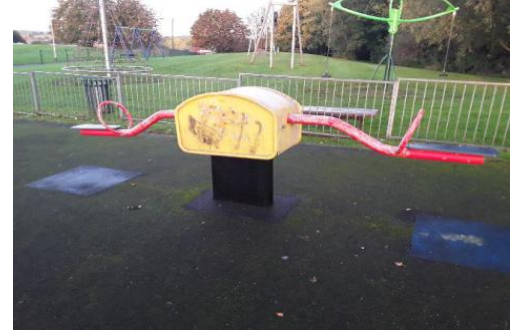
**Item:** See Saw  
**Manufacturer:** Wicksteed Playgrounds  
**Surface Type:** Wet Pour  
**Item Part Number:** Jolly Gerald  
**Item Quantity:** 1  
**Equipment Compliance:** Yes  
**Surface Area Compliance:** Yes  
**Total Findings:** 4

There is surface corrosion / rust present on the item - Consider treating the item

The seat has minor damage or wear - Monitor for any further deterioration and replace as required

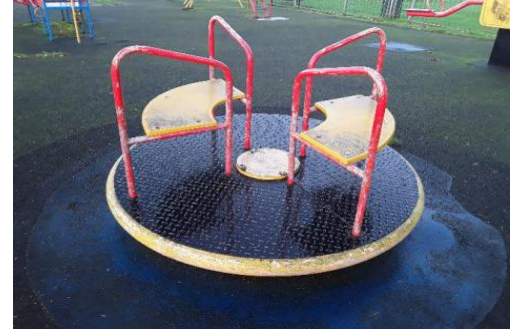
**Item:** Roundabout  
**Manufacturer:** Wicksteed Playgrounds  
**Surface Type:** Wet Pour  
**Item Quantity:** 1  
**Equipment Compliance:** No  
**Surface Area Compliance:** No

The distance between the underside of the roundabout platform and the playing surface is in excess of 110mm and contravenes the requirements of BS EN 1176 Part 5 which requires that the distance be maintained between 60mm-110mm - for the entire circumference of the roundabout - Monitor - No remedial work recommended

The surfacing dimensions are short and do not meet with the requirements of the current applicable standard - Monitor - no remedial action recommended

The bearing is showing signs of wear - Monitor for any further deterioration and replace as required

There is damage to the surface - Repair the damaged areas of surfacing

The seat has minor damage or wear - Monitor for any further deterioration and replace as required

There is surface corrosion / rust present on the item - Consider treating the item

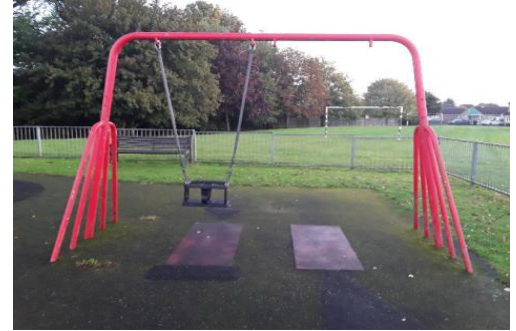
**Item:** 1 Bay 2 Seat (Cradle)  
**Manufacturer:** Wicksteed Playgrounds  
**Surface Type:** Wet Pour  
**Item Part Number:** Swing frame height: 2228mm  
**Item Quantity:** 1  
**Equipment Compliance:** No  
**Surface Area Compliance:** Yes  
**Total Findings:** 4

There is surface corrosion / rust present on the item - Consider treating the item

There is minor damage to the surface - Monitor for any further deterioration and repair as required

The seat clearance from finished surface level to the underside of the seat is too low and does not meet the requirements of BS EN 1176 Part 2 (350mm minimum clearance required) - Adjust seat height/s (400mm-500mm is recommended)

The item has missing component(s) - Consider replacing missing components

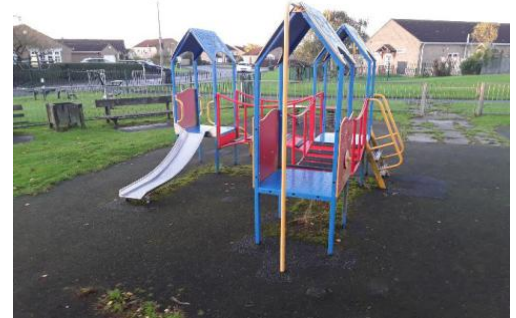
**Item:** Multi Play (Toddler)  
**Manufacturer:** Wicksteed Playgrounds  
**Surface Type:** Wet Pour  
**Item Quantity:** 1  
**Equipment Compliance:** No  
**Surface Area Compliance:** Yes

The safety surface is uneven under and around the fireman's pole creating trip hazards - Provide a uniform surface

The free space between the fireman's pole and the platform is less than the minimum recommended dimension of 350mm in BS EN 1176 Part 1; this is however an intended design feature by the manufacturer to assist younger users in accessing the pole and is a very low risk finding - no remedial action is recommended - Monitor - No remedial work recommended

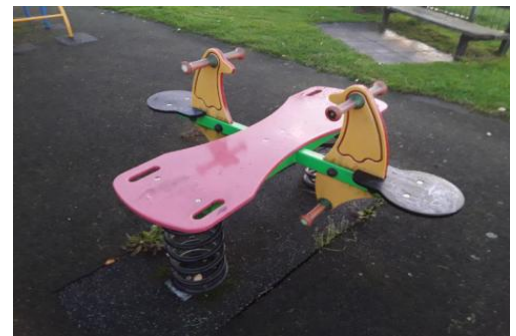
**Item:** Spring See-Saw  
**Manufacturer:** Wicksteed Playgrounds  
**Surface Type:** Wet Pour  
**Item Quantity:** 1  
**Equipment Compliance:** Yes  
**Surface Area Compliance:** Yes

There are gaps opening between the surfacing and the edging surround or between the joints in the surfacing - Monitor for any further deterioration and repair as required

There is/are bolt cap covers missing or damaged on the item - Replace missing or damaged bolt cap covers

A number of fixing(s) have worked loose - Secure all loose fixings

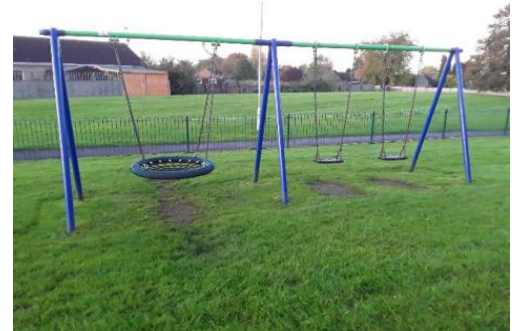
**Item:** 2 Bay 2 Flat 1 Inclusive Seat  
**Manufacturer:** Wicksteed Playgrounds  
**Surface Type:** Grass Matrix Tiles  
**Item Part Number:** Frame height: 2230mm  
**Item Quantity:** 1  
**Equipment Compliance:** No  
**Surface Area Compliance:** Yes  
**Total Findings:** 3

There is some notable evidence of chain wear - Monitor for any further deterioration and replace when 40% worn

The chain openings are in excess of the 8.6mm as recommended by BS EN 1176 - Monitor - No remedial work recommended

The basket bushes are showing signs of wear - Monitor for any further deterioration and replace as required

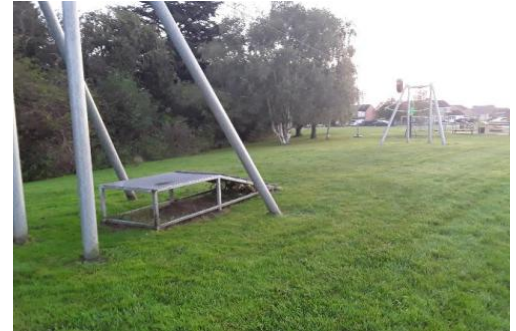
**Item:** Cable Runway  
**Manufacturer:** Wicksteed Playgrounds  
**Surface Type:** Grass Matrix Tiles  
**Item Quantity:** 1  
**Equipment Compliance:** No  
**Surface Area Compliance:** Yes

The chain links are worn excessively and require renewing - Replace worn chains

The traveller brake isn't working - Repair / replace the brake

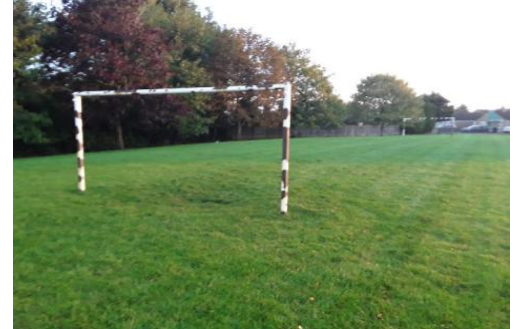
**Item:** Football Goal  
**Manufacturer:** Unknown  
**Surface Type:** Grass  
**Item Quantity:** 2  
**Equipment Compliance:** N/A  
**Surface Area Compliance:** N/A

NB: We have undertaken a maintenance inspection only of the football goal(s); full load testing falls outside the scope of our inspection. - Implement load testing as required

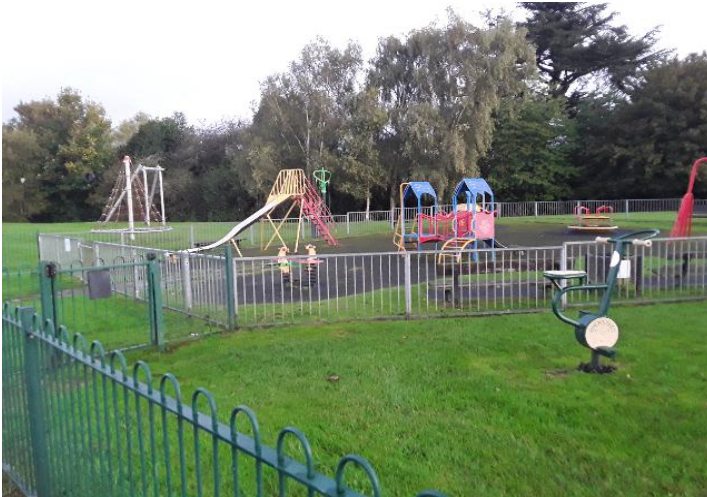
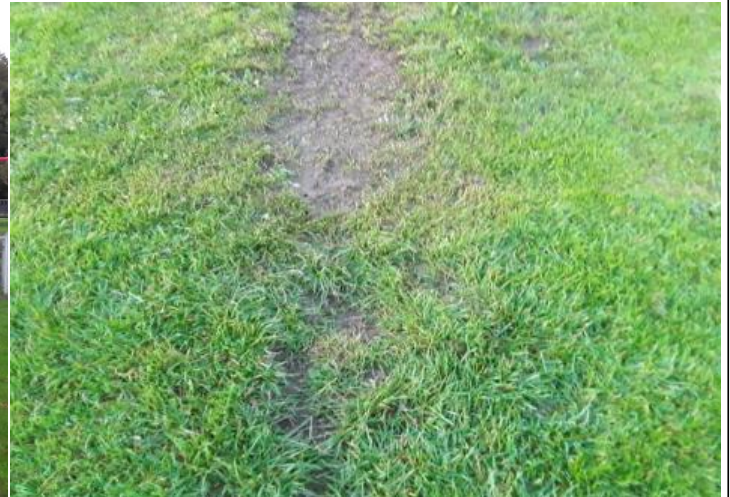
**Item:** Ancillary Items - Site General  
**Manufacturer:** Not Applicable

**Finding:** The grass mats are silted up, the soil is compacted and the area will become very slippery when the soil is wet. **Action:** Reinstate as required

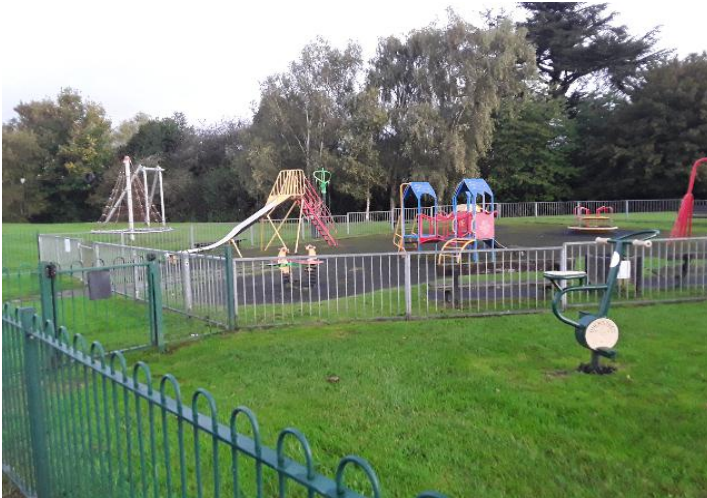
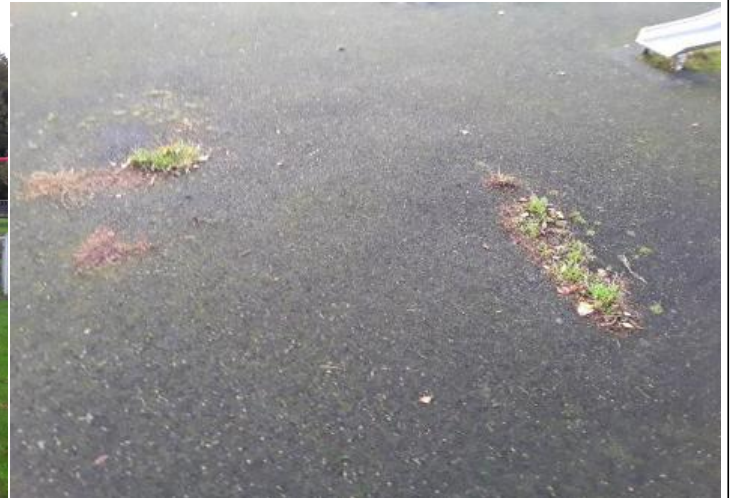
**Item:** Ancillary Items - Site General  
**Manufacturer:** Not Applicable

**Finding:** There is weed / vegetation growth on and around the wet pour safety surface  
**Action:** Remove weed / vegetation growth

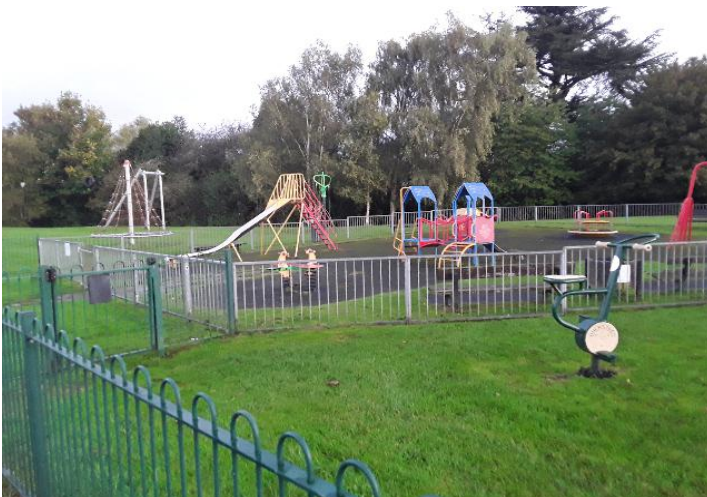
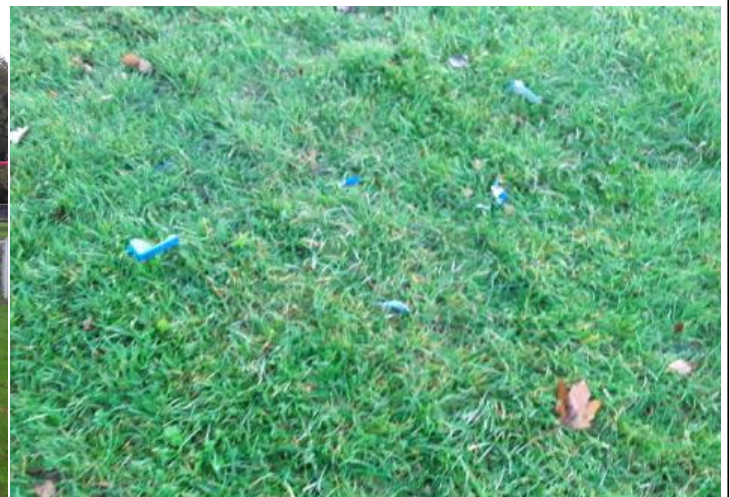
**Item:** Ancillary Items - Site General  
**Manufacturer:** Not Applicable

**Finding:** There is litter/debris in the area  
**Action:** Remove litter/debris from the area and maintain

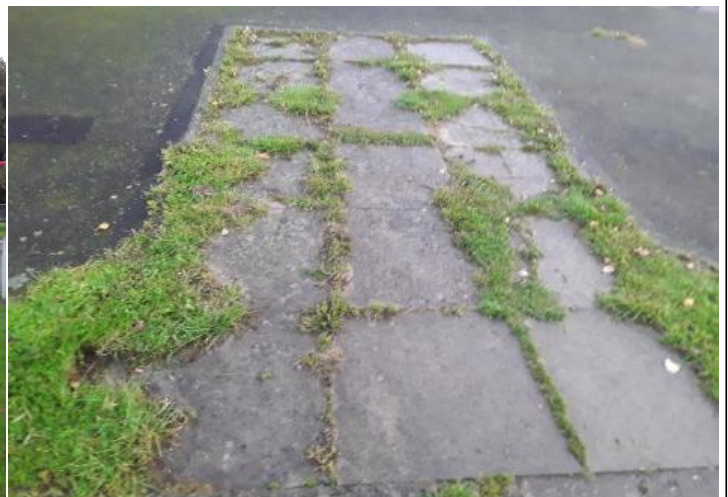
**Item:** Ancillary Items - Site General  
**Manufacturer:** Not Applicable

**Finding:** There is weed / vegetation growth on and around the paved surface

**Action:** Remove weed / vegetation growth

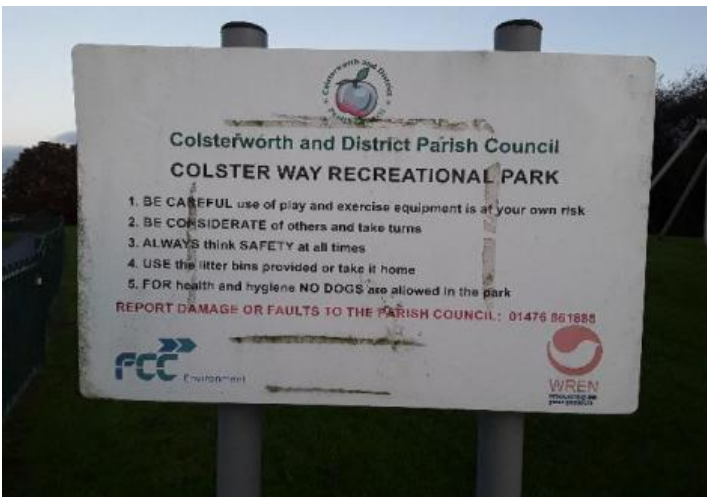
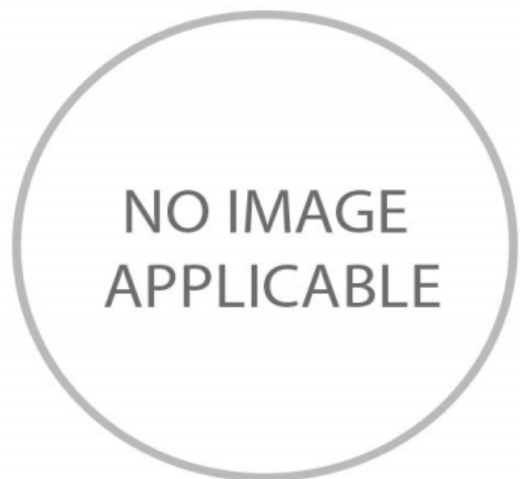
**Item:** Ancillary Items - Sign  
**Manufacturer:** Unknown

**Finding:** BS EN 1176 Part 7 recommends that signage shall include emergency contact details

**Action:** Provide additional information

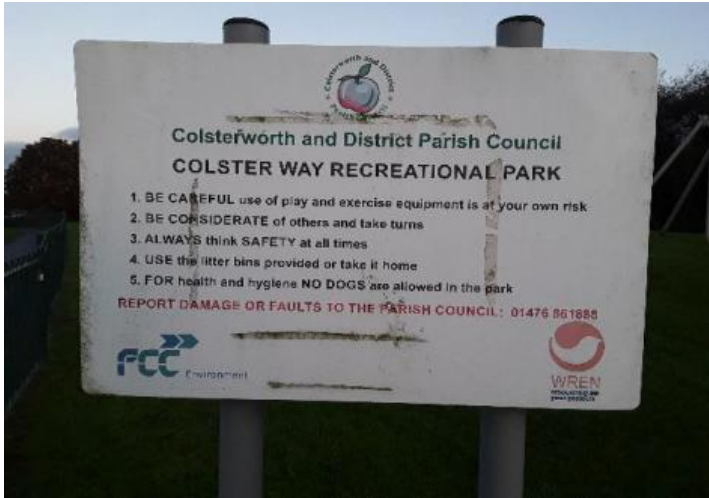
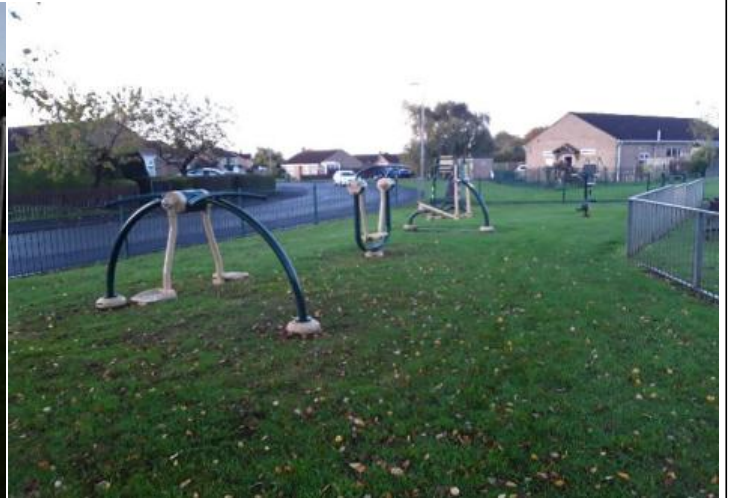
**Item:** Ancillary Items - Sign  
**Manufacturer:** Unknown

**Finding:** Signage should be provided for the outdoor fitness equipment in accordance with the requirements of BS EN 16630, key requirements of the sign include, but are not limited to, intended users, medical safety and emergency contact details

**Action:** Provide appropriate signage

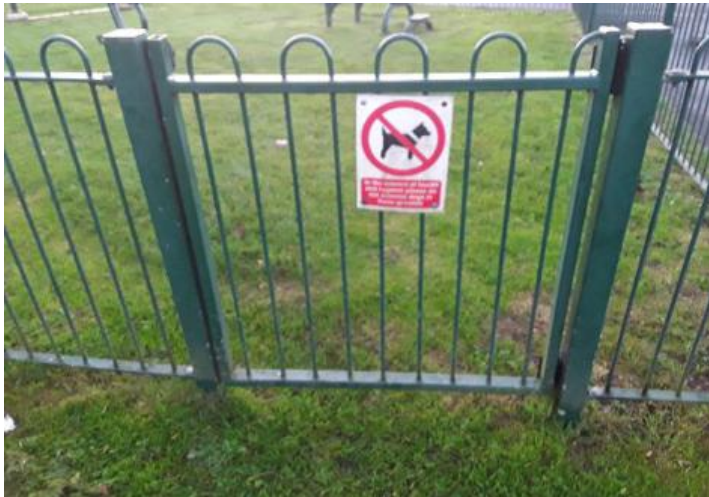
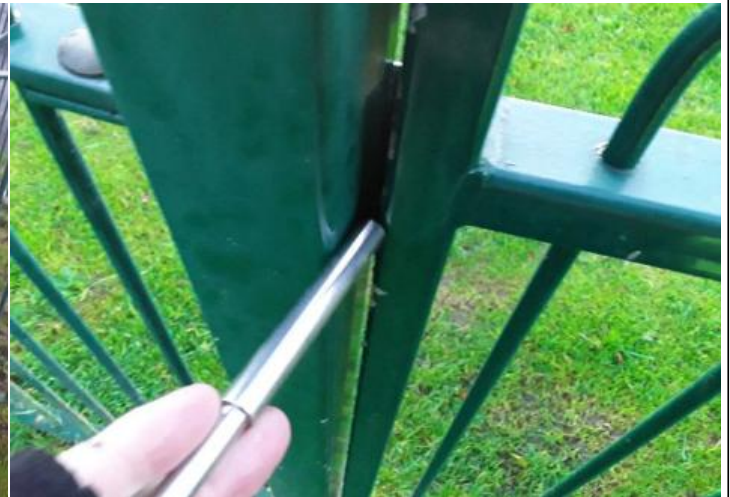
**Item:** Gates - Gate - Self Closing  
**Manufacturer:** Unknown  
**Risk Level:** L - Low Risk  
**Surface:** Grass

**Finding:** There are openings that are less than 12mm that could trap or crush fingers  
**Action:** Provide a 12mm gap throughout full range of motion at both sides of gate

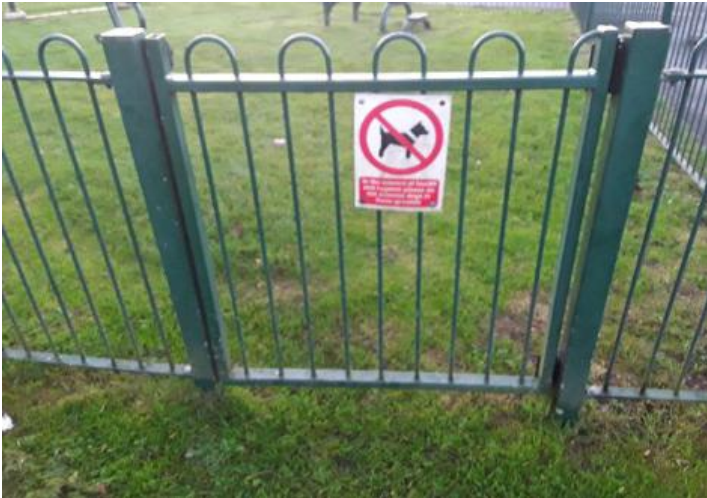
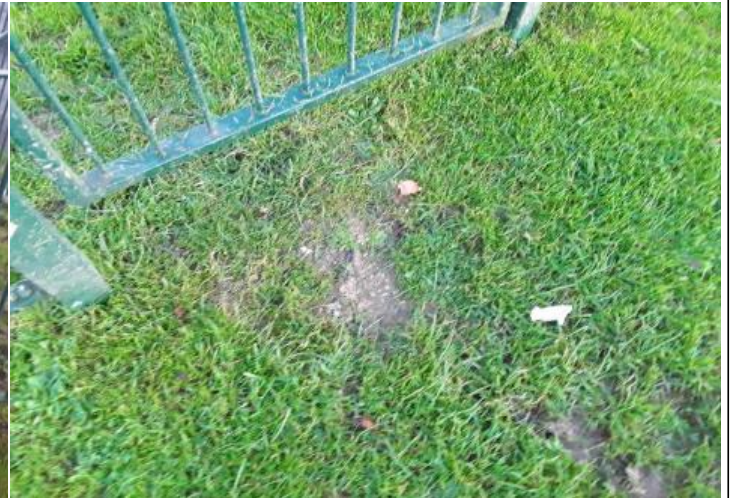
**Item:** Gates - Gate - Self Closing  
**Manufacturer:** Unknown

**Finding:** The area under the gate has eroded and may become slippery

**Action:** Reinststate eroded area

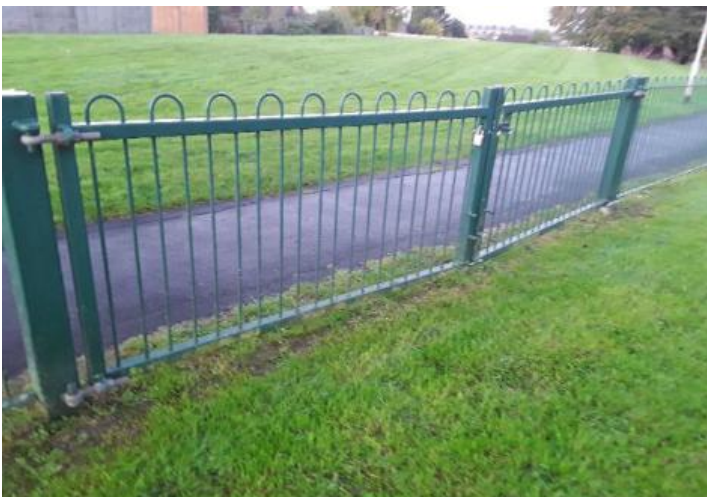
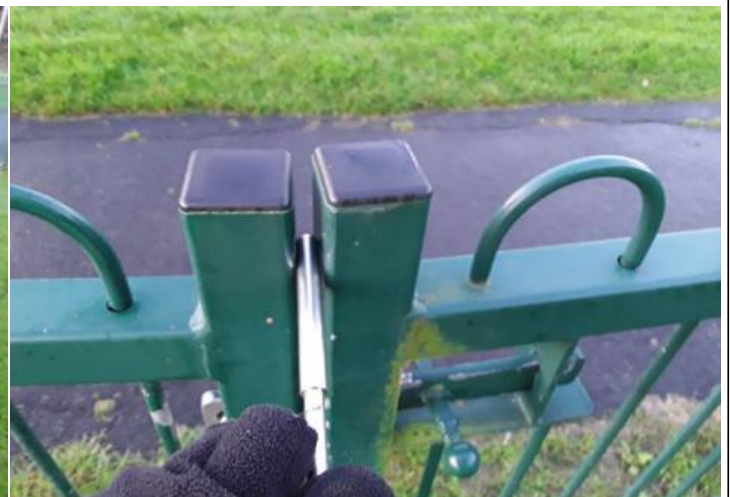
**Item:** Gates - Maintenance Gate  
**Manufacturer:** Unknown

**Finding:** There are openings that are less than 12mm that could trap or crush fingers

**Action:** Provide a 12mm gap throughout full range of motion at both sides of gate

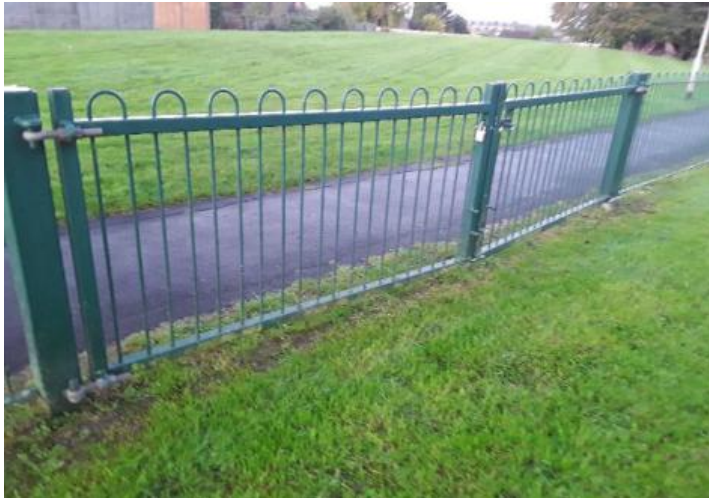
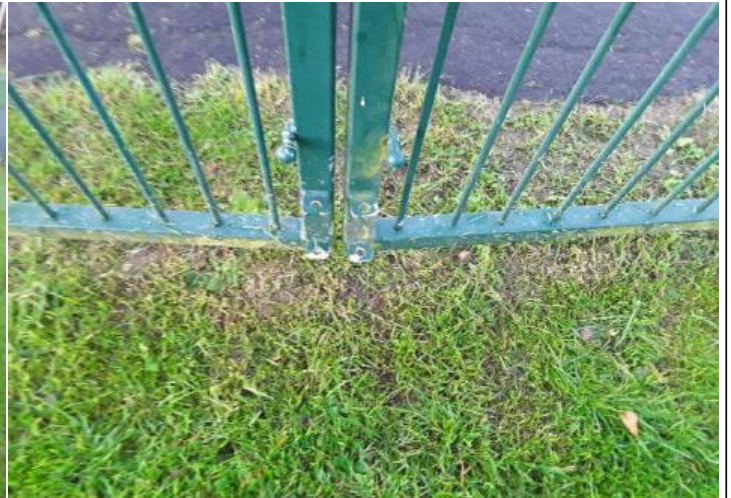
**Item:** Gates - Maintenance Gate  
**Manufacturer:** Unknown

**Finding:** The gate has no drop bolt sleeves and/or drop bolts fitted

**Action:** Provide drop bolt sleeves and/or drop bolts

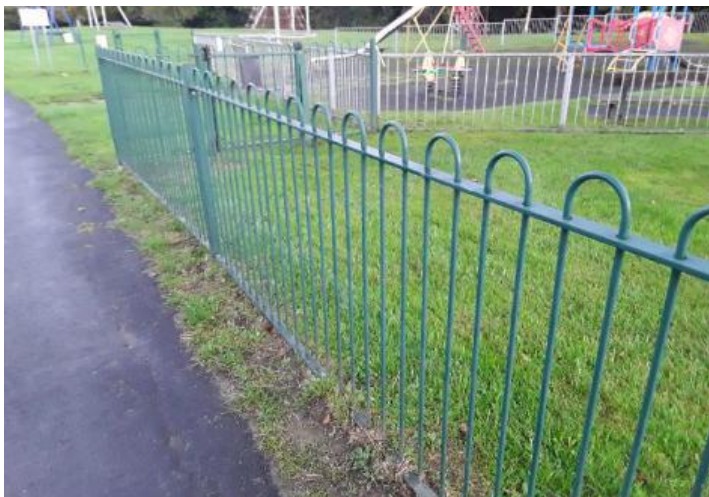
**Item:** Fences - Fence - Bow Top  
**Manufacturer:** Unknown

**Finding:** A number of fixings have worked loose around the fencing

**Action:** Secure all loose fixings

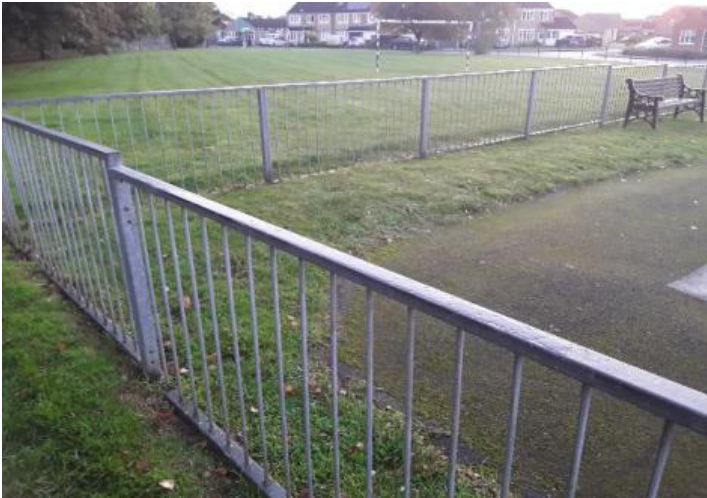
**Item:** Fences - Fencing - Flat Top  
**Manufacturer:** Unknown

**Finding:** There is minor damage to the fence sections

**Action:** Monitor for any further deterioration and repair as required

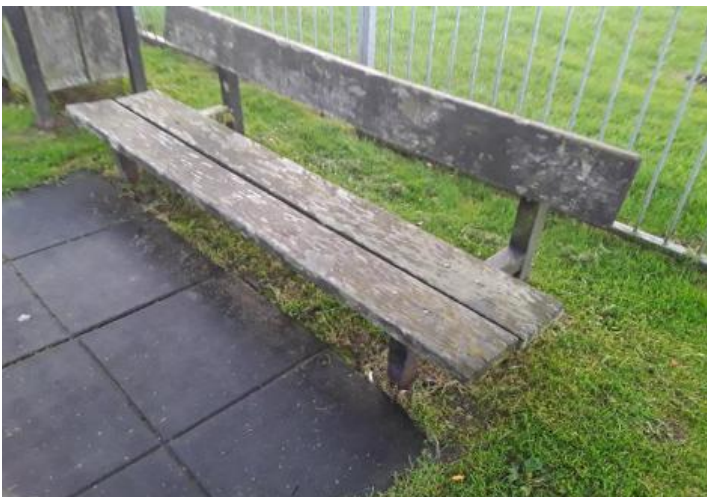
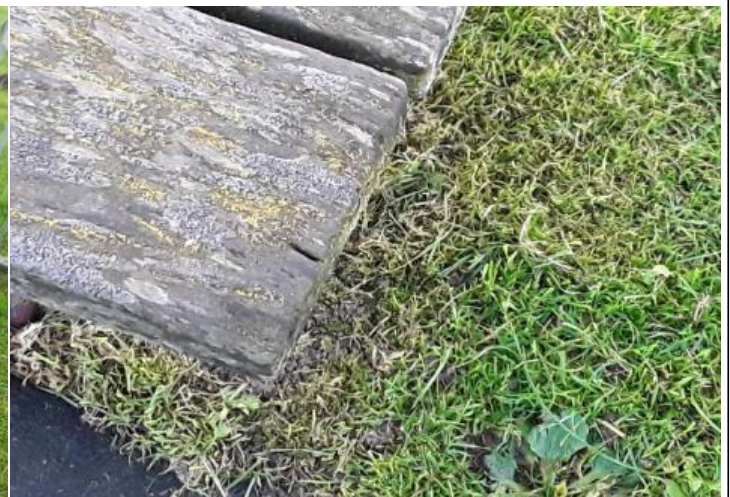
**Item:** Ancillary Items - Bench  
**Manufacturer:** Wicksteed Playgrounds

**Finding:** Parts of the timber are rough or splintered

**Action:** Remove all rough or sharp edges

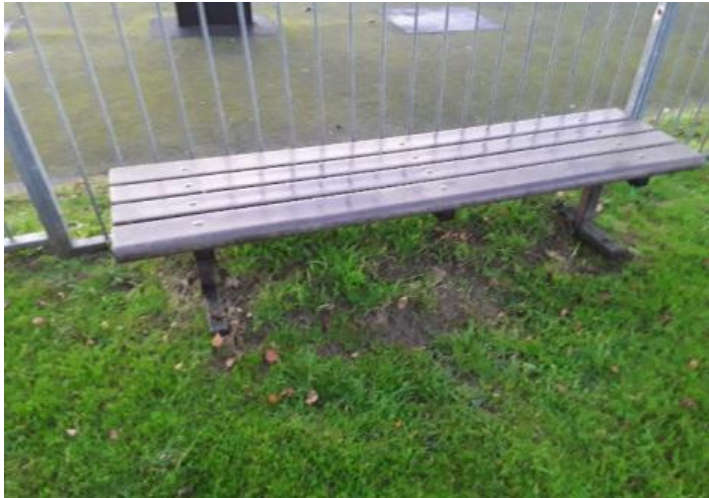
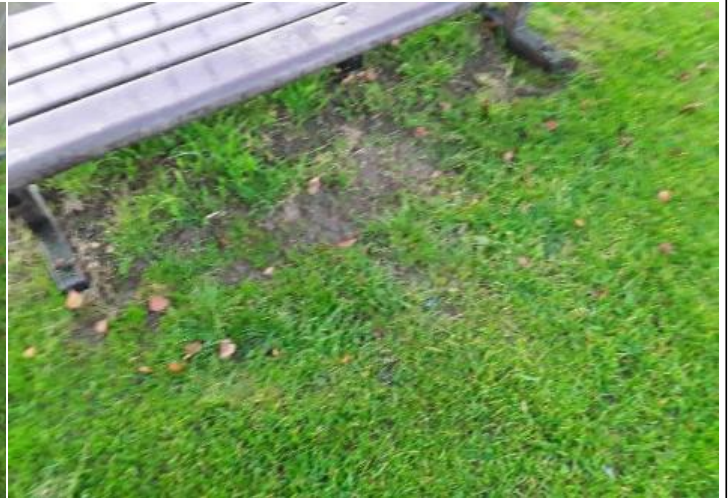
**Item:** Ancillary Items - Bench  
**Manufacturer:** Unknown

**Finding:** The area around the item has eroded and may become slippery

**Action:** Reinststate eroded area

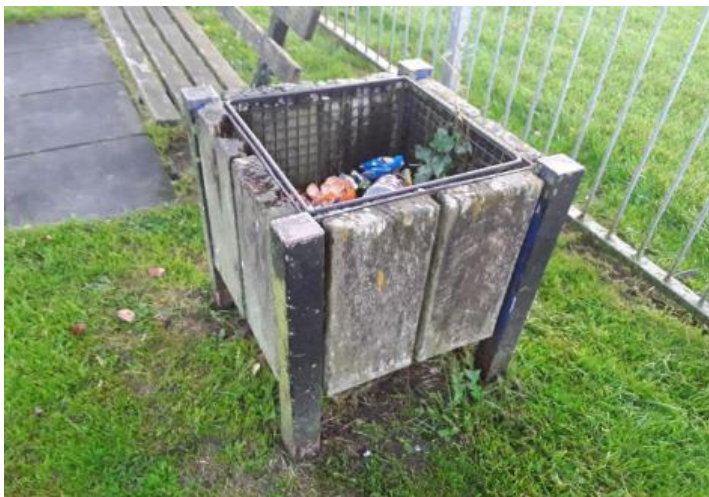
**Item:** Ancillary Items - Litter Bin  
**Manufacturer:** Wicksteed Playgrounds

**Finding:** There are parts of the timber on the structure that have rotted

**Action:** Replace all affected timbers

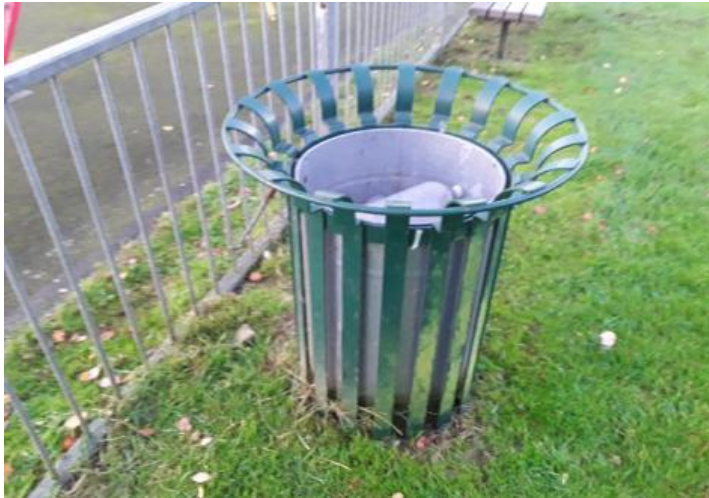
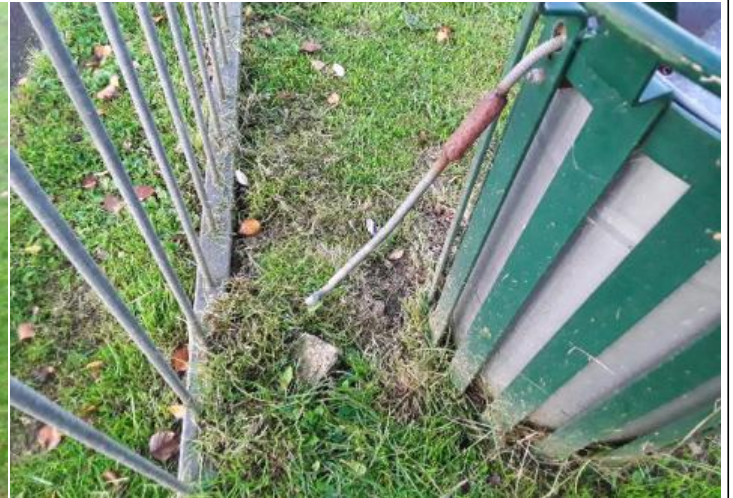
**Item:** Ancillary Items - Litter Bin  
**Manufacturer:** Unknown

**Finding:** There is a redundant threaded bolt attached to the bin  
**Action:** Remove the threaded bolt

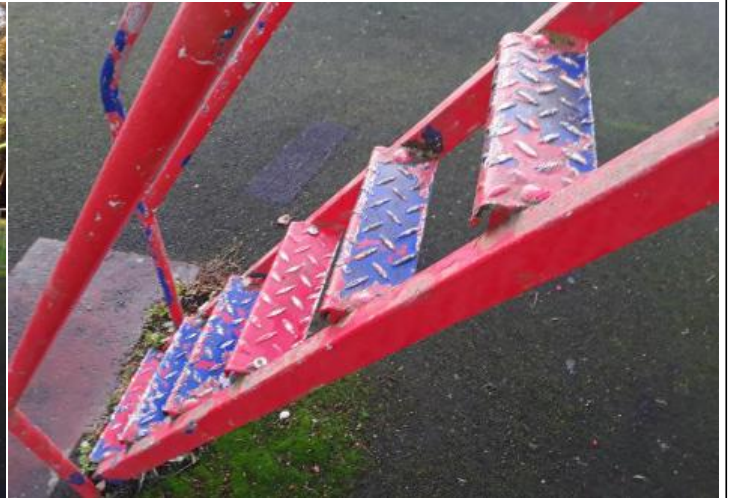
**Item:** Other - Free Standing Slide  
**Manufacturer:** Wicksteed Playgrounds

**Finding:** The paint is flaking off the metalwork

**Action:** Rub down and re-paint

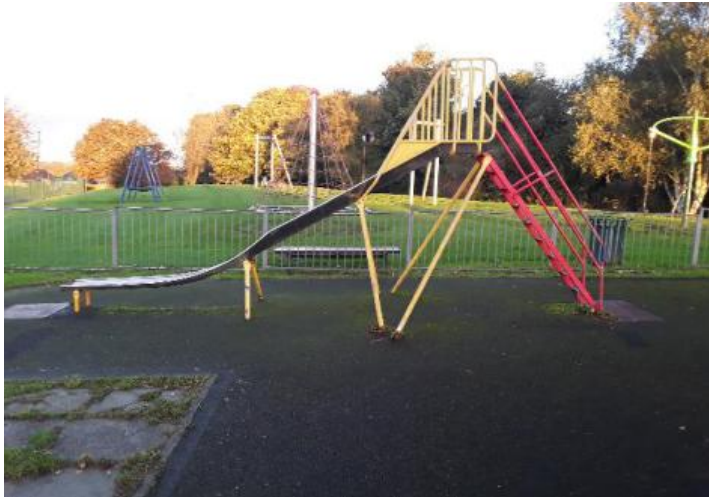
**Item:** Other - Free Standing Slide  
**Manufacturer:** Wicksteed Playgrounds

**Finding:** The paintwork on this item has been damaged or worn exposing the metal underneath which is rusting / corroding

**Action:** Treat affected areas and repaint

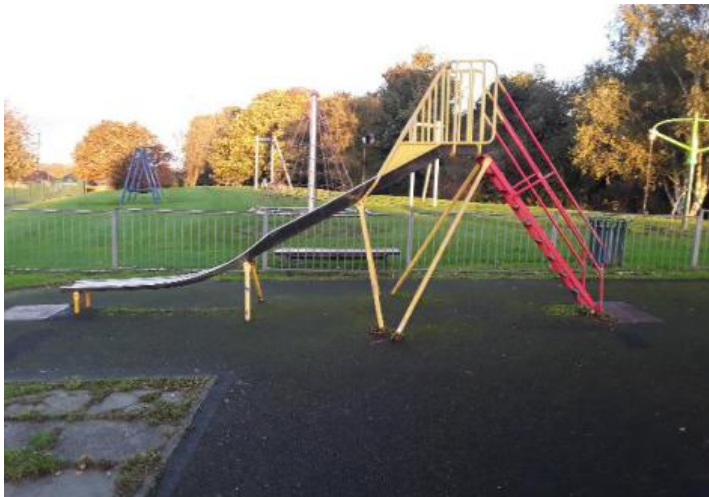
**Item:** Other - Free Standing Slide  
**Manufacturer:** Wicksteed Playgrounds

**Finding:** The item fails to meet the requirements of BS EN 1176 Part 1 4.2.7.2 head and neck entrapment in the barriers and/or steps

**Action:** Monitor - No remedial work recommended

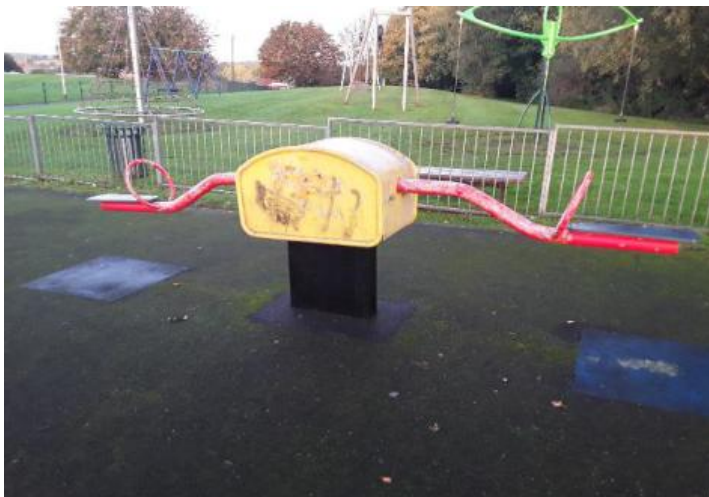
**Item:** Rocking Equipment - See Saw  
**Manufacturer:** Wicksteed Playgrounds

**Finding:** There is surface corrosion / rust present on the item

**Action:** Consider treating the item

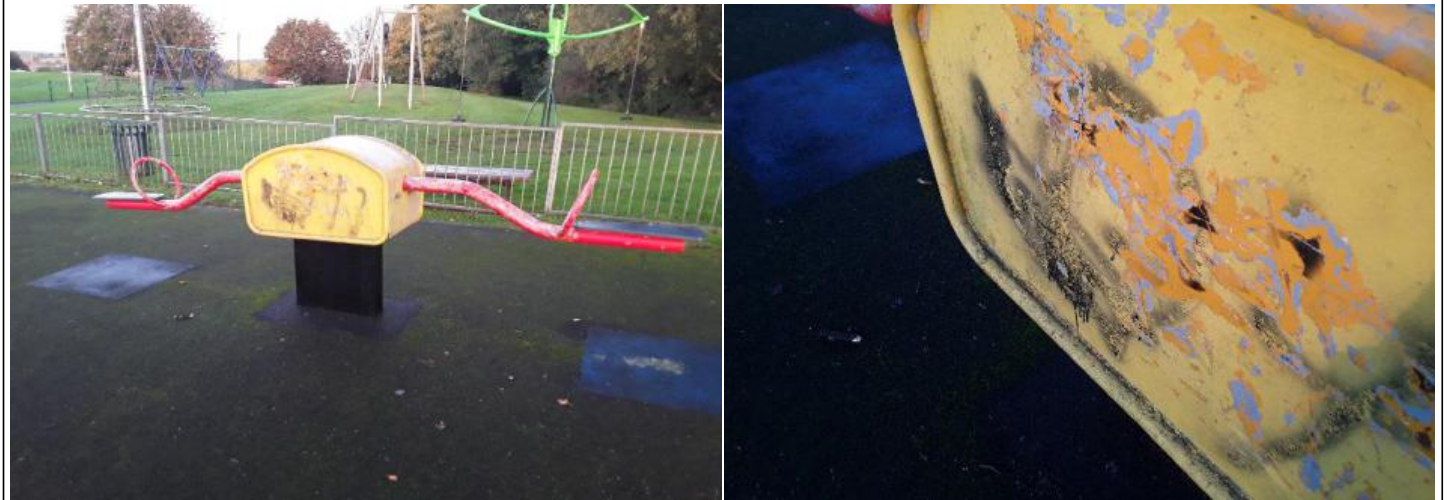
**Item:** Rocking Equipment - See Saw  
**Manufacturer:** Wicksteed Playgrounds  
**Risk Level:** V - Very Low Risk  
**Surface:** Wet Pour

**Finding:** There is some graffiti present  
**Action:** Remove the graffiti

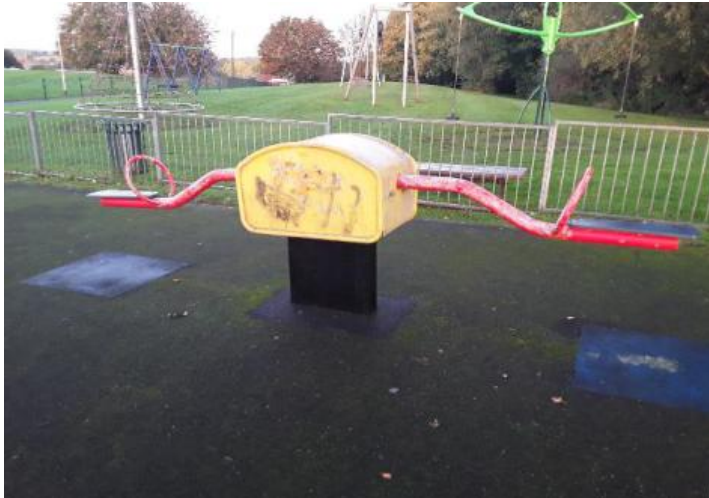
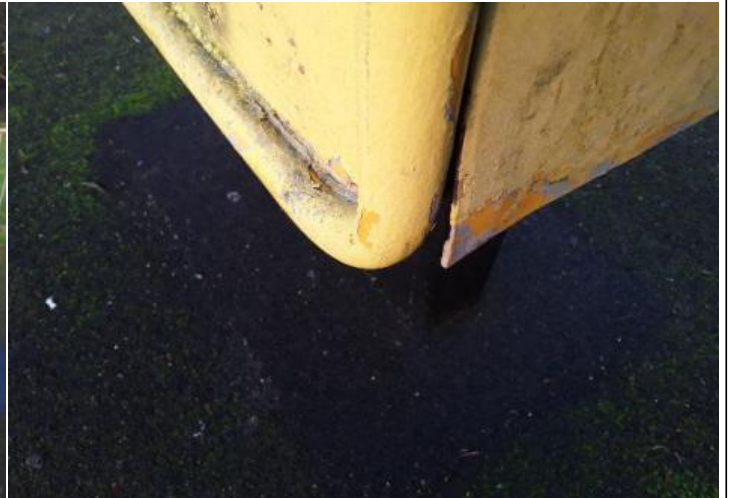
**Item:** Rocking Equipment - See Saw  
**Manufacturer:** Wicksteed Playgrounds

**Finding:** There is a sharp projecting edge on the centre shroud

**Action:** Resecure the edge

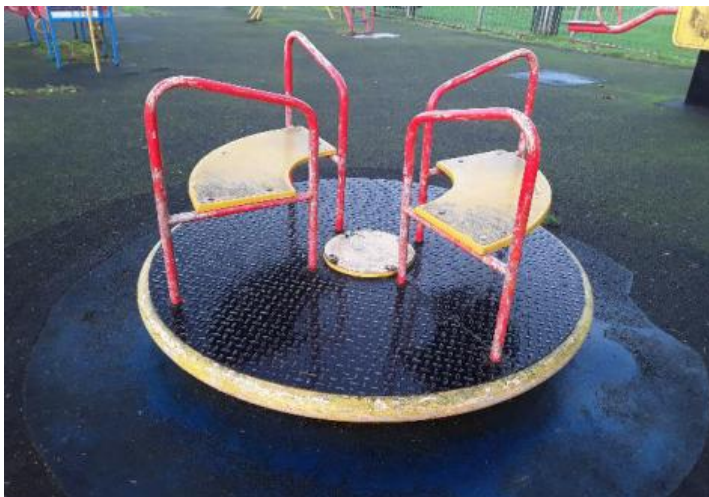
**Item:** Rotor Play - Roundabout  
**Manufacturer:** Wicksteed Playgrounds

**Finding:** The distance between the underside of the roundabout platform and the playing surface is in excess of 110mm and contravenes the requirements of BS EN 1176 Part 5 which requires that the distance be maintained between 60mm-110mm - for the entire circumference of the roundabout

**Action:** Monitor - No remedial work recommended

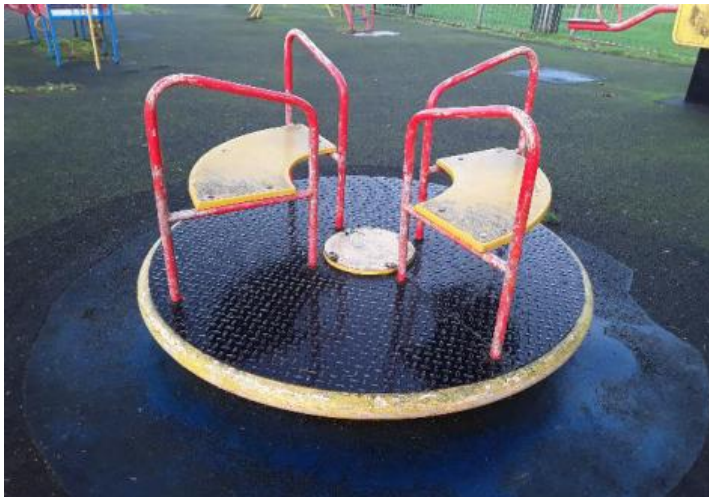
**Item:** Rotor Play - Roundabout  
**Manufacturer:** Wicksteed Playgrounds

**Finding:** The bearing is showing signs of wear

**Action:** Monitor for any further deterioration and replace as required

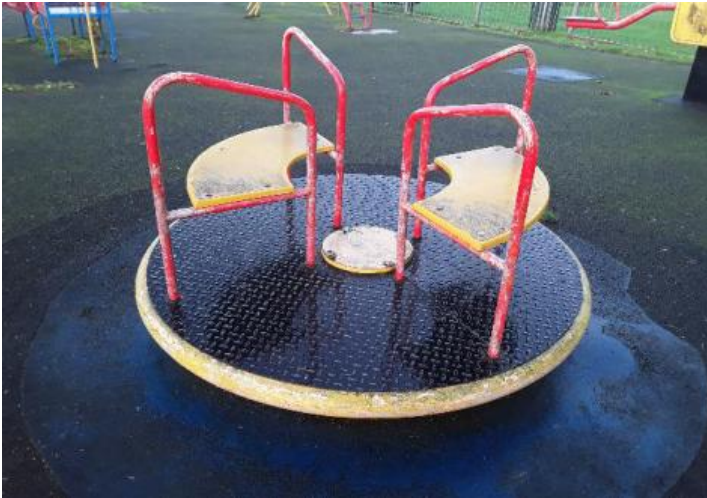
**Item:** Rotor Play - Roundabout  
**Manufacturer:** Wicksteed Playgrounds

**Finding:** There is damage to the surface

**Action:** Repair the damaged areas of surfacing

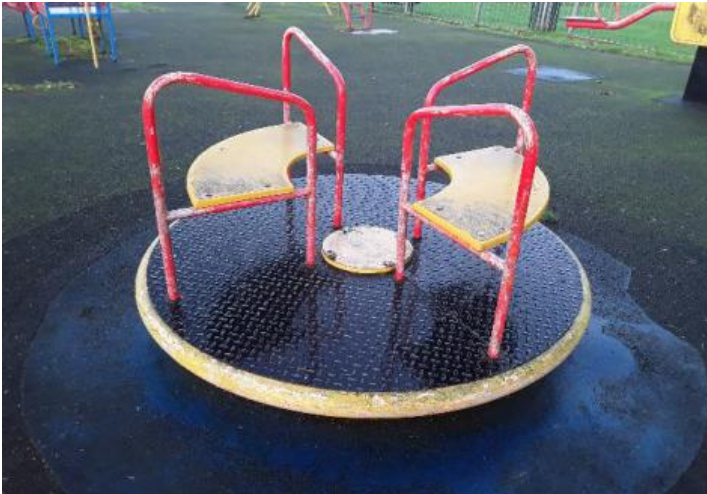
**Item:** Rotor Play - Roundabout  
**Manufacturer:** Wicksteed Playgrounds

**Finding:** The seat has minor damage or wear

**Action:** Monitor for any further deterioration and replace as required

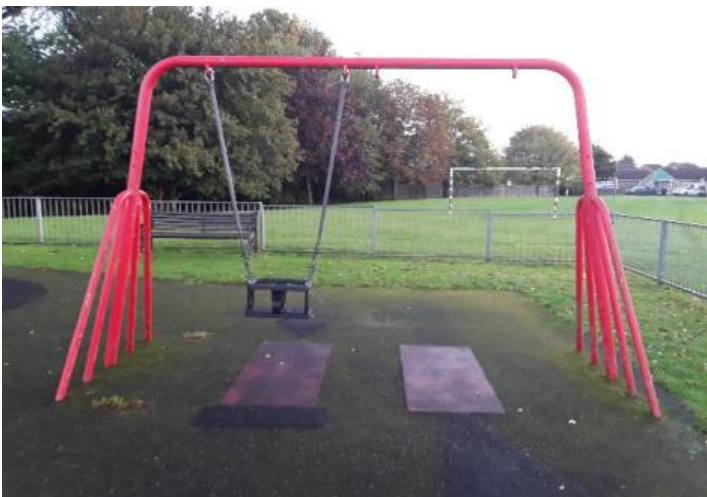
**Item:** Swings - 1 Bay 2 Seat (Cradle)  
**Manufacturer:** Wicksteed Playgrounds

**Finding:** There is surface corrosion / rust present on the item

**Action:** Consider treating the item

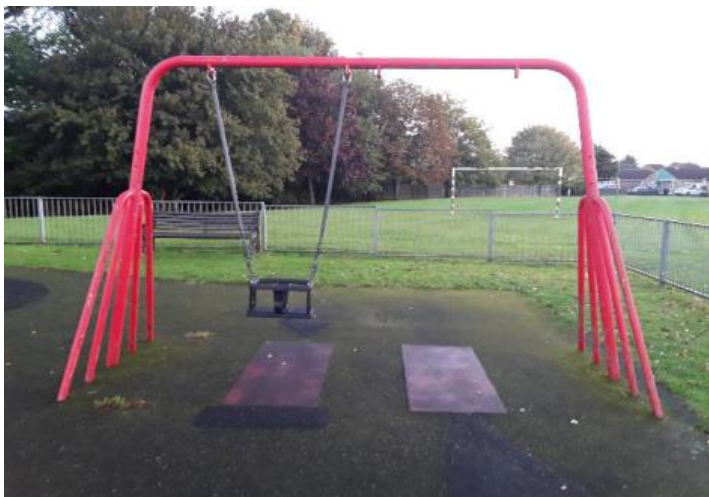
**Item:** Swings - 1 Bay 2 Seat (Cradle)  
**Manufacturer:** Wicksteed Playgrounds

**Finding:** The seat clearance from finished surface level to the underside of the seat is too low and does not meet the requirements of BS EN 1176 Part 2 (350mm minimum clearance required)

**Action:** Adjust seat height/s (400mm-500mm is recommended)

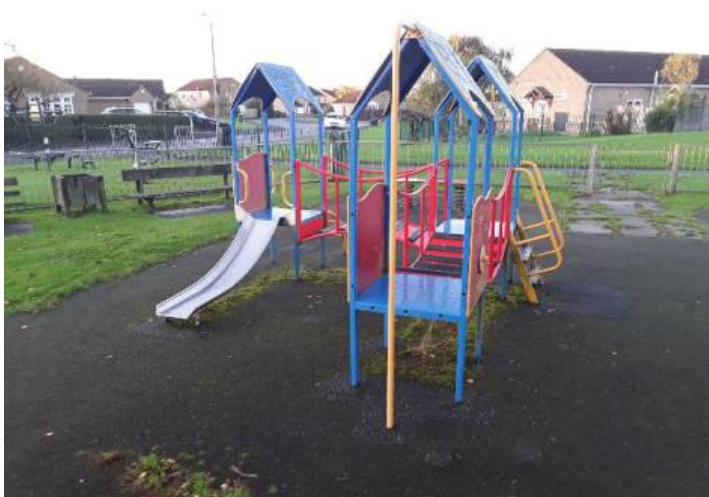
**Item:** Activity Equipment - Multi Play (Toddler)  
**Manufacturer:** Wicksteed Playgrounds

**Finding:** The safety surface is uneven under and around the fireman's pole creating trip hazards

**Action:** Provide a uniform surface
