# the **play inspection** company

## Annual Inspection

Colsterworth & District Parish Council

Colster Way Play Area

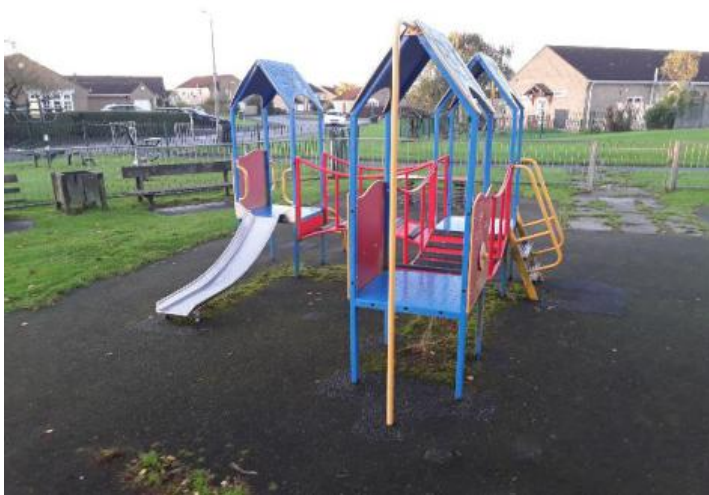
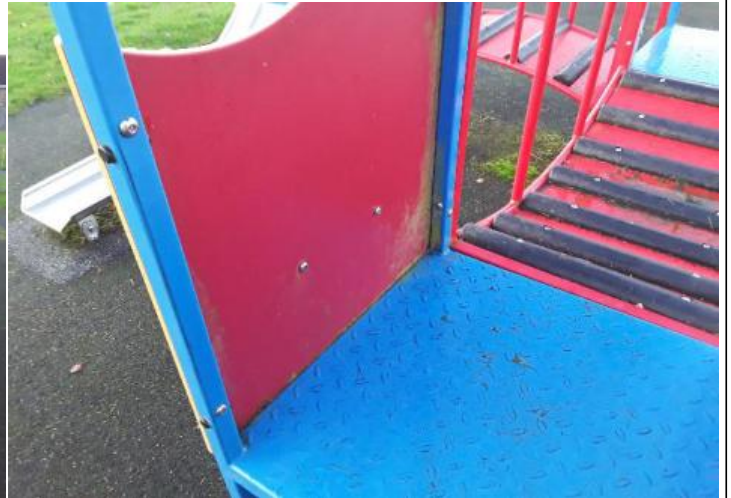
**Item:** Activity Equipment - Multi Play (Toddler)  
**Manufacturer:** Wicksteed Playgrounds

**Finding:** There is algae or moss on the surface of the equipment

**Action:** Clean and treat appropriately

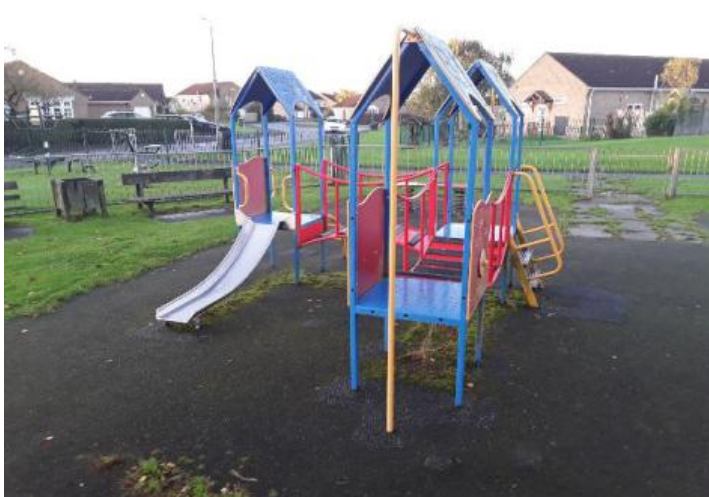
The free space between the fireman's pole and the platform is less than the minimum recommended dimension of 350mm in BS EN 1176 Part 1; this is however an intended design feature by the manufacturer to assist younger users in accessing the pole and is a very low risk finding - no remedial action is recommended - Monitor - No remedial work recommended

**Item:** Activity Equipment - Multi Play (Toddler)  
**Manufacturer:** Wicksteed Playgrounds

**Finding:** The free space between the fireman's pole and the platform is less than the minimum recommended dimension of 350mm in BS EN 1176 Part 1; this is however an intended design feature by the manufacturer to assist younger users in accessing the pole and is a very low risk finding - no remedial action is recommended

**Action:** Monitor - No remedial work recommended

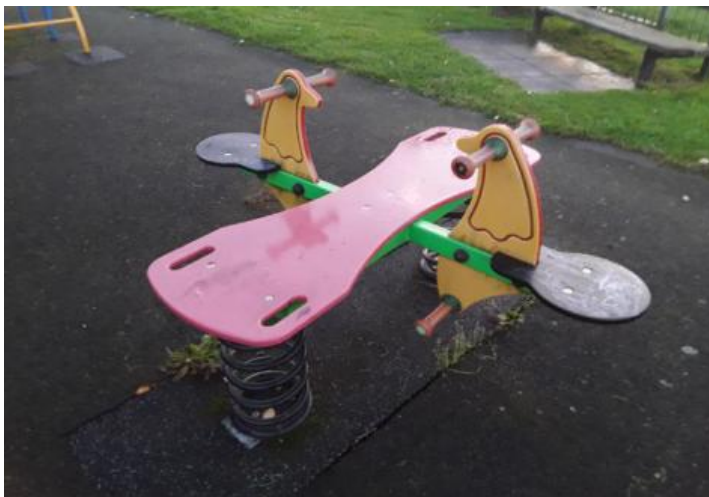
**Item:** Rocking Equipment - Spring See-Saw  
**Manufacturer:** Wicksteed Playgrounds

**Finding:** There is/are bolt cap covers missing or damaged on the item  
**Action:** Replace missing or damaged bolt cap covers

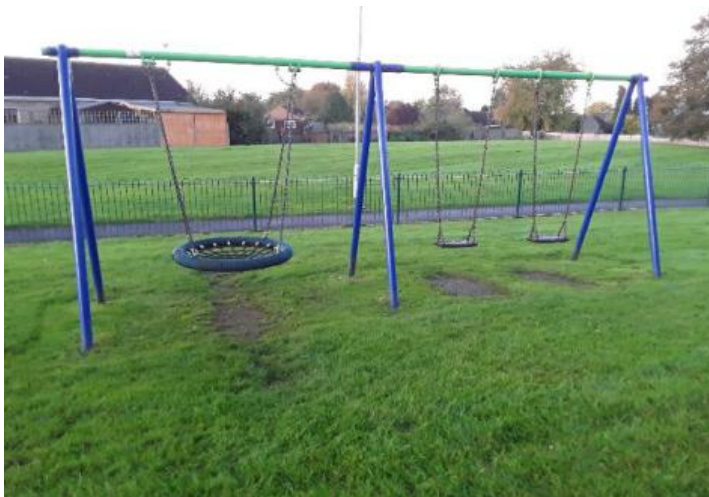
**Item:** Swings - 2 Bay 2 Flat 1 Inclusive Seat  
**Manufacturer:** Wicksteed Playgrounds

**Finding:** The chain openings are in excess of the 8.6mm as recommended by BS EN 1176

**Action:** Monitor - No remedial work recommended

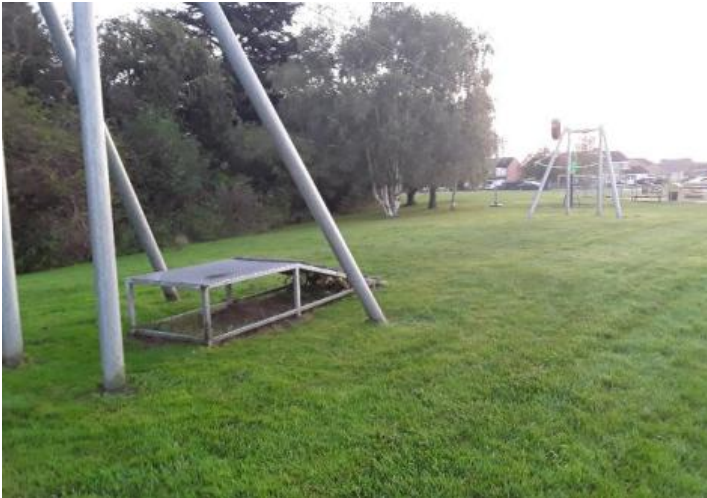
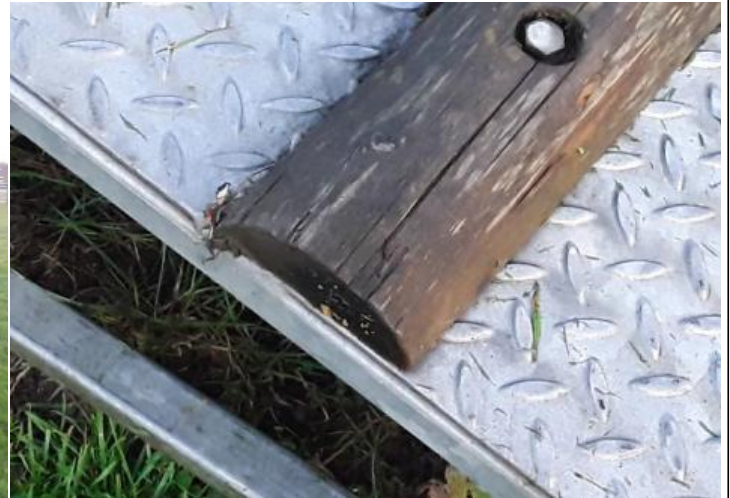
**Item:** Other - Cable Runway  
**Manufacturer:** Wicksteed Playgrounds

**Finding:** Parts of the timber are rough or splintered

**Action:** Remove all rough or sharp edges

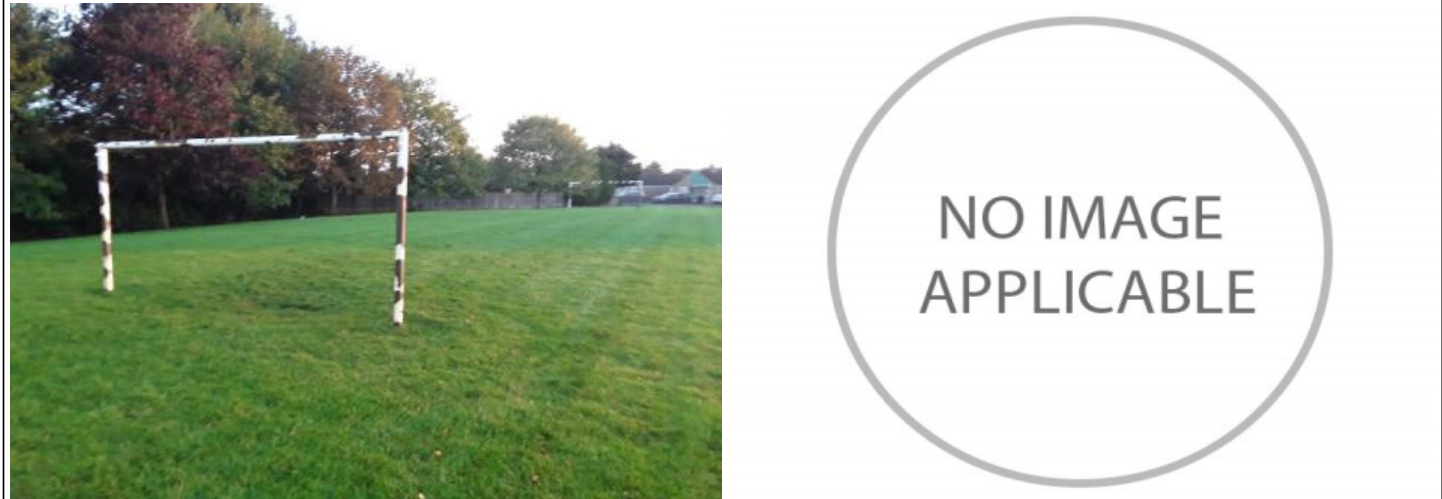
**i** 0 - Risk Assessment not Undertaken (Finding 1)

**Item:** Multi Use Games Area - Football Goal  
**Manufacturer:** Unknown  
**Risk Level:** N - Risk Assessment not Undertaken  
**Surface:** Grass

**Finding:** NB: We have undertaken a maintenance inspection only of the football goal(s); full load testing falls outside the scope of our inspection.  
**Action:** Implement load testing as required

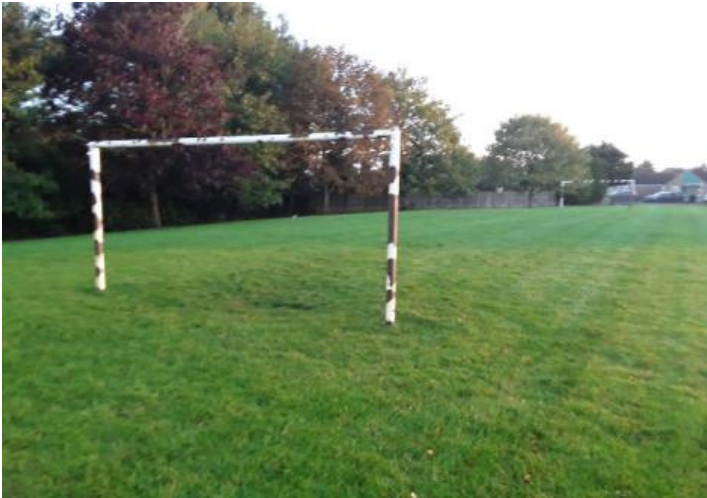
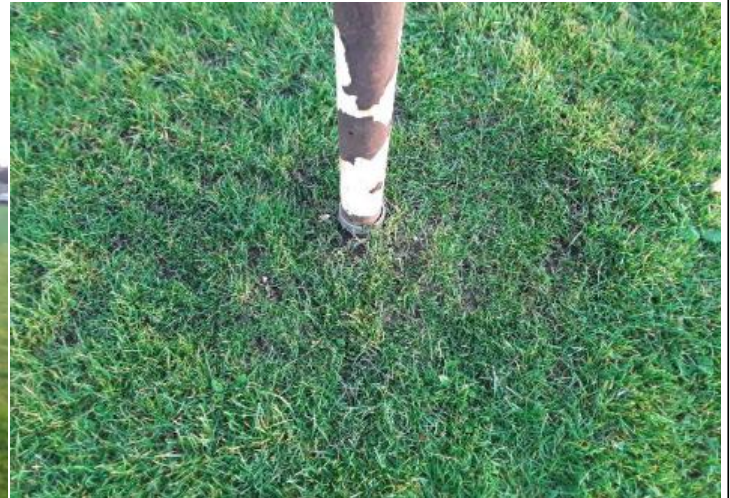
**Item:** Multi Use Games Area - Football Goal  
**Manufacturer:** Unknown

**Risk Level:** L - Low Risk  
**Surface:** Grass

**Finding:** There is minor movement of the posts in the ground sockets

**Action:** Monitor and resecure if required
