Annual Inspection

Colsterworth & District Parish Council

Woolsthorpe By Colsterworth Play Area

Inspection Ref: 2514002

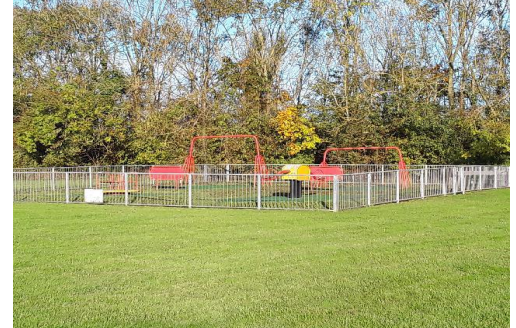
Item: Site General
Manufacturer: Not Applicable
Surface Type: N/A
Item Quantity: 1
Equipment Compliance: N/A
Surface Area Compliance: N/A

There is weed / vegetation growth on and around the surface - Remove weed / vegetation growth

There is algae, silt or moss growth on the surface resulting in slippery conditions - Clean and treat appropriately

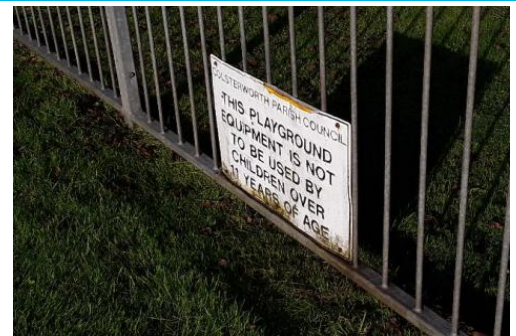
Item: Sign
Manufacturer: Unknown
Surface Type: N/A
Item Quantity: 1
Equipment Compliance: N/A
Surface Area Compliance: N/A

It is recommended that signage, with information including the site address, contact information for maintenance issues and emergency contact details are provided for the facility - Provide in accordance with the recommendations

There is minor damage to the sign - Monitor and replace if required

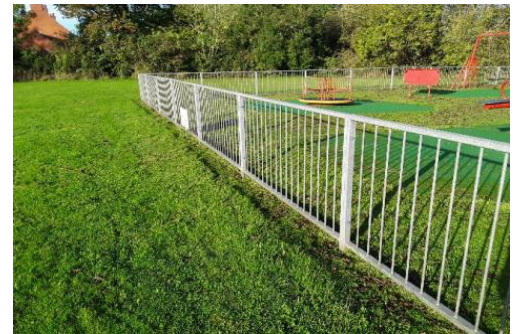
Item: Fencing - Flat Top
Manufacturer: Unknown
Surface Type: Grass
Item Quantity: 1
Equipment Compliance: N/A
Surface Area Compliance: N/A

There is minor damage to the fence sections - Monitor for any further deterioration and repair as required

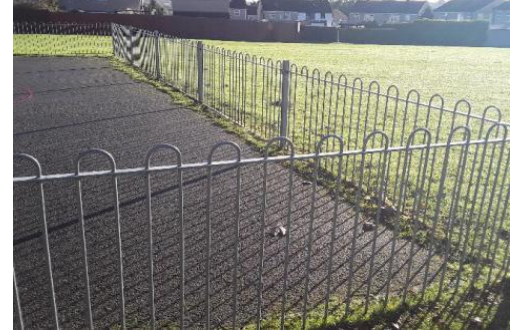
Item: Fence - Bow Top
Manufacturer: Not Identified
Surface Type: Grass
Item Quantity: 1
Equipment Compliance: N/A
Surface Area Compliance: N/A

There is / are post caps missing or damaged on the fence - Replace missing / damaged post caps

There is or are fixings missing on the item - Replace all missing fixings

There is some damage to the fence sections - Monitor for any further deterioration and repair as required

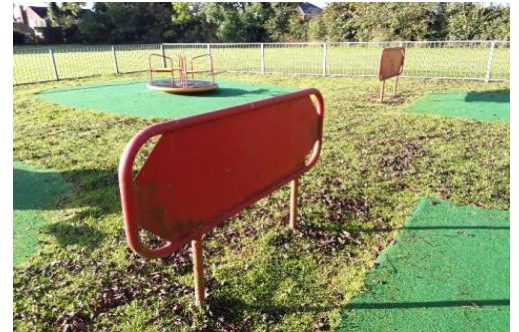
Item: Swing Barrier
Manufacturer: Wicksteed Playgrounds
Surface Type: Grass
Item Part Number: Swing barriers
Item Quantity: 2
Equipment Compliance: N/A
Surface Area Compliance: N/A
Total Findings: 1

The paint is flaking off the metalwork - Rub down and re-paint

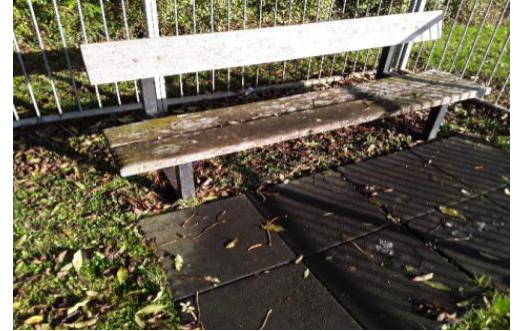
Item: Bench
Manufacturer: Wicksteed Playgrounds
Surface Type: Rubber Tiles
Item Quantity: 1
Equipment Compliance: N/A
Surface Area Compliance: N/A

There are gaps opening in between the tiles - Monitor for any further deterioration and repair as required

There is fire damage to the surfacing - Monitor for any further deterioration and repair as required

There are trip hazards at the edges of the tiled surface - Remove trip hazard

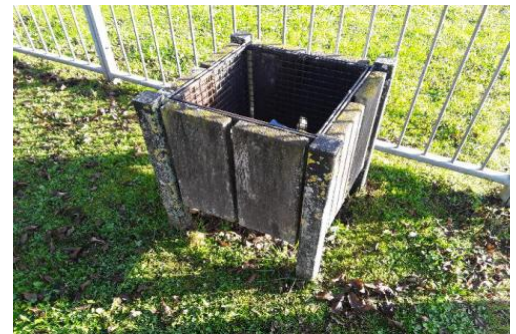
Item: Litter Bin
Manufacturer: Wicksteed Playgrounds
Surface Type: Grass
Item Quantity: 1
Equipment Compliance: N/A
Surface Area Compliance: N/A

There is fire damage to the item - Monitor for any further deterioration and repair as required

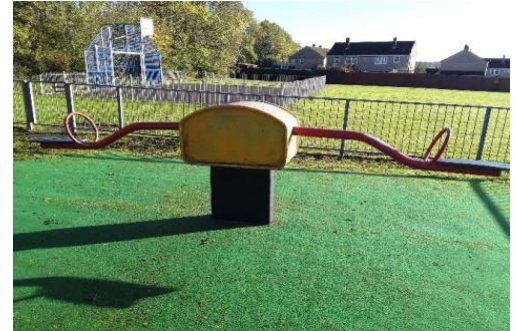
Item: See Saw
Manufacturer: Wicksteed Playgrounds
Surface Type: Notts Sports
Item Part Number: Jolly Gerald
Item Quantity: 1
Equipment Compliance: Yes
Surface Area Compliance: Yes
Total Findings: 3

The seat has minor damage or wear - Monitor for any further deterioration and replace as required

There is surface corrosion / rust present on the item - Consider treating the item

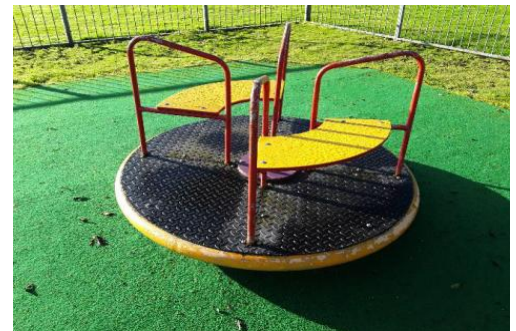
Item: Roundabout
Manufacturer: Wicksteed Playgrounds
Surface Type: Notts Sports
Item Quantity: 1
Equipment Compliance: No
Surface Area Compliance: No
Total Findings: 4

The bearing is showing signs of wear - Monitor for any further deterioration and replace as required

The distance between the underside of the roundabout platform and the playing surface is in excess of 110mm and contravenes the requirements of BS EN 1176 Part 5 which requires that the distance be maintained between 60mm-110mm - for the entire circumference of the roundabout - Monitor - No remedial work recommended

There is surface corrosion / rust present on the item - Consider treating the item

The surfacing dimensions are short and do not meet with the requirements of the current applicable standard - Monitor - no remedial action recommended

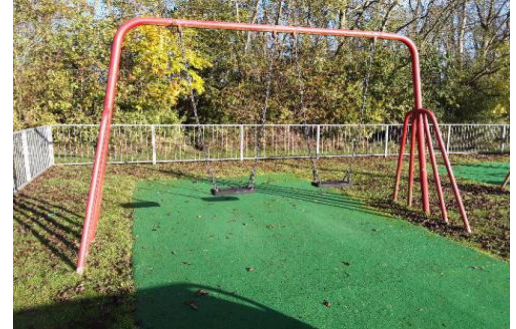
Item: 1 Bay 2 Seat (Flat)
Manufacturer: Wicksteed Playgrounds
Surface Type: Notts Sports
Item Part Number: Frame height: 2228mm
Item Quantity: 1
Equipment Compliance: Yes
Surface Area Compliance: Yes
Total Findings: 1

The bushes are showing signs of wear - Monitor for any further deterioration and replace as required

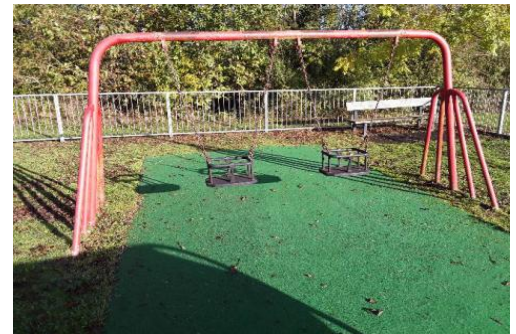
Item: 1 Bay 2 Seat (Cradle)
Manufacturer: Wicksteed Playgrounds
Surface Type: Notts Sports
Item Part Number: Frame height: 1670mm
Item Quantity: 1
Equipment Compliance: N/A
Surface Area Compliance: N/A
Total Findings: 5

There is surface corrosion / rust present on the item - Consider treating the item

The chain openings are in excess of the 8.6mm as recommended by BS EN 1176 - Monitor - No remedial work recommended

There is some notable evidence of chain wear - Monitor for any further deterioration and replace when 40% worn

The bushes are showing signs of wear - Monitor for any further deterioration and replace as required

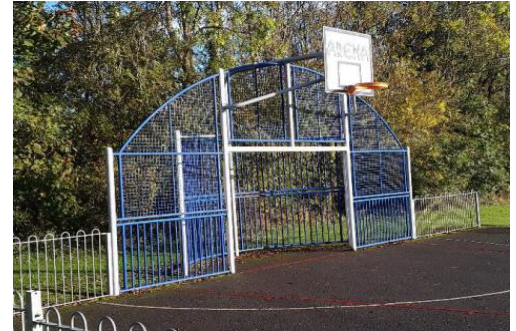
Item: Multi Use Games Area (MUGA)
Manufacturer: Unknown
Surface Type: Tarmac
Item Quantity: 1
Equipment Compliance: No
Surface Area Compliance: N/A

There is/are inserts missing - Replace missing inserts

The paintwork on this item has been damaged or worn exposing the metal underneath which is rusting / corroding - Treat affected areas and repaint

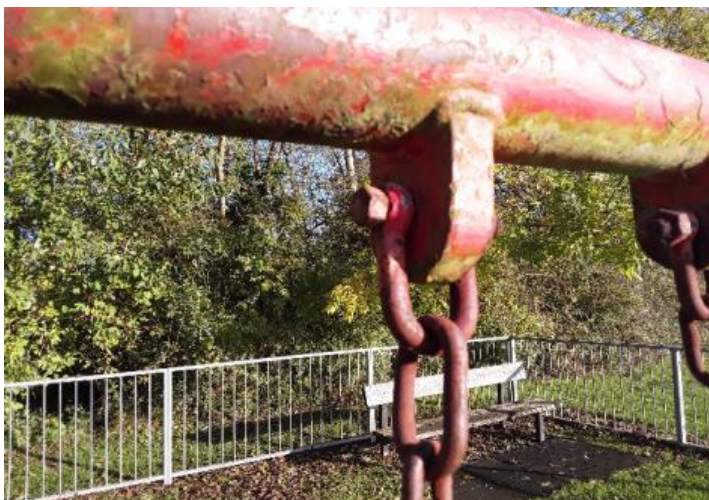
Item: Ancillary Items - Site General
Manufacturer: Not Applicable

Finding: There is algae or moss on the equipment

Action: Clean and treat appropriately

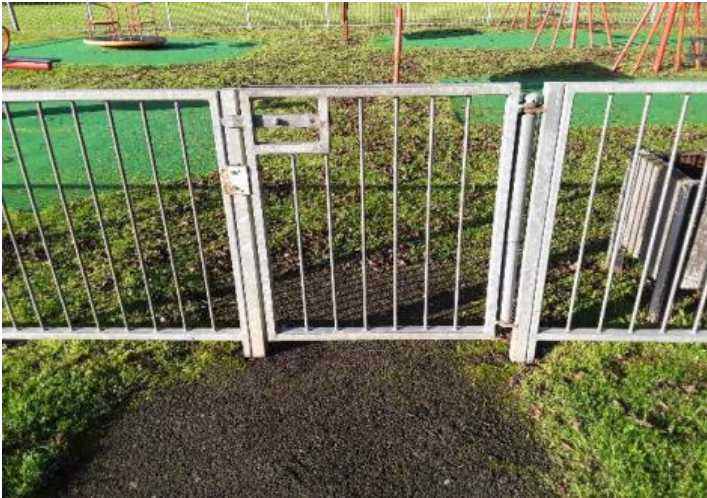
Item: Gates - Gate - Self Closing
Manufacturer: Unknown

Finding: There are openings that are less than 12mm that could trap or crush fingers

Action: Provide a 12mm gap throughout full range of motion at both sides of gate

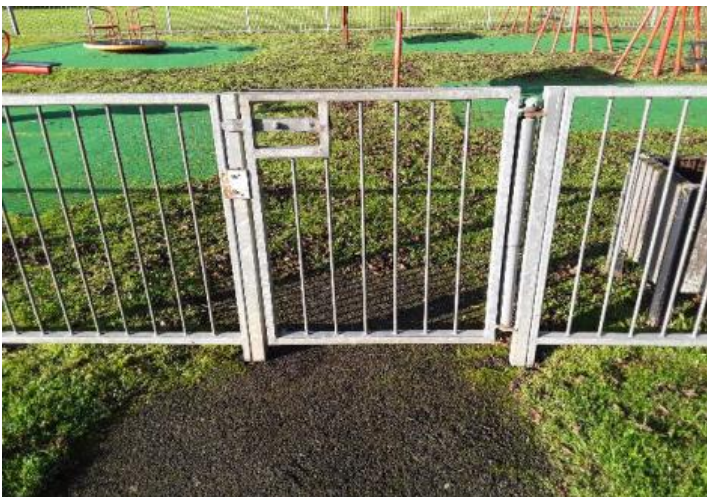
Item: Gates - Gate - Self Closing
Manufacturer: Unknown

Finding: The gate latch doesn't line up with the slot

Action: Monitor and adjust the gate if required

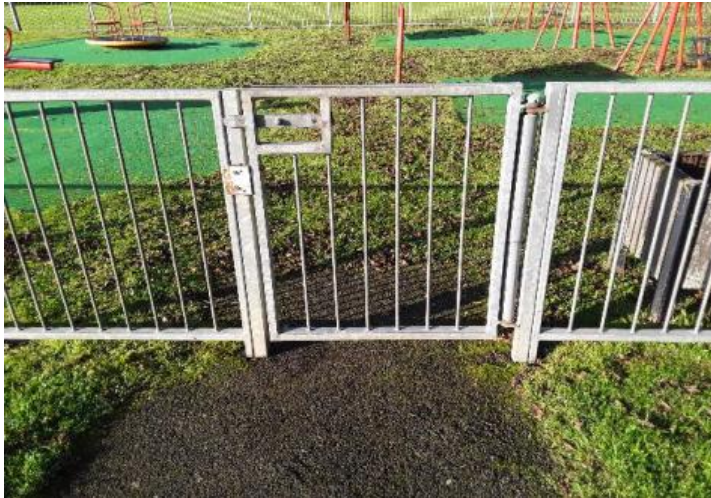
Item: Gates - Gate - Self Closing
Manufacturer: Unknown

Finding: The gate is closing too quickly (less than 4 seconds)

Action: Take corrective action to ensure that the gate closes in 4-8 seconds from 90 degrees

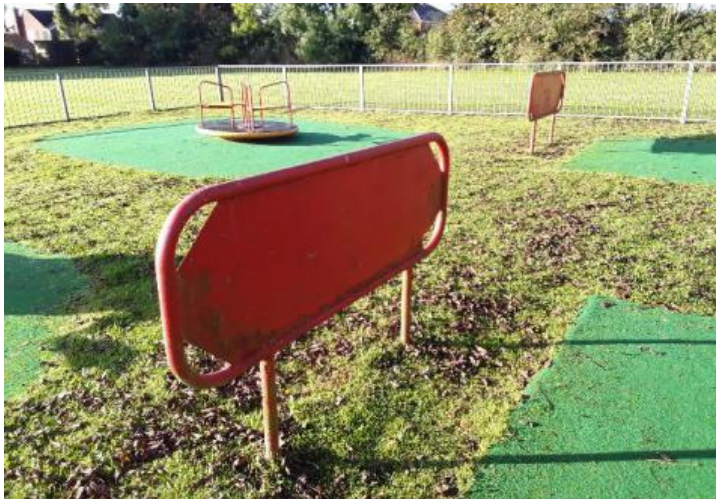
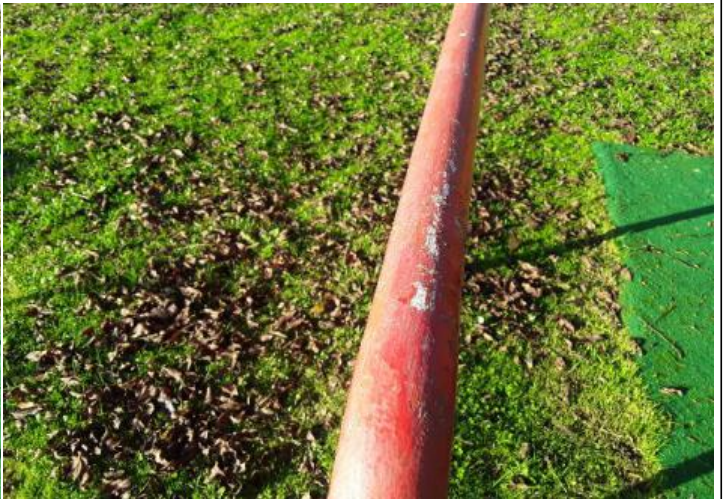
Item: Swings - Swing Barrier
Manufacturer: Wicksteed Playgrounds
Risk Level: L - Low Risk
Surface: Grass

Finding: The paint is flaking off the metalwork
Action: Rub down and re-paint

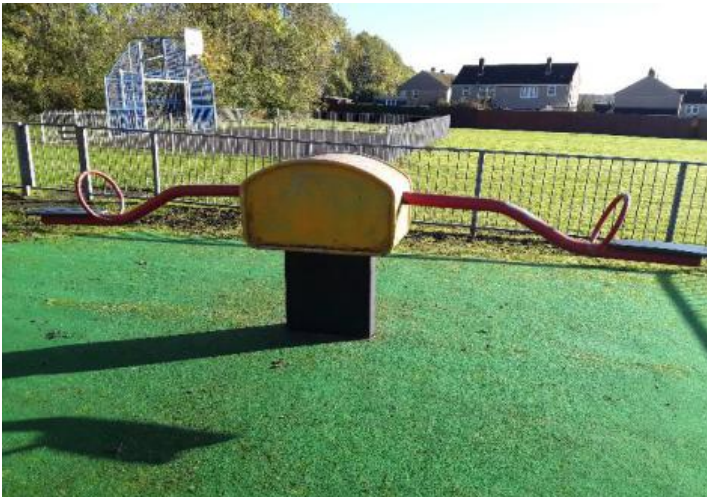
Item: Rocking Equipment - See Saw
Manufacturer: Wicksteed Playgrounds

Finding: There is an exposed sharp corner on the shroud

Action: Remove the sharp corner
