## Annual Inspection

Colsterworth & District Parish Council

Colster Way Play Area

Inspection Ref: 2184915

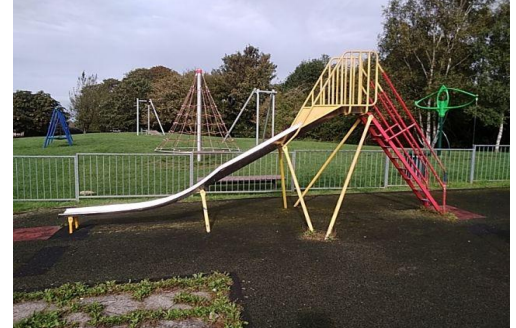
**Item:** Free Standing Slide  
**Manufacturer:** Wicksteed Playgrounds  
**Surface Type:** Wet Pour  
**Item Quantity:** 1  
**Equipment Compliance:** N/A  
**Surface Area Compliance:** N/A

Minor damage to the safety edge of the slide chute. - Monitor

The slide is predominately south facing and will catch the majority of the sun's heat during the day. Slide surfaces can become very warm during periods of sustained sunny weather - Monitor - No remedial work recommended

There is / are toggle entrapment/s present in contravention of the recommendations set out in BS EN 1176 Part 3 - Monitor - no remedial work recommended

The item fails to meet the requirements of BS EN 1176 Part 1 4.2.7.2 head and neck entrapment in the barriers and/or steps - Monitor - No remedial work recommended

Parts of the steel on this item have corroded excessively and the metal has perforated in places at the base of the main stanchion - Replace the main stanchion

**Finding:** Minor damage to the safety edge of the slide chute.

**Finding:** There is / are toggle entrapment/s present in contravention of the recommendations set out in BS EN 1176 Part 3

**Finding:** The item fails to meet the requirements of BS EN 1176 Part 1 4.2.7.2 head and neck entrapment in the barriers and/or steps  
**Action:** Monitor - No remedial work recommended

**Finding:** Parts of the steel on this item have corroded excessively and the metal has perforated in places at the base of the main stanchion

**Action:** Replace the main stanchion

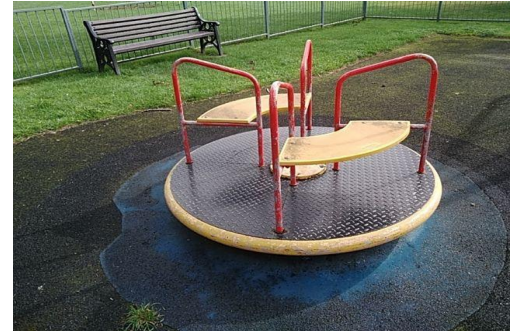
**Item:** Roundabout  
**Manufacturer:** Wicksteed Playgrounds  
**Surface Type:** Wet Pour  
**Item Quantity:** 1  
**Equipment Compliance:** N/A  
**Surface Area Compliance:** N/A

The distance between the underside of the roundabout platform and the playing surface is in excess of 110mm and contravenes the requirements of BS EN 1176 Part 5 which requires that the distance be maintained between 60mm-110mm - for the entire circumference of the roundabout. - Monitor - No remedial work recommended

Slight vertical movement in the platform may be due to wear in the bearings. - Monitor. Grease the bearings annually in accordance with the manufacturer's specification.

The safety surface under or around this unit has been damaged - Monitor for any further deterioration and repair as required

**Finding:** Slight vertical movement in the platform may be due to wear in the bearings.

**Finding:** The safety surface under or around this unit has been damaged

**Action:** Monitor for any further deterioration and repair as required

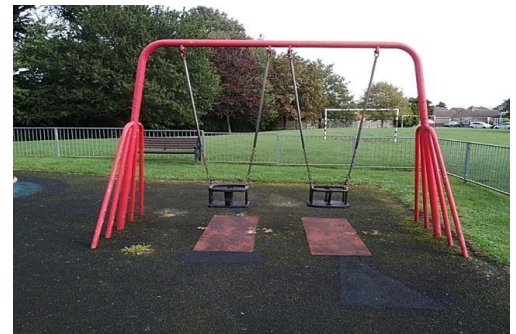
**Item:** 1 Bay 2 Seat (Cradle)  
**Manufacturer:** Wicksteed Playgrounds  
**Surface Type:** Wet Pour  
**Item Quantity:** 1  
**Equipment Compliance:** N/A  
**Surface Area Compliance:** N/A

The chain links are worn in excess of 40% and require renewing - Replace worn chains

The bushes are showing signs of wear - Monitor for any further deterioration and replace as required

**Finding:** The chain links are worn in excess of 40% and require renewing

**Finding:** The bushes are showing signs of wear

**Action:** Replace worn chains

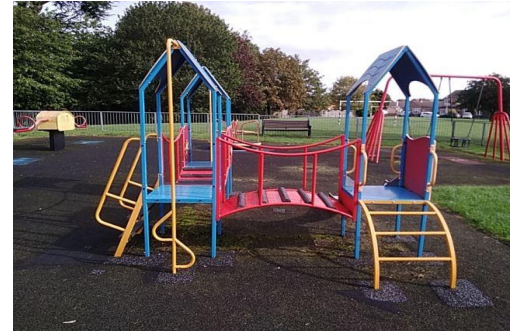
**Item:** Multi Play (Toddler)  
**Manufacturer:** Wicksteed Playgrounds  
**Surface Type:** Wet Pour  
**Item Quantity:** 1  
**Equipment Compliance:** N/A  
**Surface Area Compliance:** N/A

There is algae or moss growth on the surface resulting in slippery conditions - Clean and treat appropriately

The free space between the fireman's pole and the platform is less than the minimum recommended dimension of 350mm in BS EN 1176 Part 1; this is however an intended design feature by the manufacturer to assist younger users in accessing the pole and is a very low risk finding - no remedial action is recommended - Monitor - No remedial work recommended

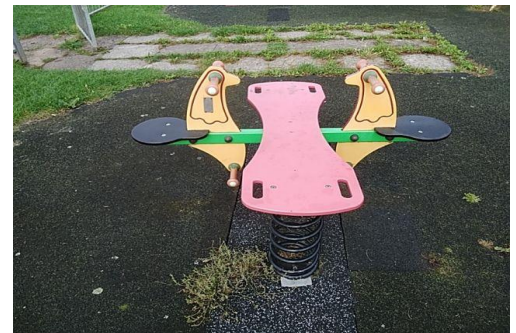
**Item:** Spring See-Saw  
**Manufacturer:** Wicksteed Playgrounds  
**Surface Type:** Wet Pour  
**Item Quantity:** 1  
**Equipment Compliance:** N/A  
**Surface Area Compliance:** N/A

There are post / end caps missing from the item - Replace missing post cap x 1

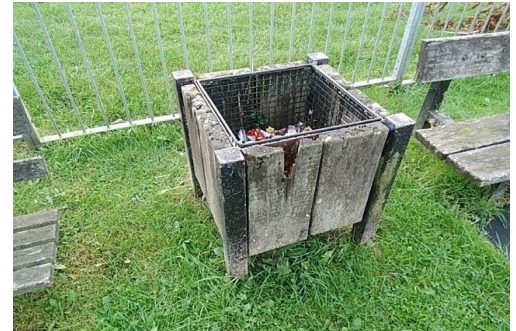
**Item:** Litter Bin  
**Manufacturer:** Wicksteed Playgrounds  
**Surface Type:** Grass  
**Item Quantity:** 1  
**Equipment Compliance:** N/A  
**Surface Area Compliance:** N/A

Wood rot at the timber slats. - Replace as required x 8

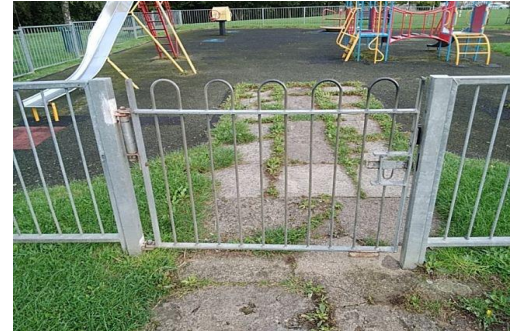
**Item:** Gate - Self Closing  
**Manufacturer:** Unknown  
**Surface Type:** Paving Slabs  
**Item Quantity:** 1  
**Equipment Compliance:** N/A  
**Surface Area Compliance:** N/A

Uneven paving slabs may create trip hazards. - Monitor - rework as required.

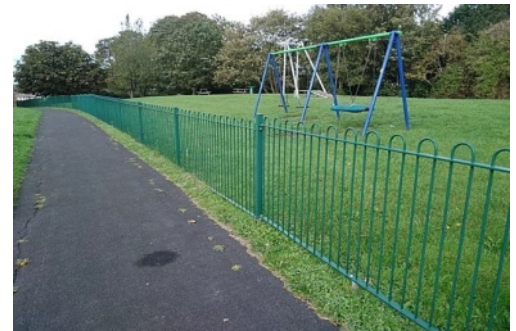
**Item:** Fence - Bow Top  
**Manufacturer:** Unknown  
**Surface Type:** Grass  
**Item Quantity:** 1  
**Equipment Compliance:** N/A  
**Surface Area Compliance:** N/A

1 cap is missing. - Replace the missing cap - refer to the manufacturers for replacement parts.

Loose stones have been laid at the area of ground erosion - Monitor

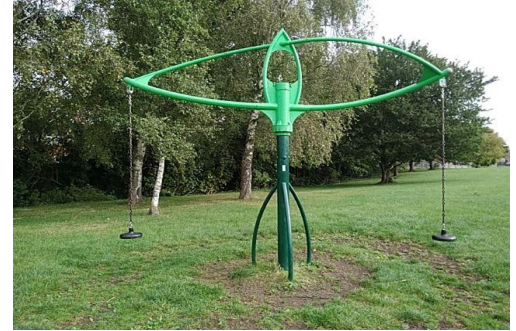
**Item:** Overhead Rotator  
**Manufacturer:** Wicksteed Playgrounds  
**Surface Type:** Grass Matrix Tiles  
**Item Quantity:** 1  
**Equipment Compliance:** N/A  
**Surface Area Compliance:** N/A

The chain links are worn in excess of 40% and require renewing - Replace worn chains

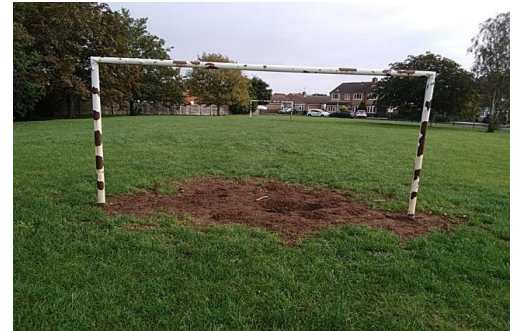
**Item:** Posts  
**Manufacturer:** Unknown  
**Surface Type:** Grass  
**Item Quantity:** 2  
**Equipment Compliance:** N/A  
**Surface Area Compliance:** N/A

Corrosion - Rub down and repaint as required

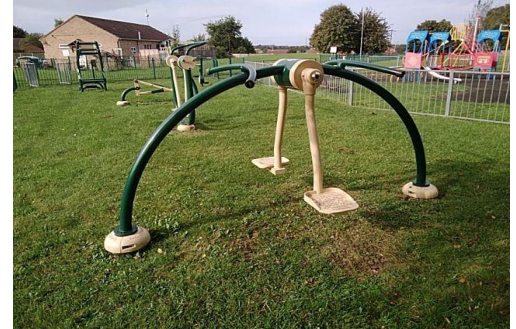
**Item:** Surfer  
**Manufacturer:** Wicksteed Playgrounds  
**Surface Type:** Grass Matrix Tiles  
**Item Quantity:** 1  
**Equipment Compliance:** N/A  
**Surface Area Compliance:** N/A

There is/are bolt cap covers missing or damaged on the item - Replace missing or damaged bolt cap covers x 4

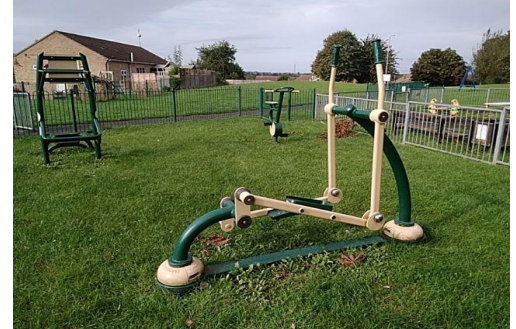
**Item:** Skier  
**Manufacturer:** Wicksteed Playgrounds  
**Surface Type:** Grass Matrix Tiles  
**Item Quantity:** 1  
**Equipment Compliance:** N/A  
**Surface Area Compliance:** N/A

The instruction label has faded - Replace the label

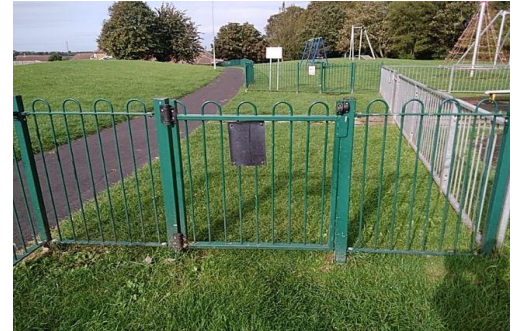
**Item:** Gate - Self Closing  
**Manufacturer:** Unknown  
**Surface Type:** Grass  
**Item Quantity:** 1  
**Equipment Compliance:** N/A  
**Surface Area Compliance:** N/A

There are post / end caps missing from the item - Replace missing post caps

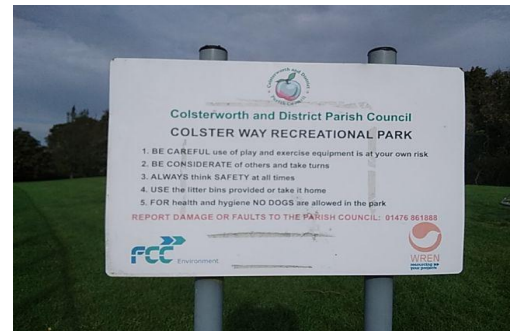
**Item:** Playground Sign  
**Manufacturer:** Unknown  
**Surface Type:** N/A  
**Item Quantity:** 2  
**Equipment Compliance:** N/A  
**Surface Area Compliance:** N/A

BS EN 1176 Part 7 recommends that signage shall include emergency contact details - Provide additional information
