Colsterworth War Memorial
Stone Investigation & Repairs
Proposed Repairs

3501/101
All Drawings Copyright of PPIY Limited

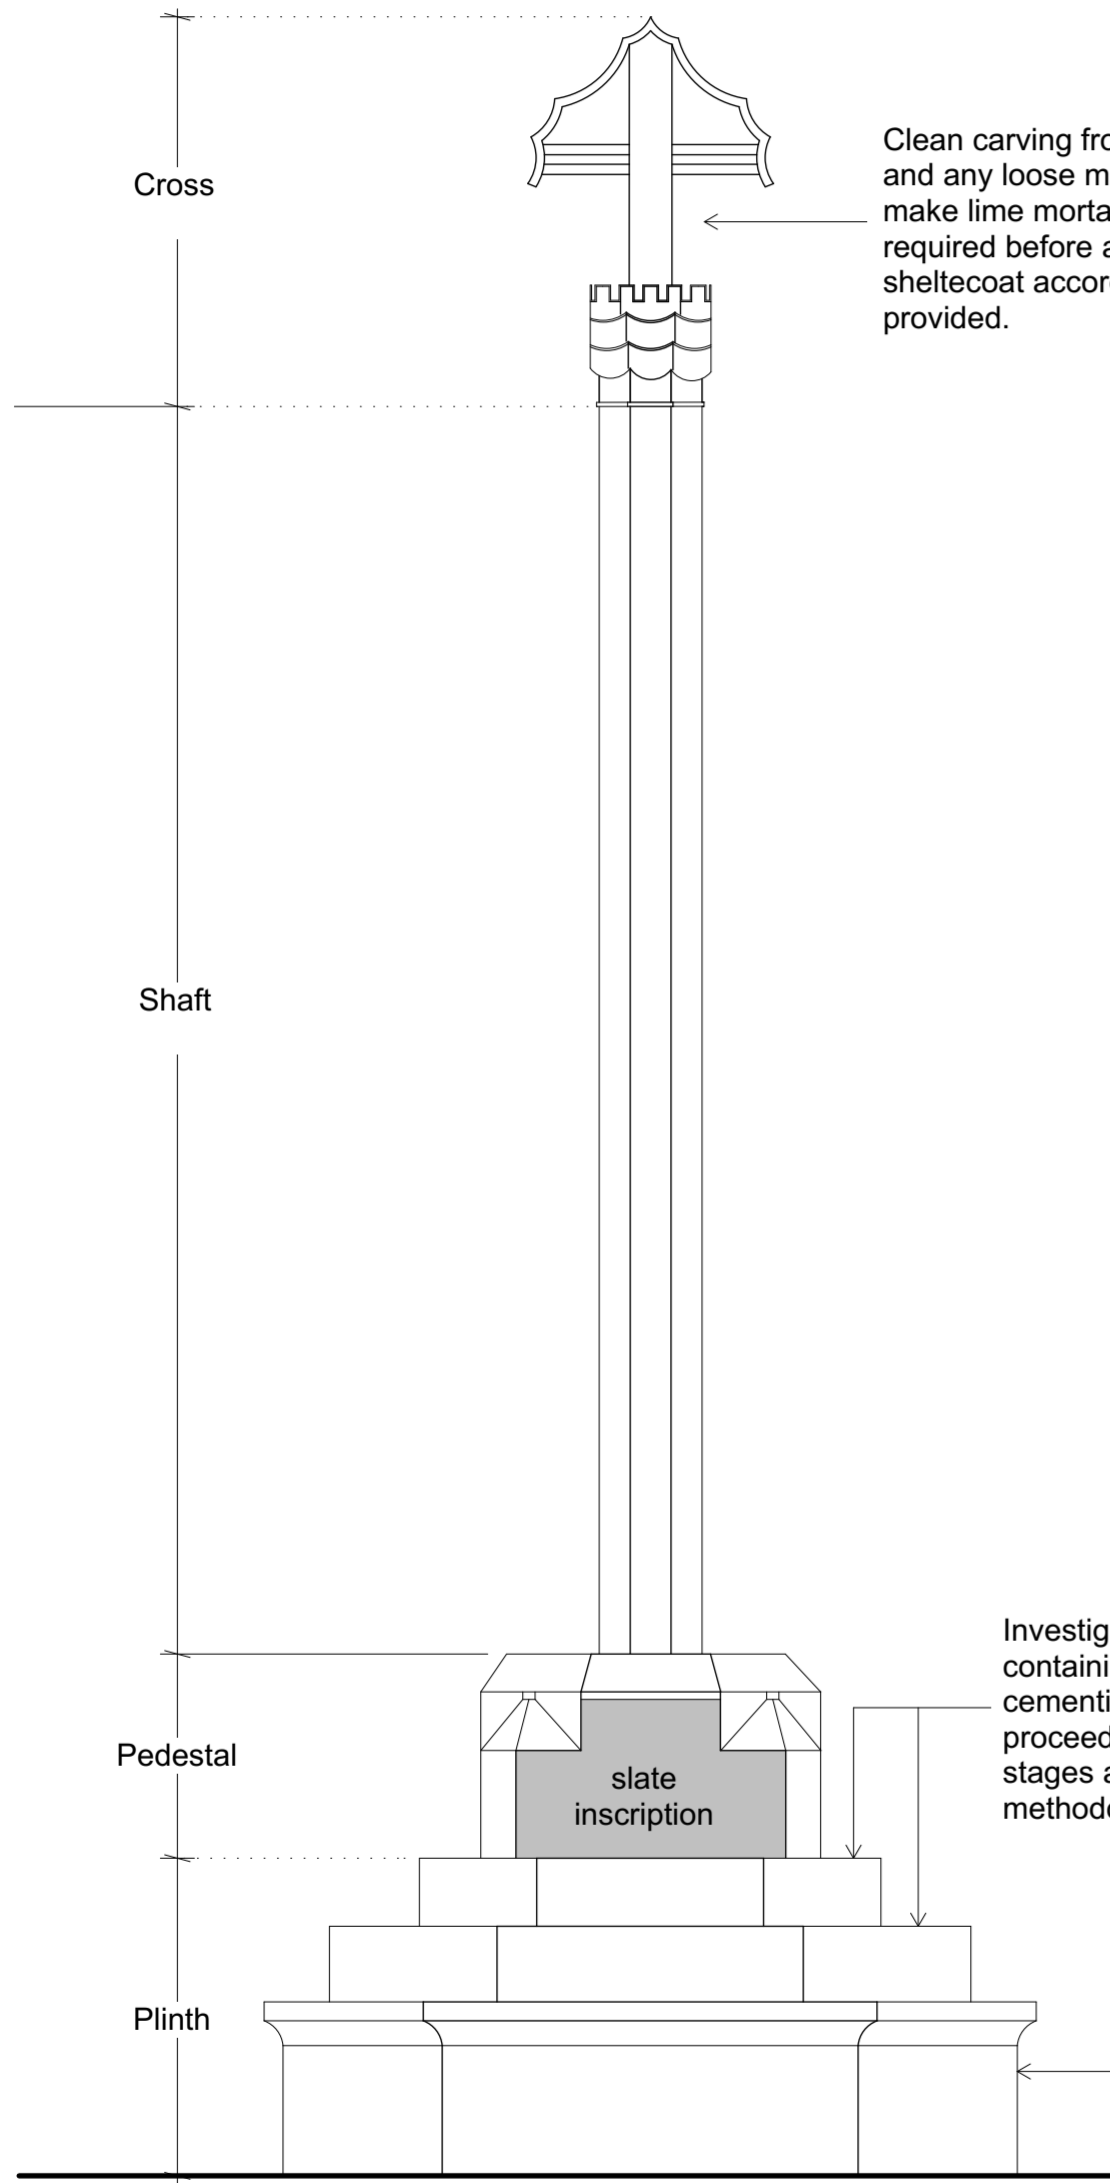
ELEVATION_PROPOSED
SCALE 1:20

Clean carving from moss and any loose material, make lime mortar repairs as required before applying a sheltecoat according to spec provided.

Investigate the two top steps for containing DPM and/or cementitious material and proceed with their removal in stages according to methodology for the first step.

Working in stages from side to side, lift the coping stones of the first plinth step for the removal of DPM and cementitious mortar, followed by stone repairs according to schedule provided. Provisionally allow for the full disassembly of the stonework (after careful recording to allow for precise reinstatement), if this is found to be bedded on hard cementitious mortar. Reinststate and repoint 100% with lime mortar according to specification.
